# Ditching related Analysis Overview

Argiris Kamoulakos

January 2019

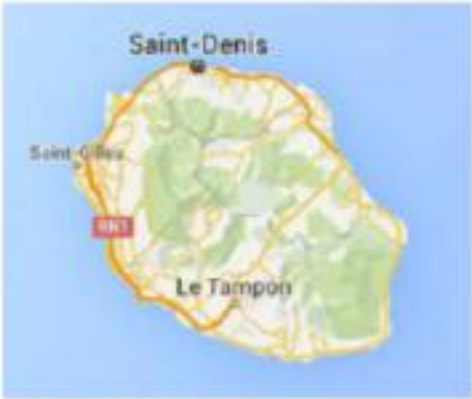
Ref.	Date Found	Debris	Location	Remarks
Item 1	29 July 2015	  <p>Right Flaperon</p>

<p>Saint-Denis, Réunion Island</p>	<ul style="list-style-type: none"><li>• <i>Confirmed</i> by French Judicial Authority belonging to MH370 on 03 September 2015</li><li>• Refer to <i>Appendix 1.12A-1</i> and <i>Appendix 1.12A-2</i></li></ul>

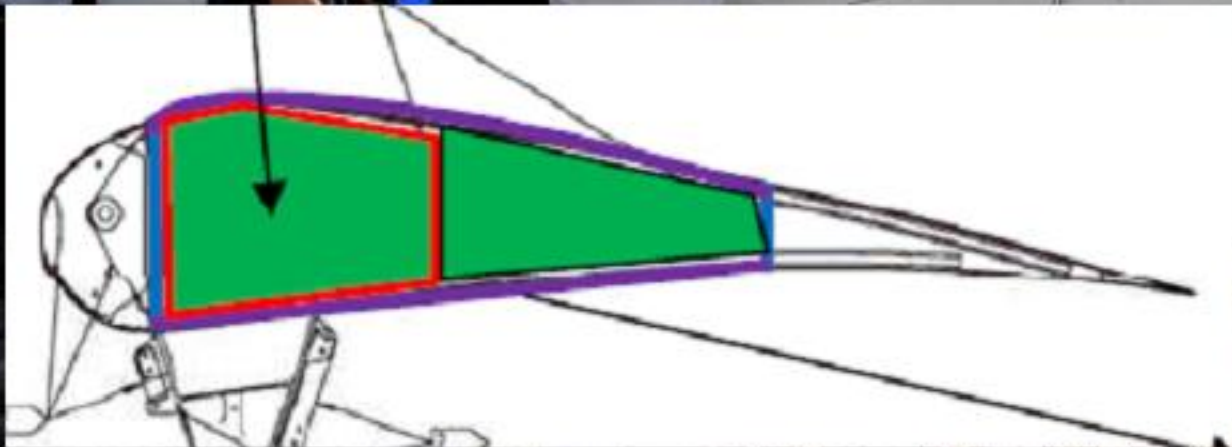
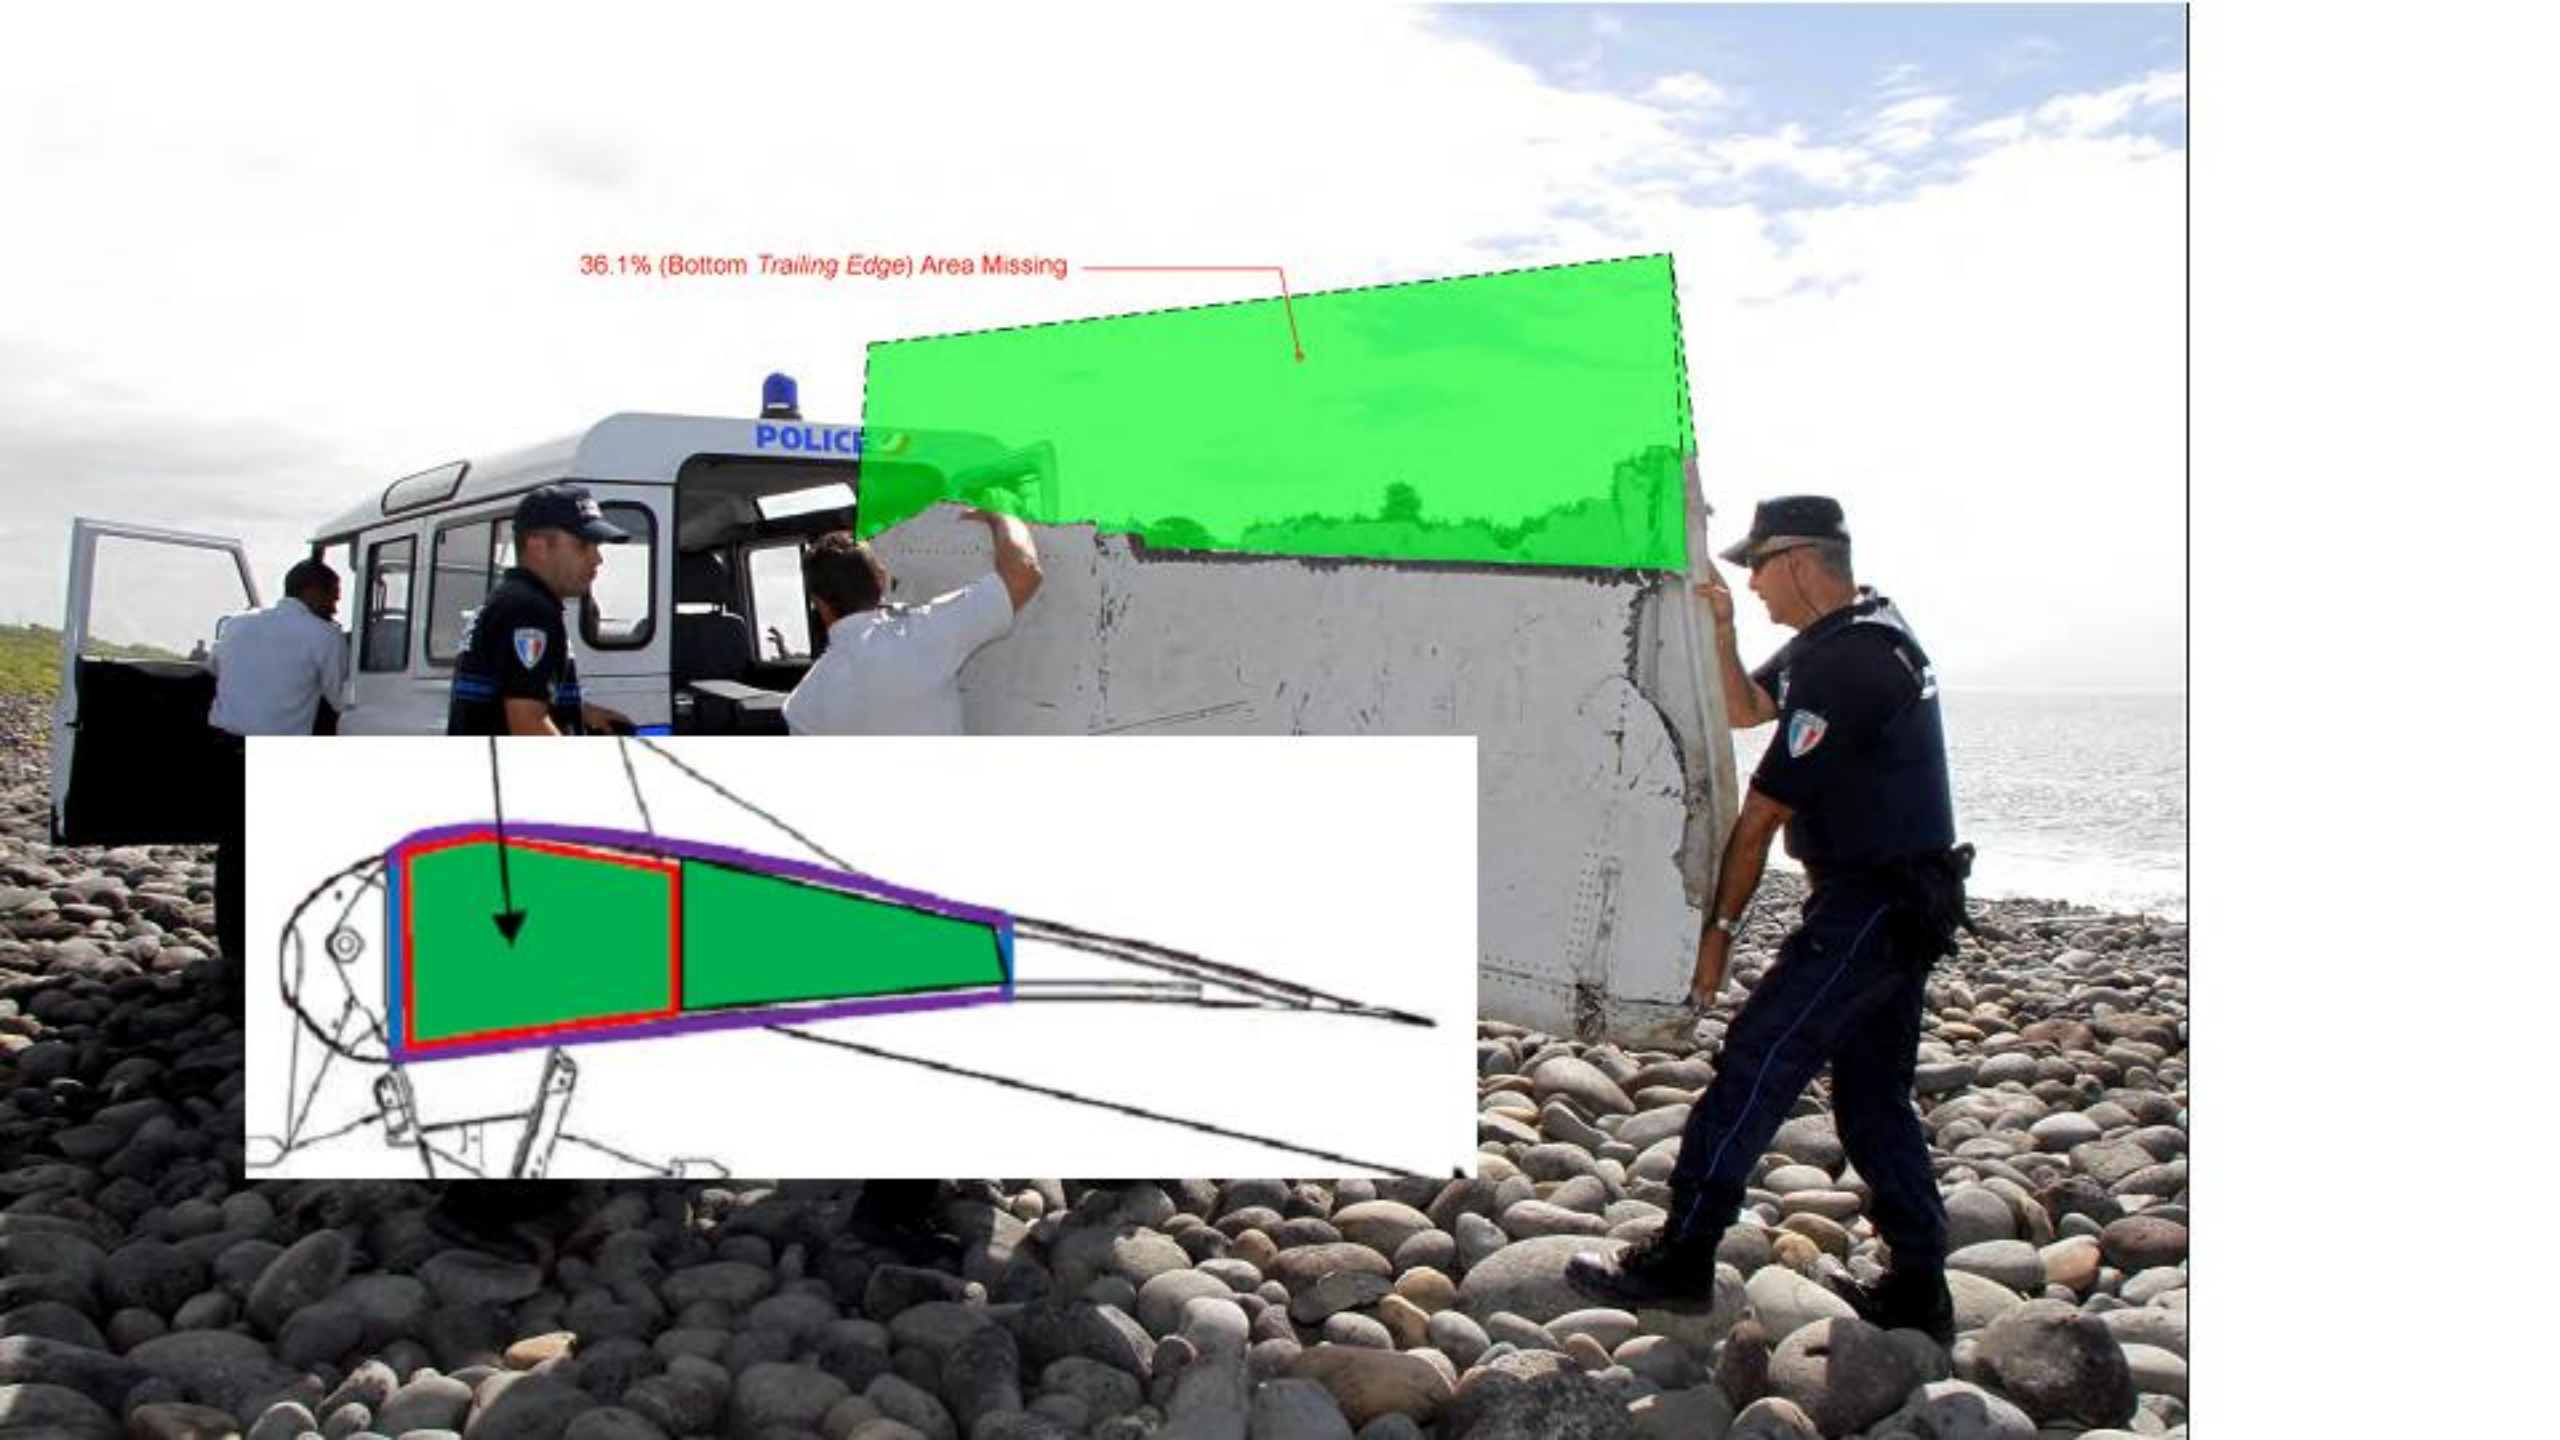
36.1% (Bottom *Trailing Edge*) Area Missing

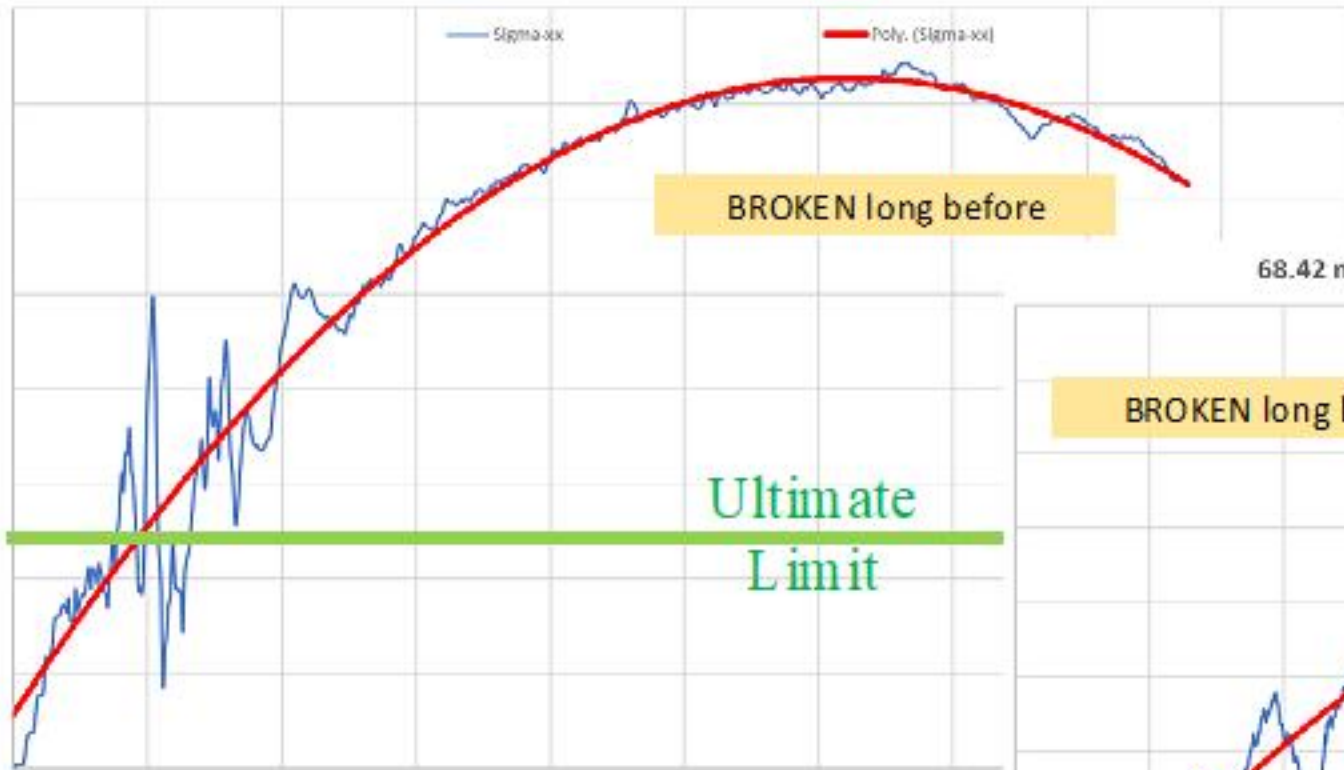
55 m/sec Horizontal speed and 10 m/sec Vertical speed

# Maximum tensile stress at the lower trailing edge skin at the 150mm spar Two different speed configurations

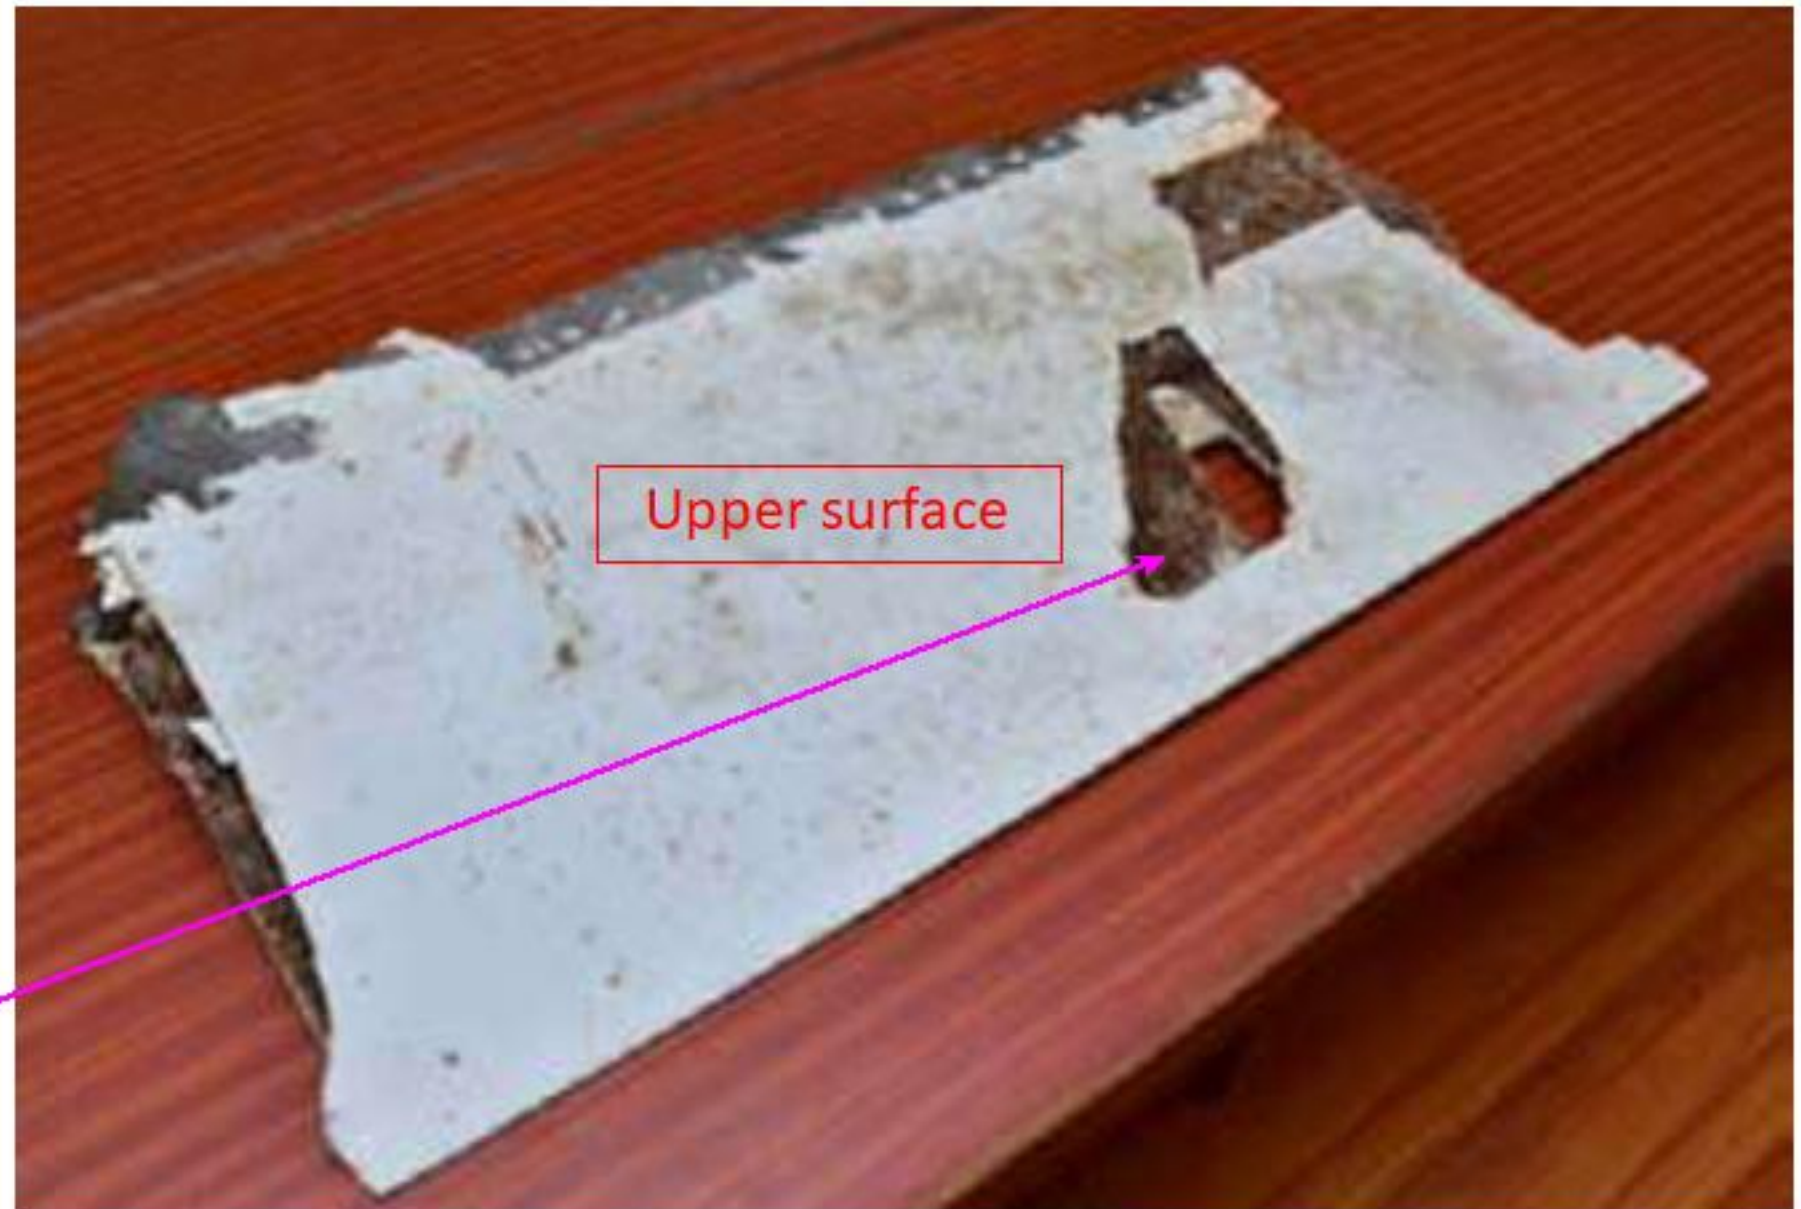
## Left Outboard Flap

Clear perforation due to high speed impact

Most likely from lower surface

CFRP skin debonded from honeycomb core at the exit hole (upper surface)

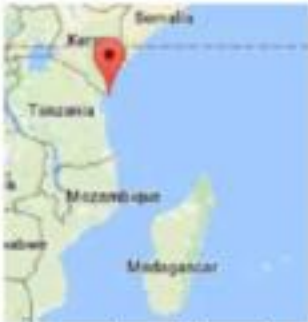
Ref.	Date Found	Debris	Location	Remarks
Item 19	20 June 2016	  <p>Right Outboard Flap</p>

<p>Pemba Island, East of Tanzania</p>	<ul style="list-style-type: none"><li>• The part is <i>confirmed</i> from MH370</li><li>• Refer to <i>Appendix 1.120</i></li></ul>

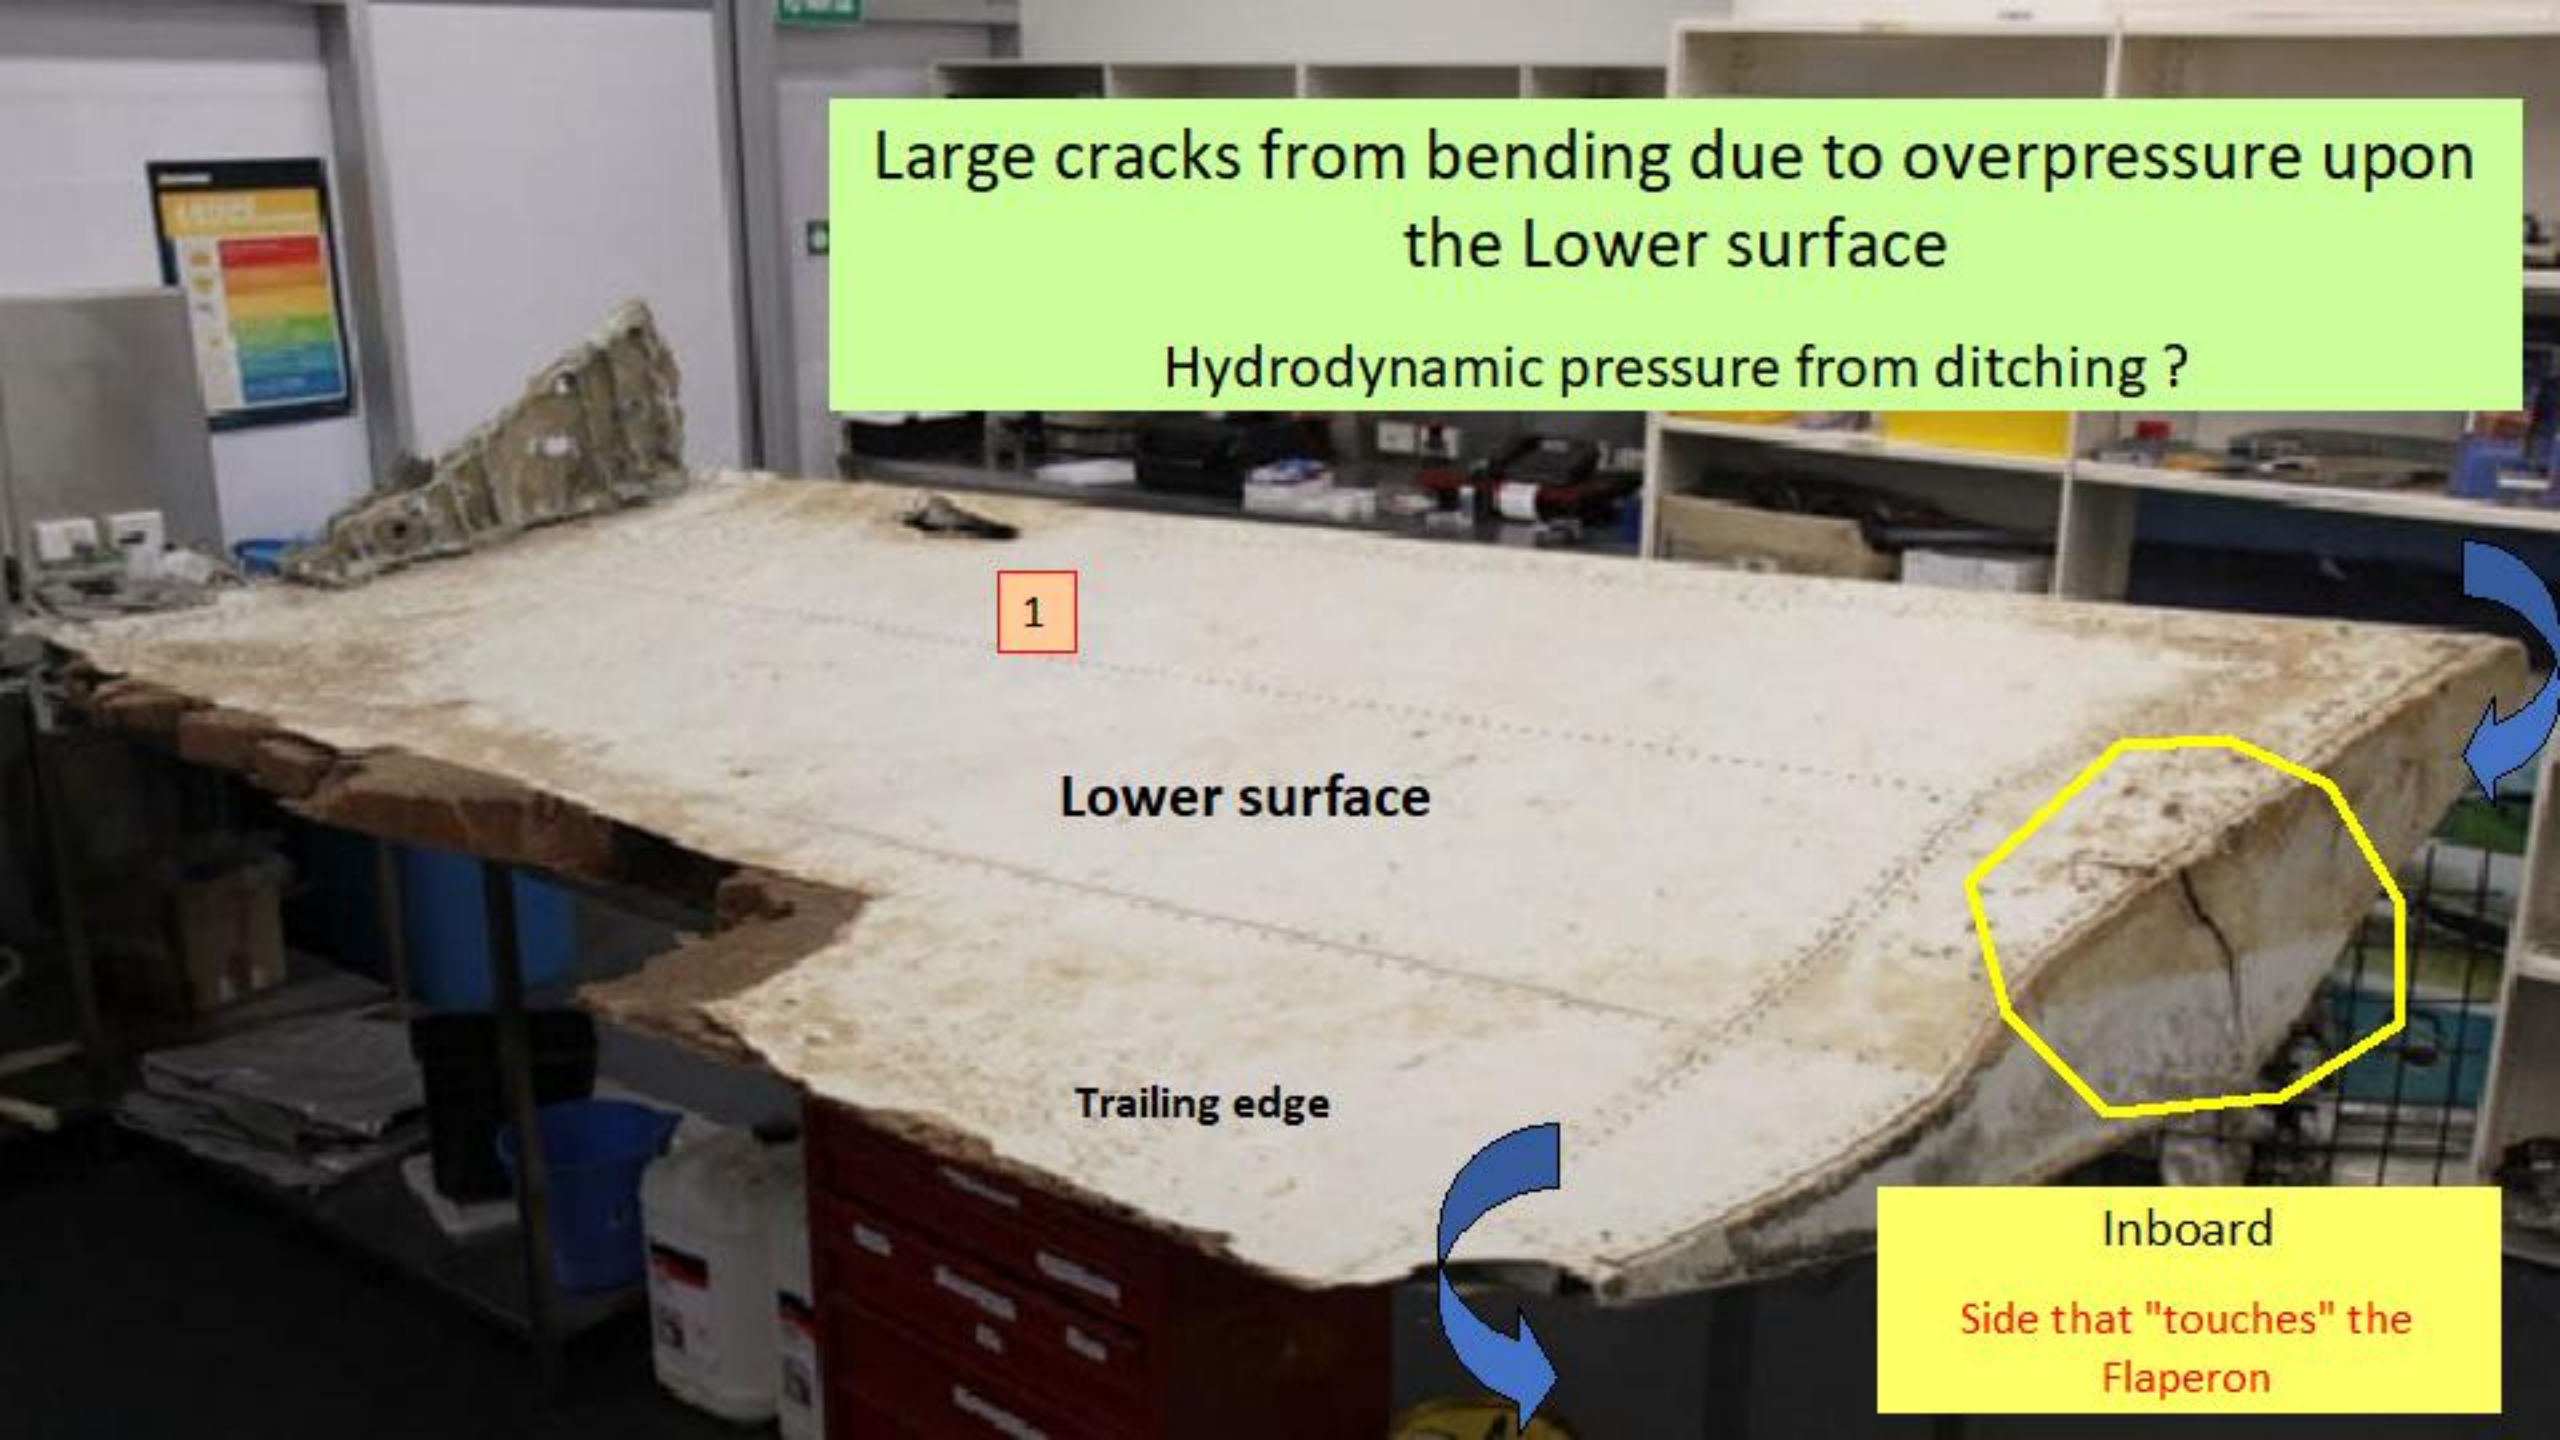
# Right Outboard Flap

Large cracks from bending due to overpressure upon  
the Lower surface

Hydrodynamic pressure from ditching ?
