Towards the last seconds of the MH370

Argiris Kamoulakos 08 March 2021

CAPTIO Team Member

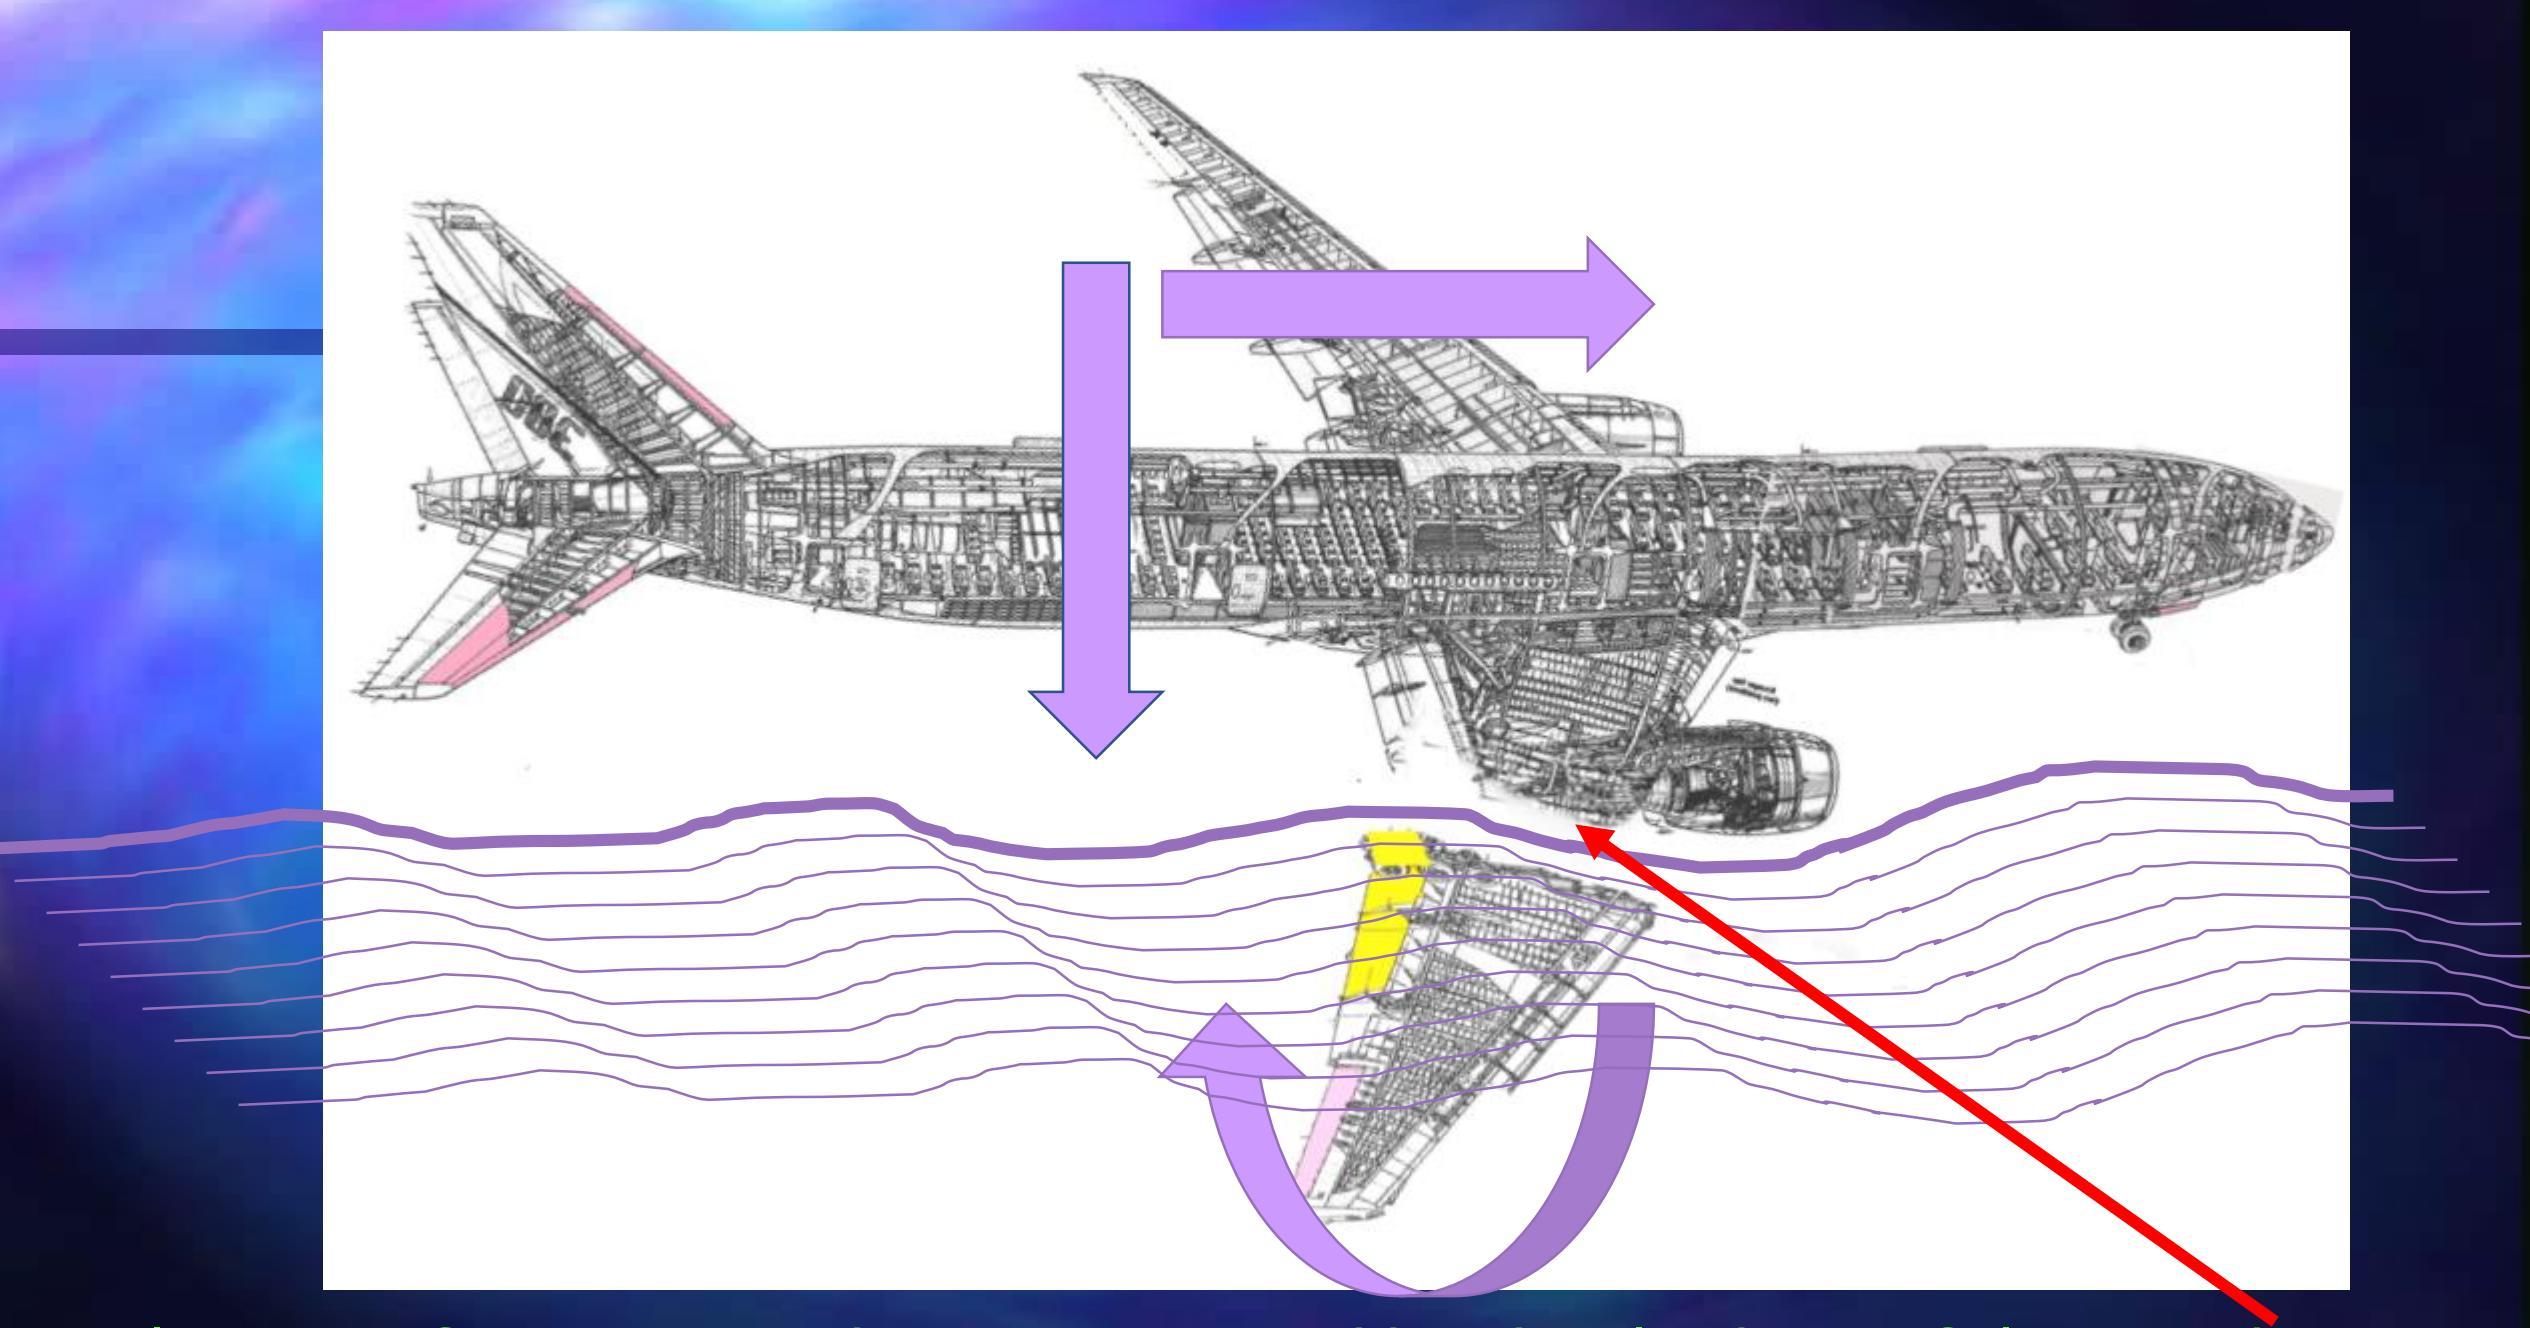
To our understanding, Rib 25 area appears to be in the vicinity of the flaperon and right engine support pylon, close to were the inner part of the outer flap begins.

Violent wing first-impact with extreme upward bending leading to failure in Rib 25 area

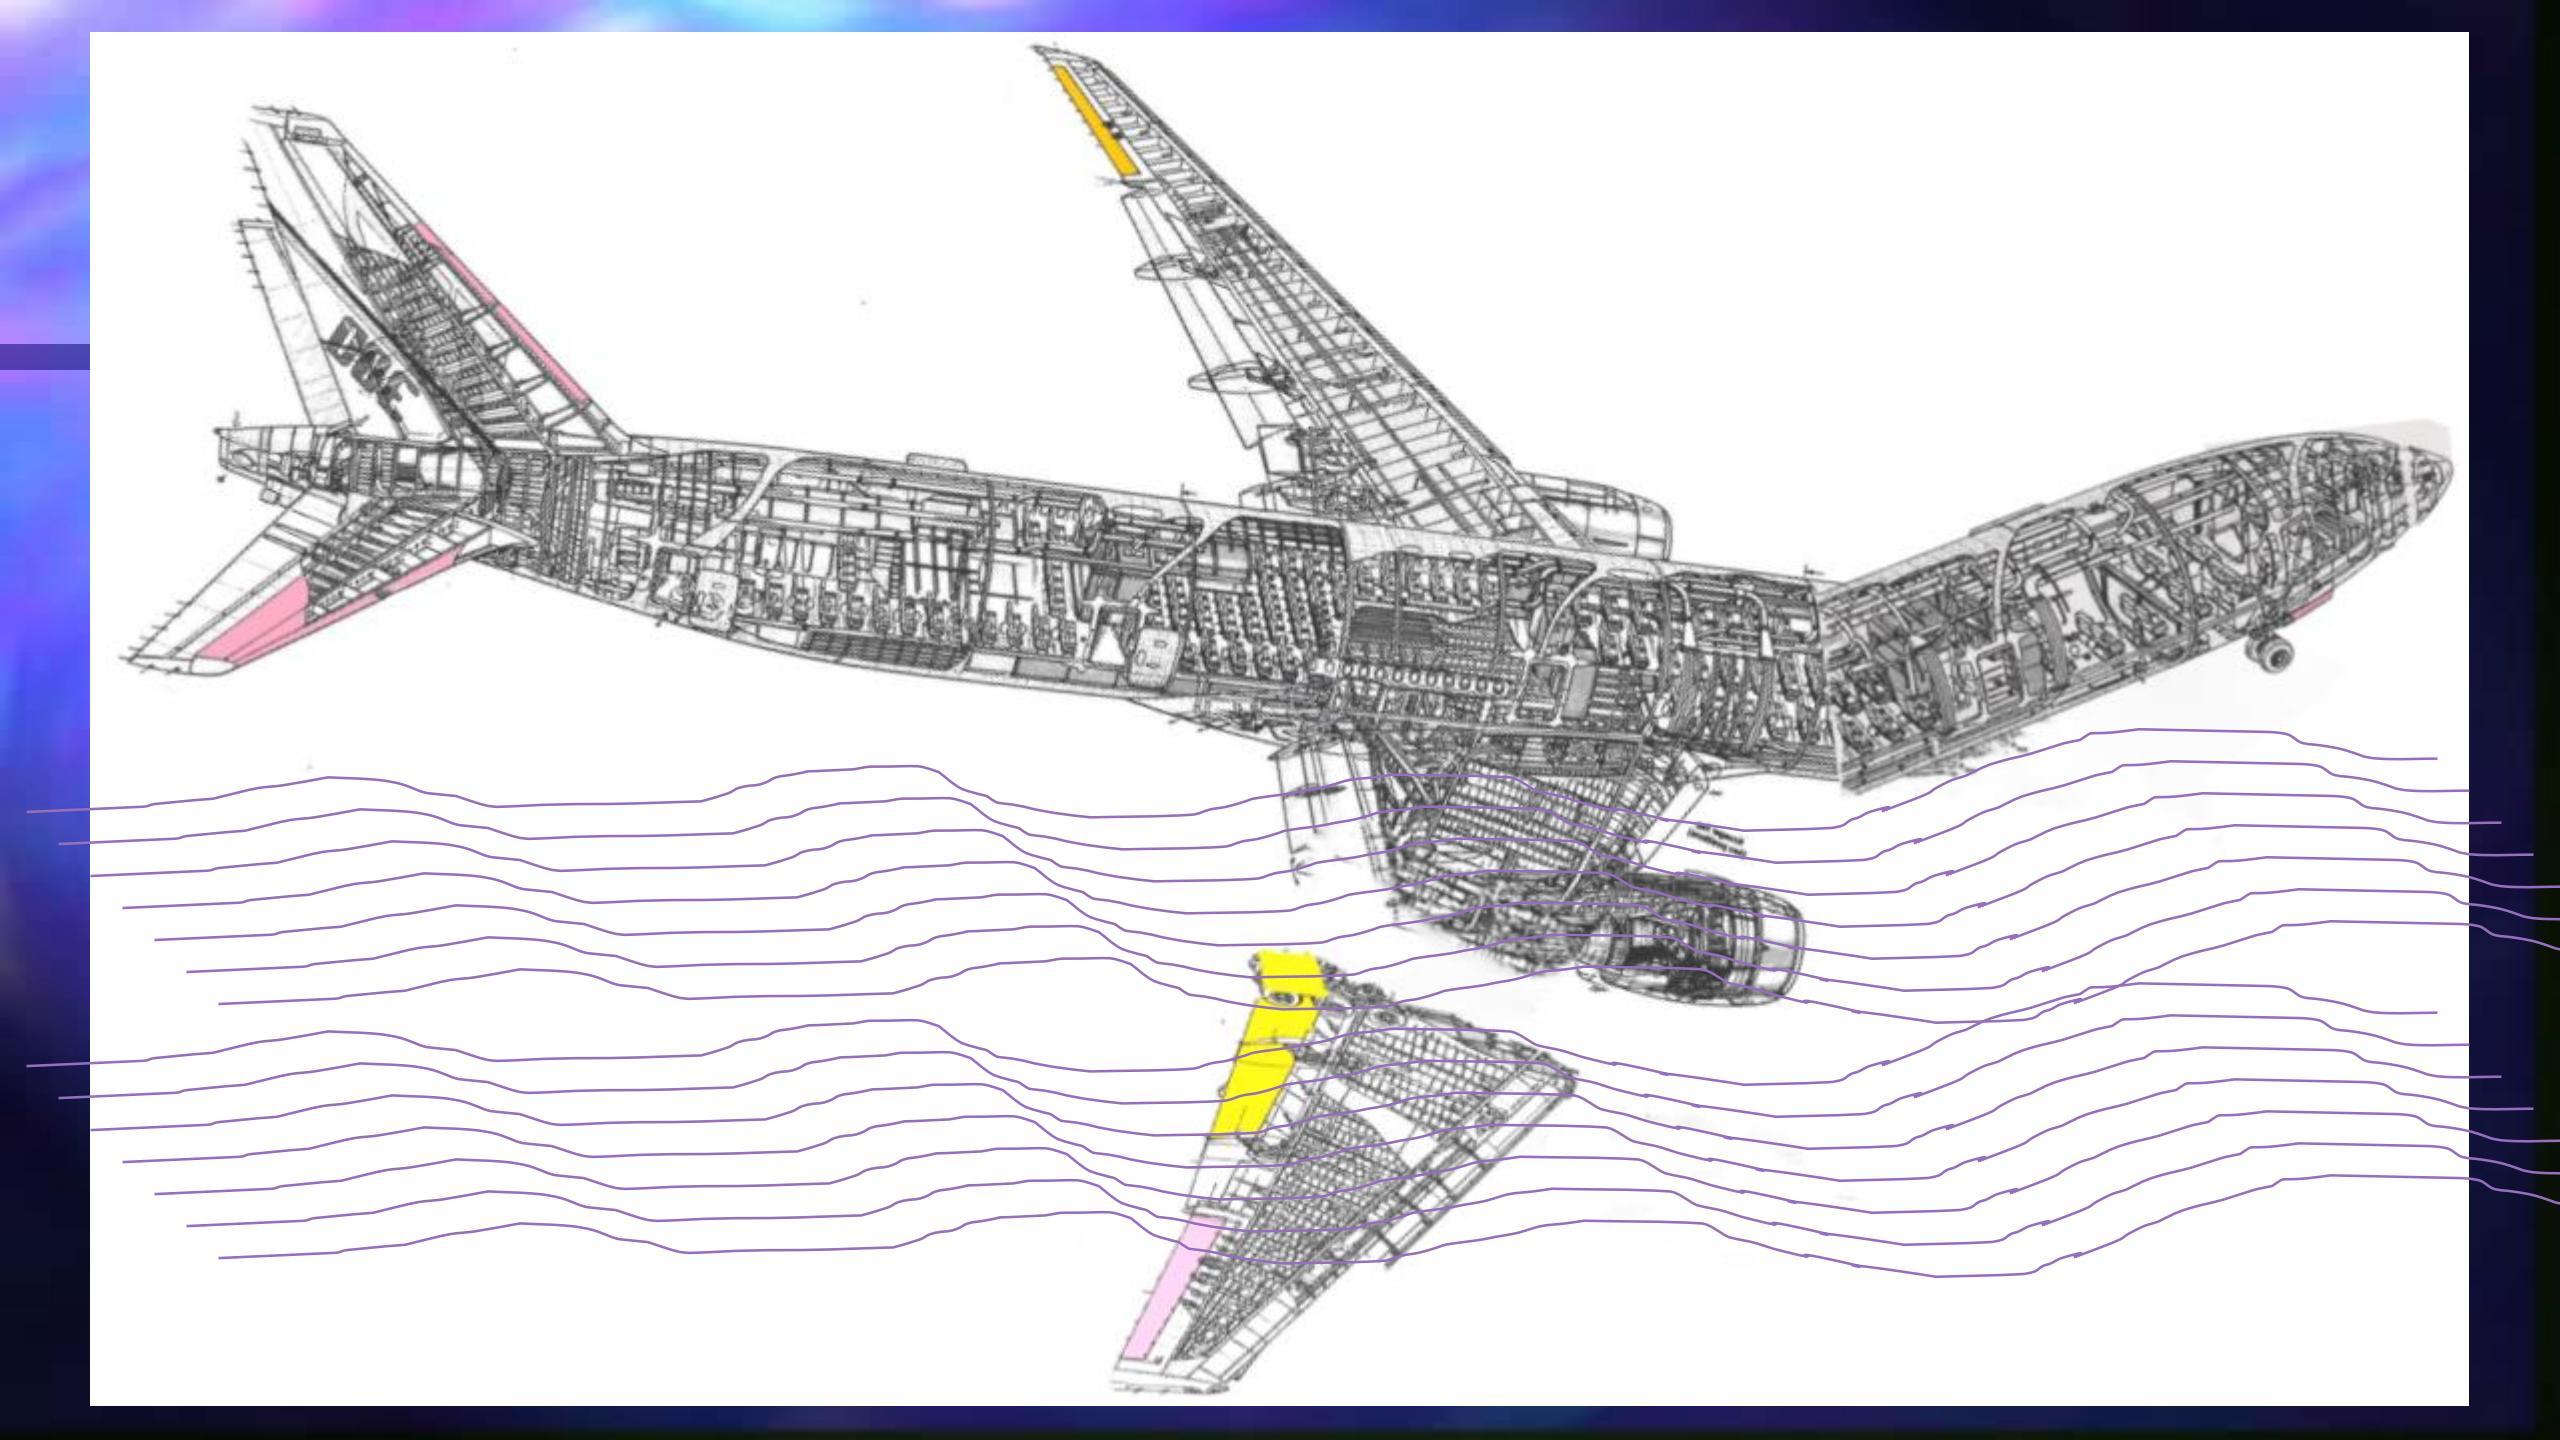
Yaw rotation and impact of the aircraft "nose"

It follows a large aircraft yaw to the right (pivoting around the deforming right wing) and impact of the aircraft frontal fuselage underbelly releasing (at least) the right hand nose gear forward door.

damage of the frontal part of the fuselage/cabin that might lead to rupture at the level of the attachment to the "central wingbox" (junction between wing and fuselage).

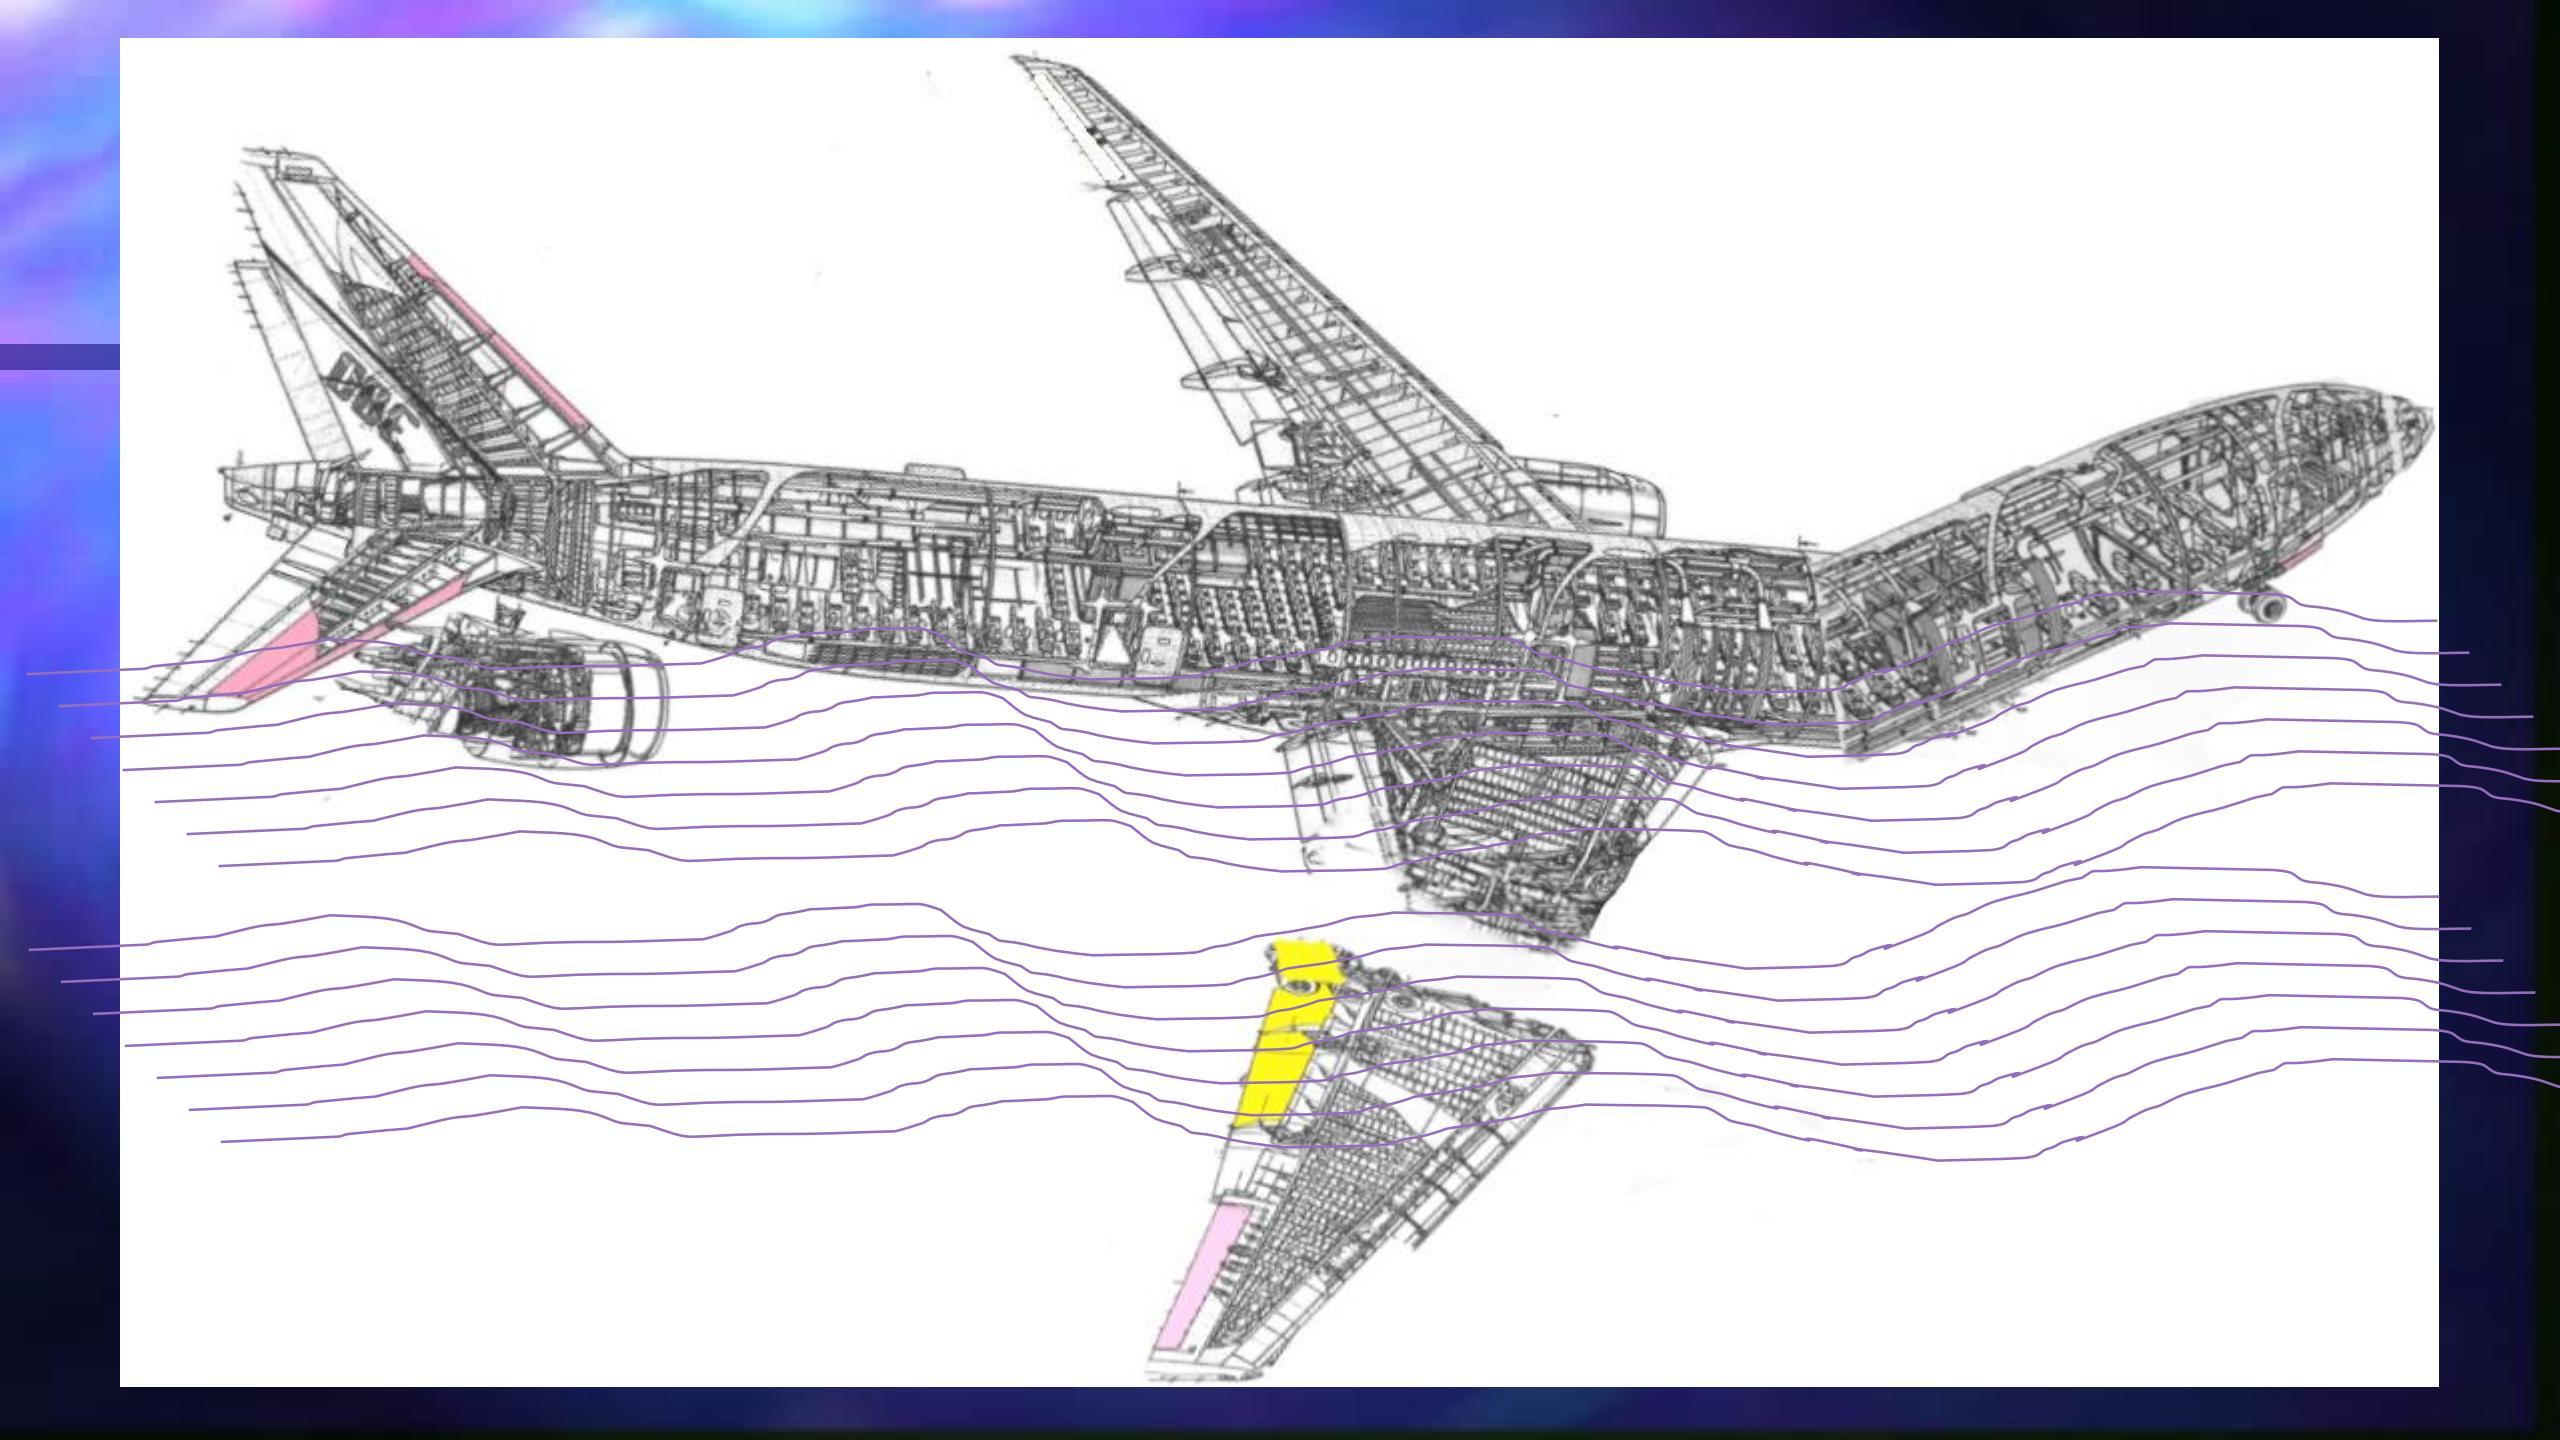
Release of the right engine

Release of the right engine from its supports due to the large vertical and axial hydrodynamic loads.
Evidence from the cowling debris failure mode (bi-axial tension) that suggests internal hydrodynamic overpressure.
Released engine and associated debris possibly moving backwards over the right wing and impacting the right horizontal stabilizer and the vertical tail fin.

Damage or eventual rupture of the rear part of the fuselage/cabin at the level behind the junction with the wing.

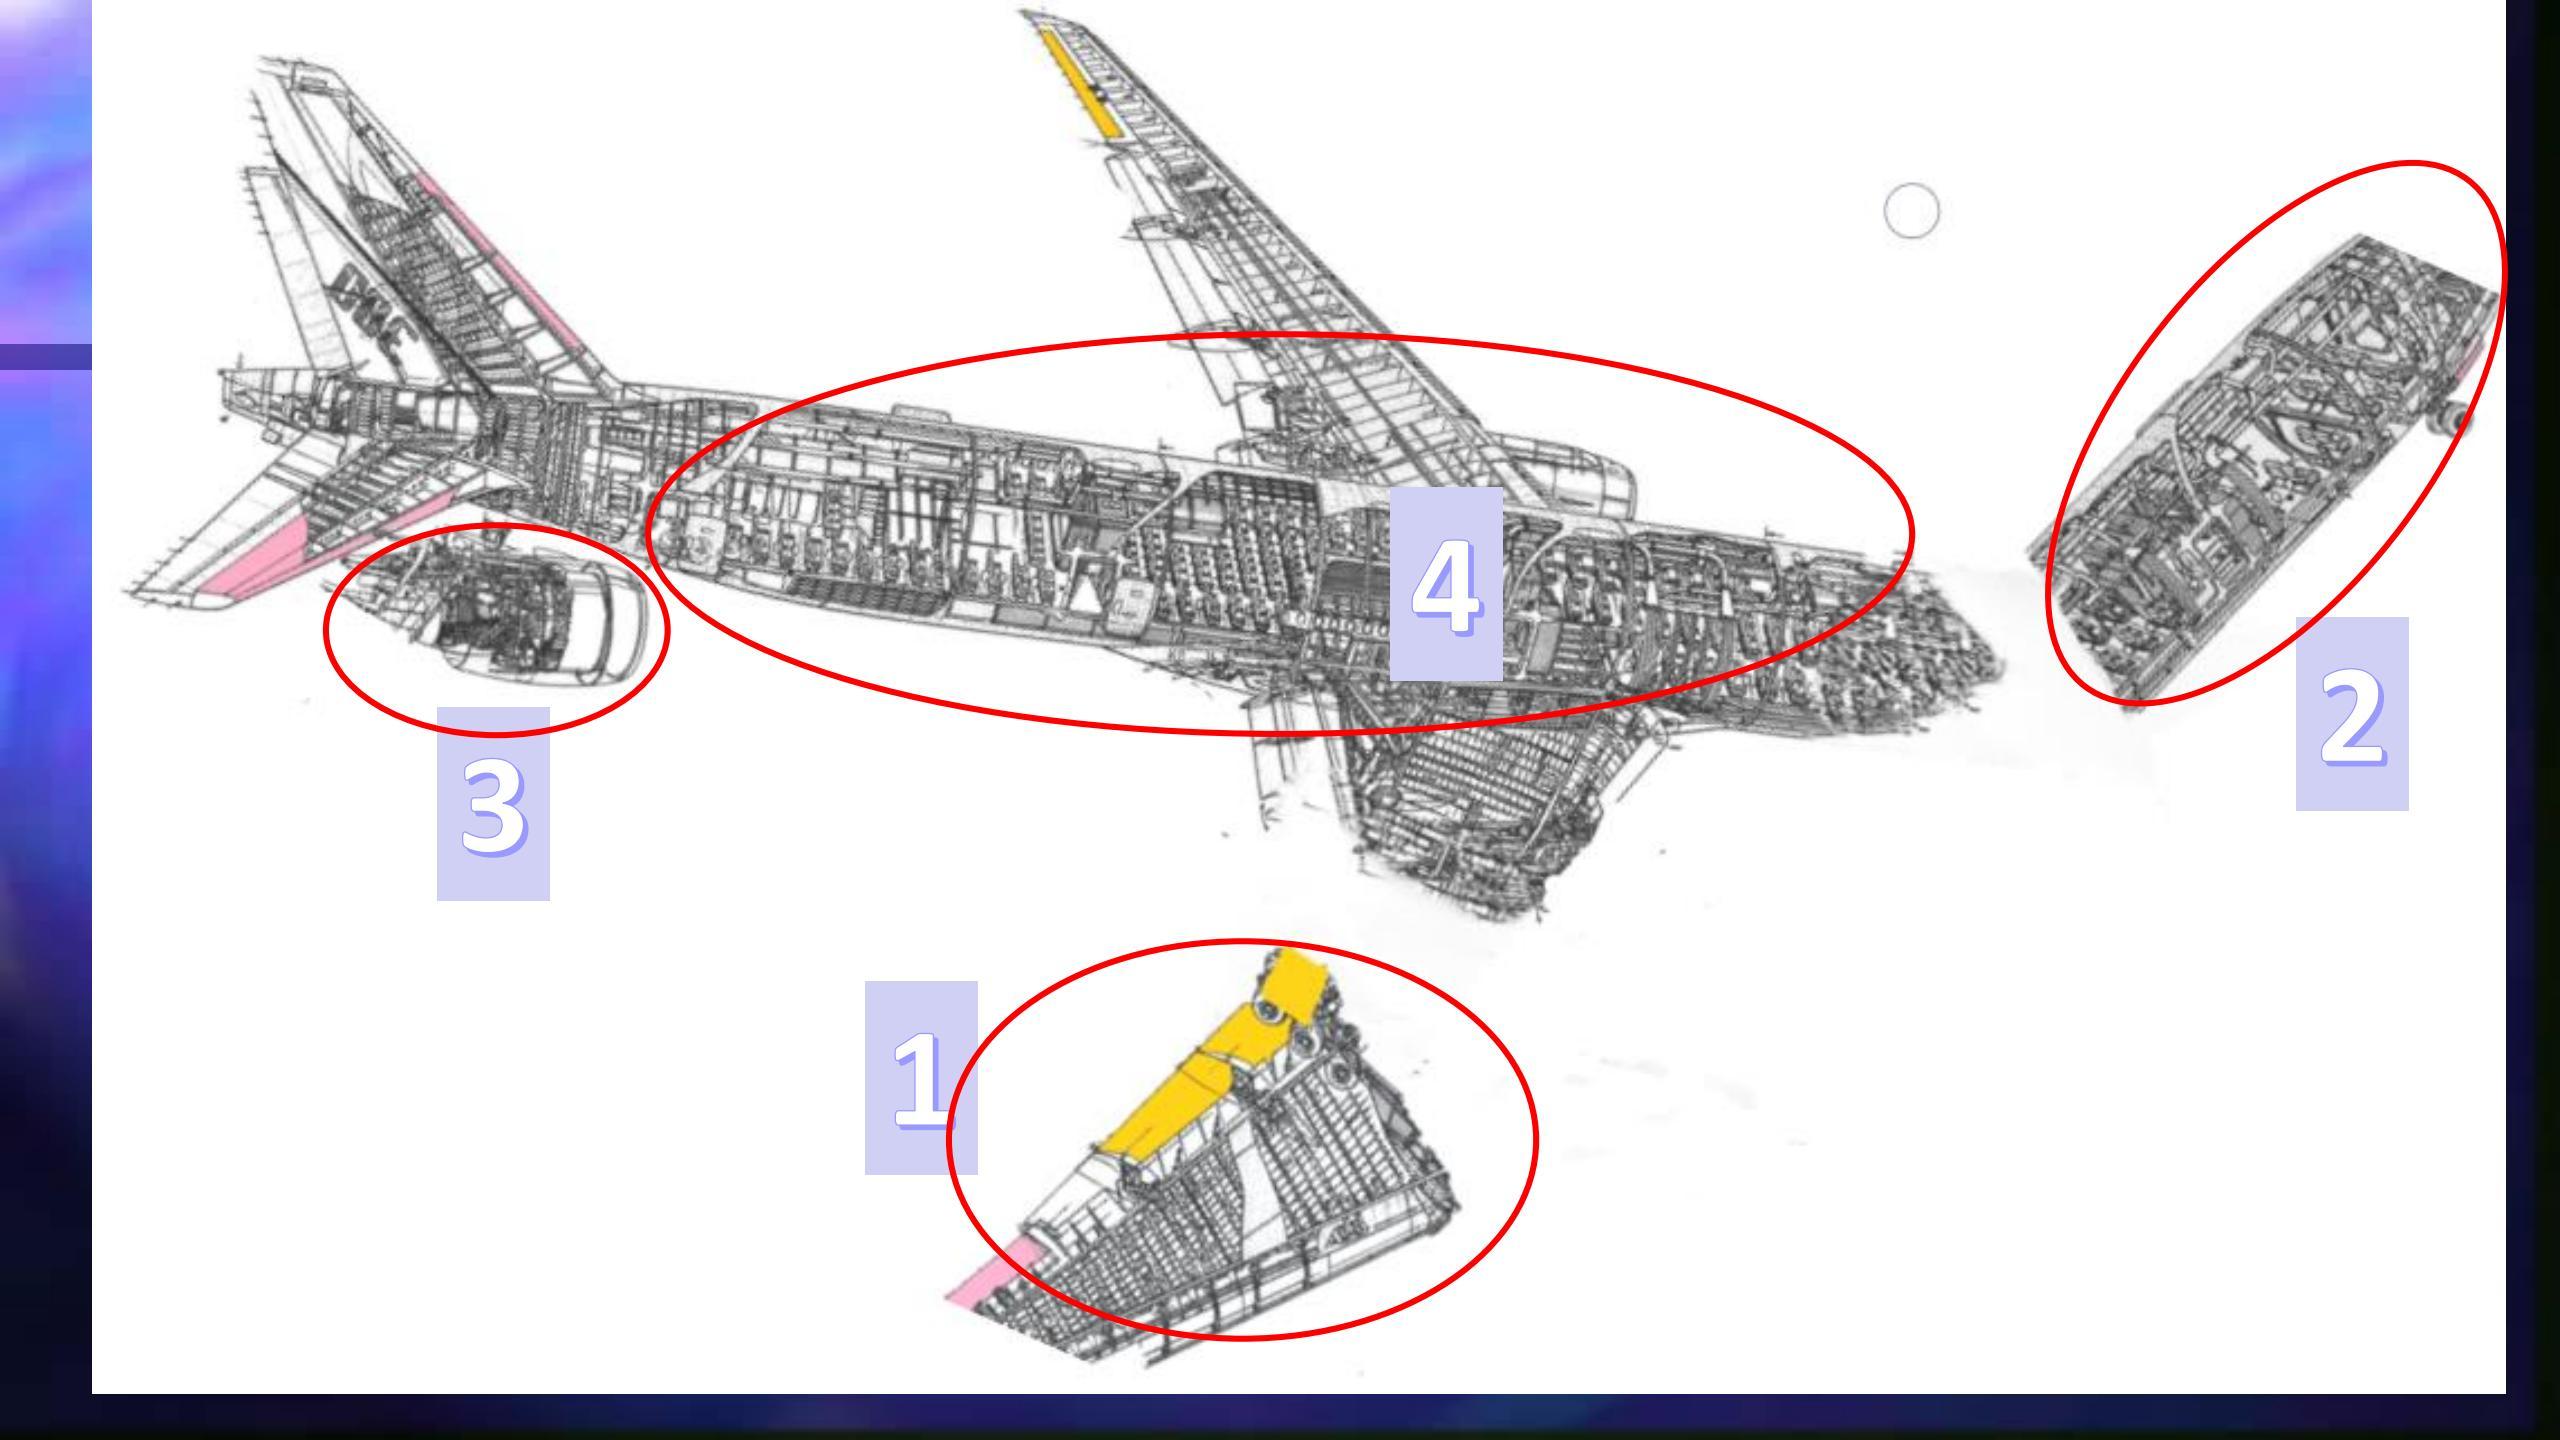
- Finally the main aircraft wreckage could consist of <u>four parts</u>:
- 1. The right wing part from the engine pylon (Rib 25 area) outwards.
- 2. The front part of the fuselage heavily damaged or detached.
- 3. The right engine.
- 4. The central fuselage with the root of the right wing and the entire left wing plus maybe the left engine and maybe the rear fuselage with the tailfin and right stabilizer heavily damaged.

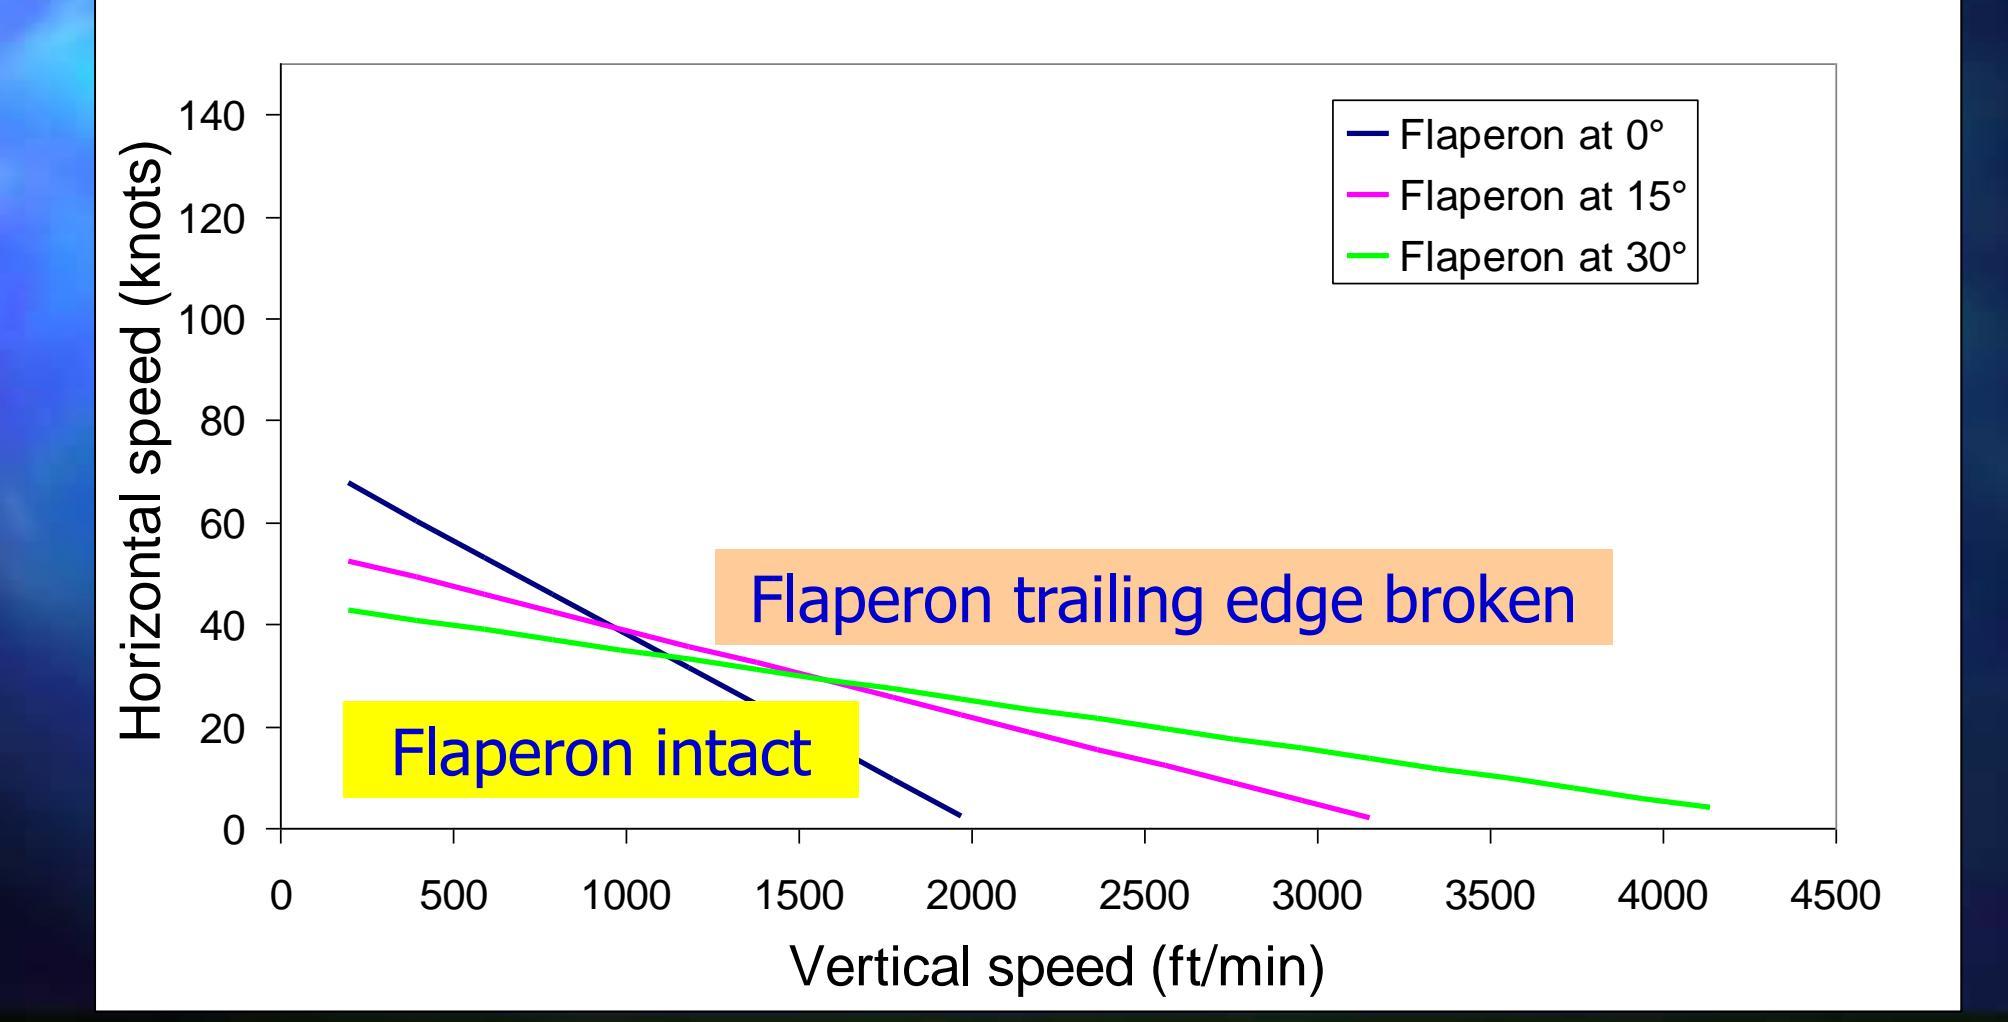
Wing at 0-15° pitch asymmetric first impact

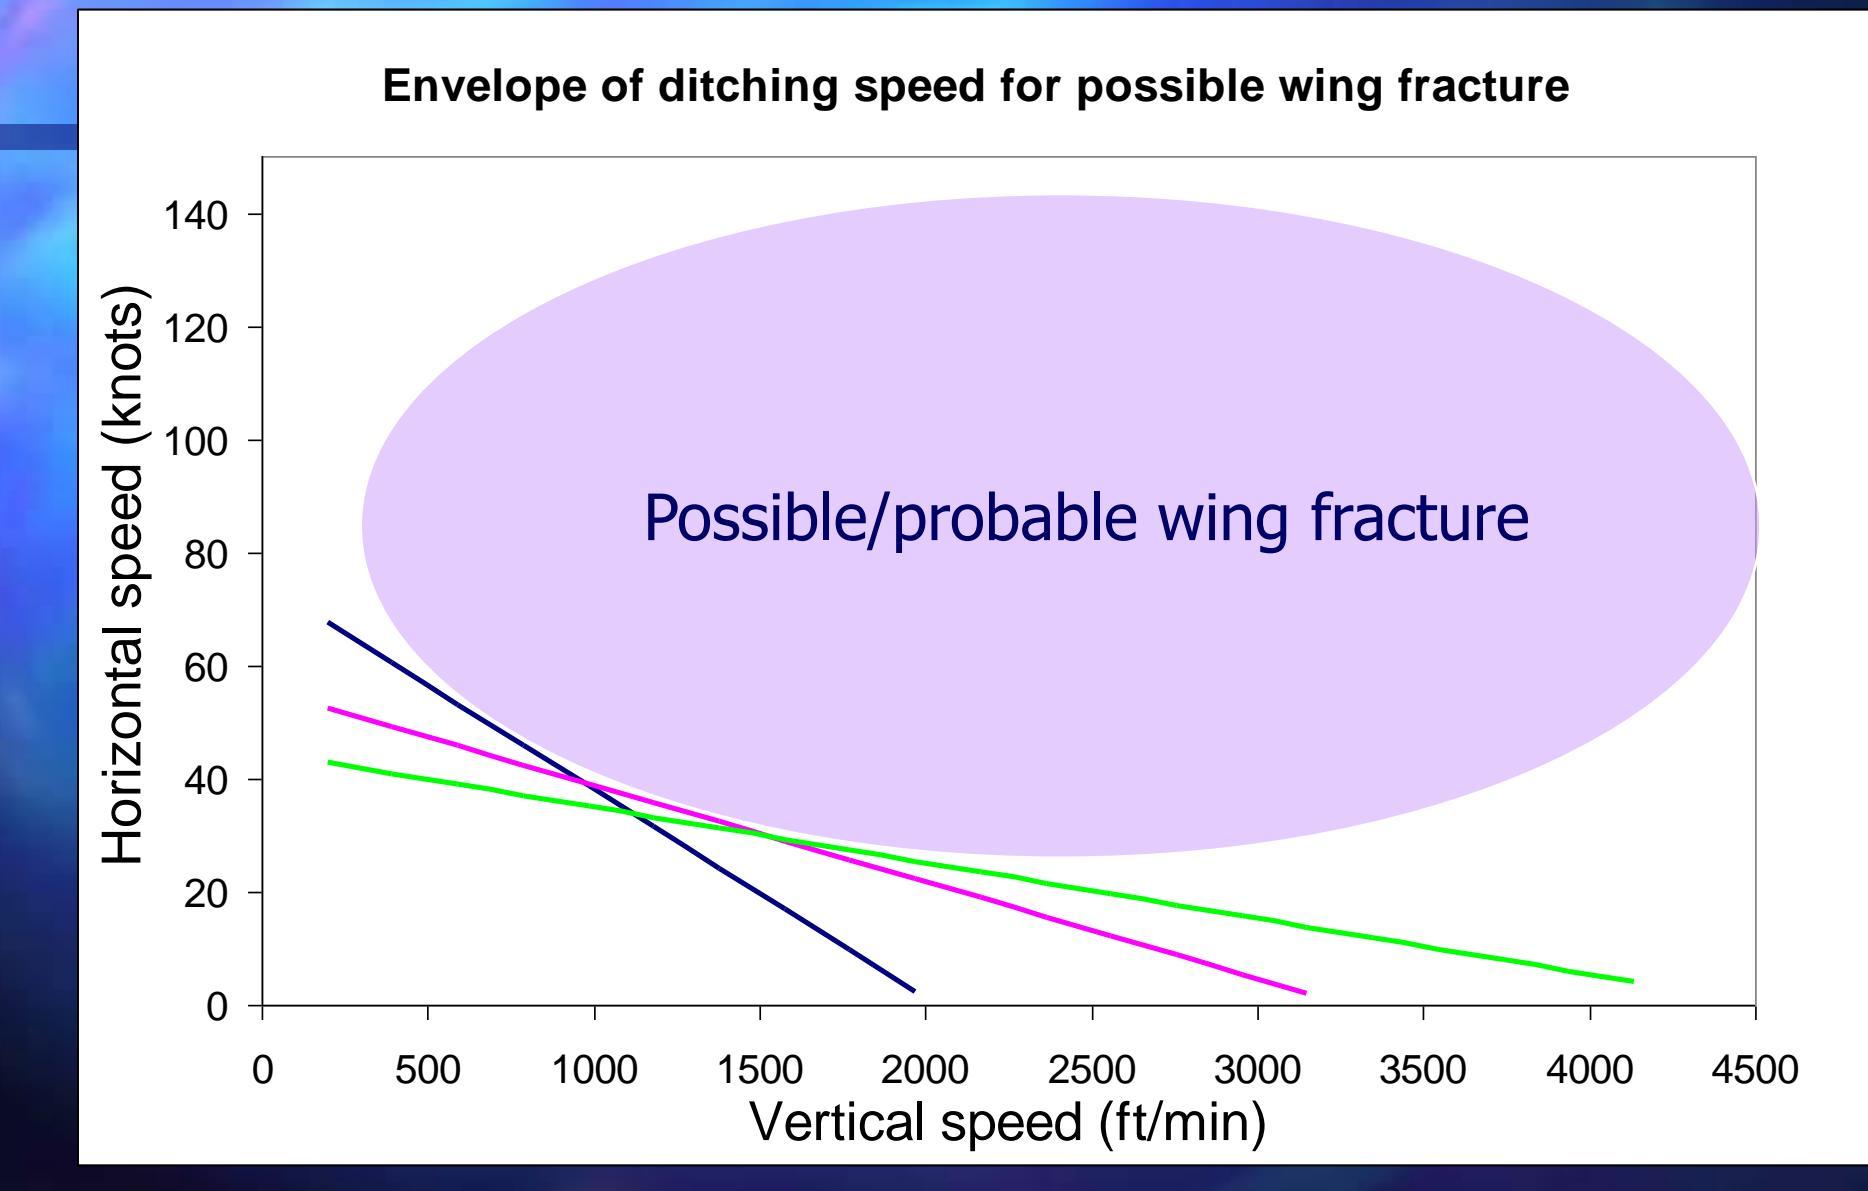
Wing at 0-15° pitch asymmetric first impact

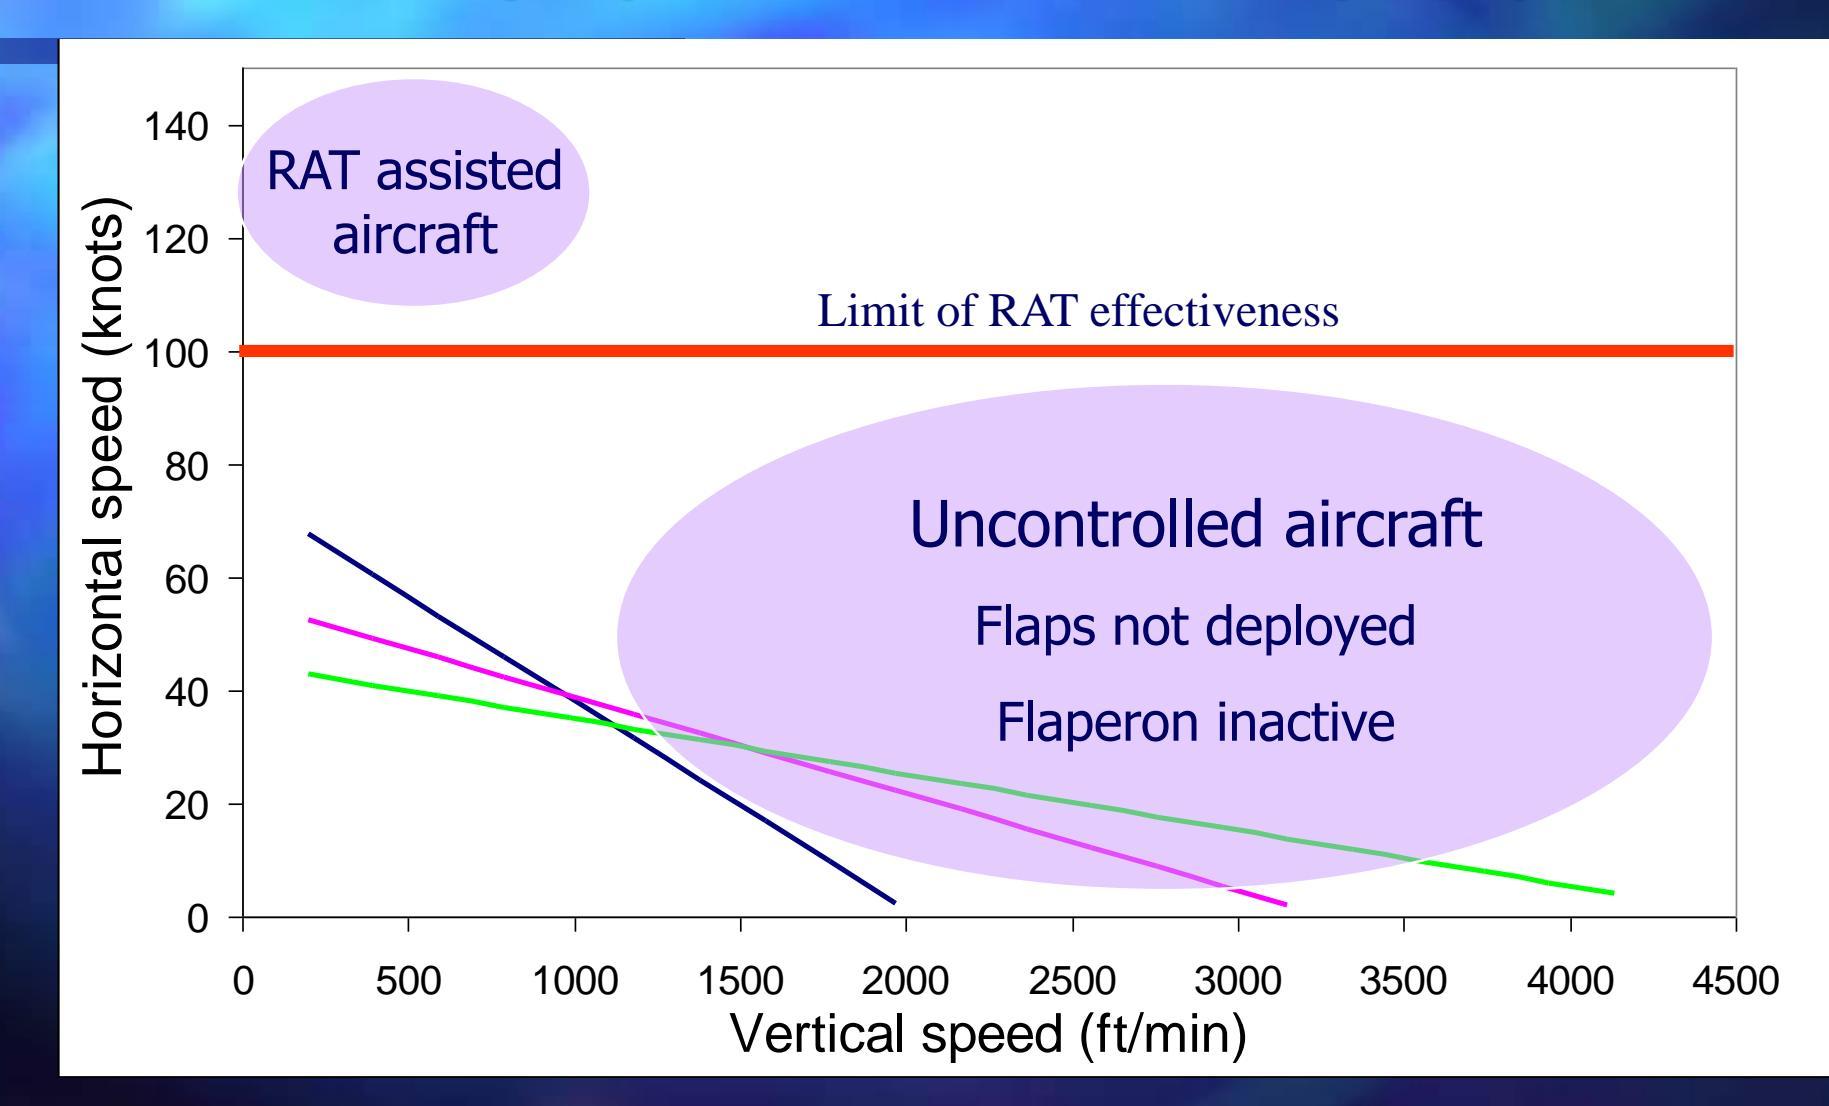
Previleging a "missed" ditching event (asymmetric first impact)
