# MH370:

## A New Theory as to What Went Wrong

*By Jean-Marc Garot, CAPTIO Team Member and former Director of the EUROCONTROL Experimental Centre, with assistance by Andres Zellweger, former FAA Research Director*

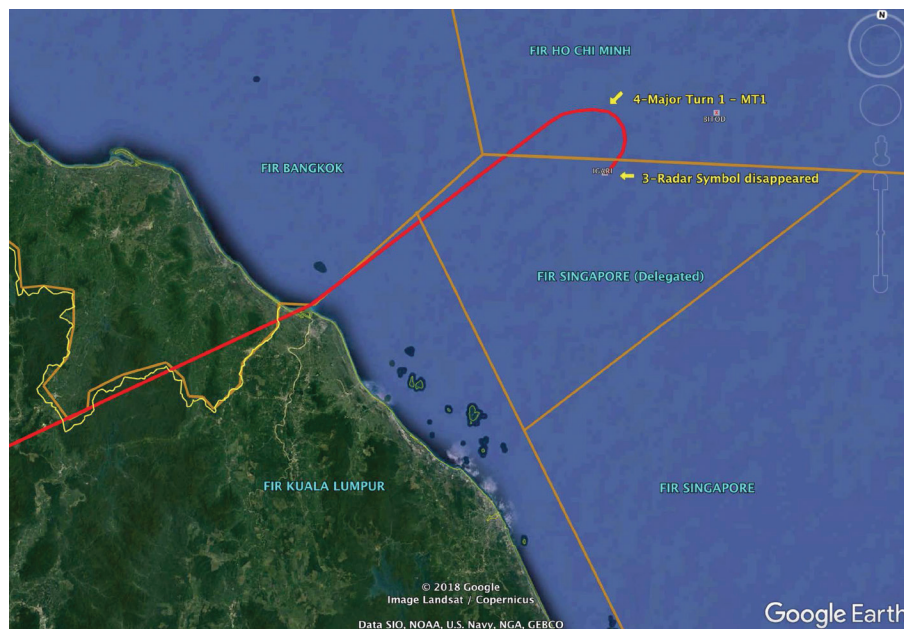
Figure 2. U-Turn Source.

There has been a lot of speculation about the tight U-turn, imperfectly recorded by military primary radars, which took place just after the disappearance of the aircraft. The official final report released by Malaysian authorities states

that this steep U-turn was difficult to simulate. Nobody knows when and where it started. It could have been executed by an experienced pilot such as the captain, but if the hijacking was carefully planned by the MH370 captain, why would he risk stalling by undertaking such an acrobatic turn?

We assume that after the Mode S transponder was manually switched off, the aircraft took a sharp U-turn in the opposite direction of where the unavoidable search and rescue would take place to mislead ATC. The final investigation report states that: "The possibility of intervention by a third party cannot be excluded." Our hypothesis is that hijackers provoked an electric shutdown simulating a power failure, which triggered the U-turn by the pilot. Shutting down the electric power can be done either by the pilot in the cockpit or by a third party manipulating circuit breakers in the electronic equipment bay (EEB) where all the flight control systems are located. The B-777 EEB is a pressurized room located under the cockpit with three possible entry points: an external trap door near the front landing gear, an internal door communicating with the cargo hold, and another trap door in the floor of the passenger cabin just outside the cockpit.

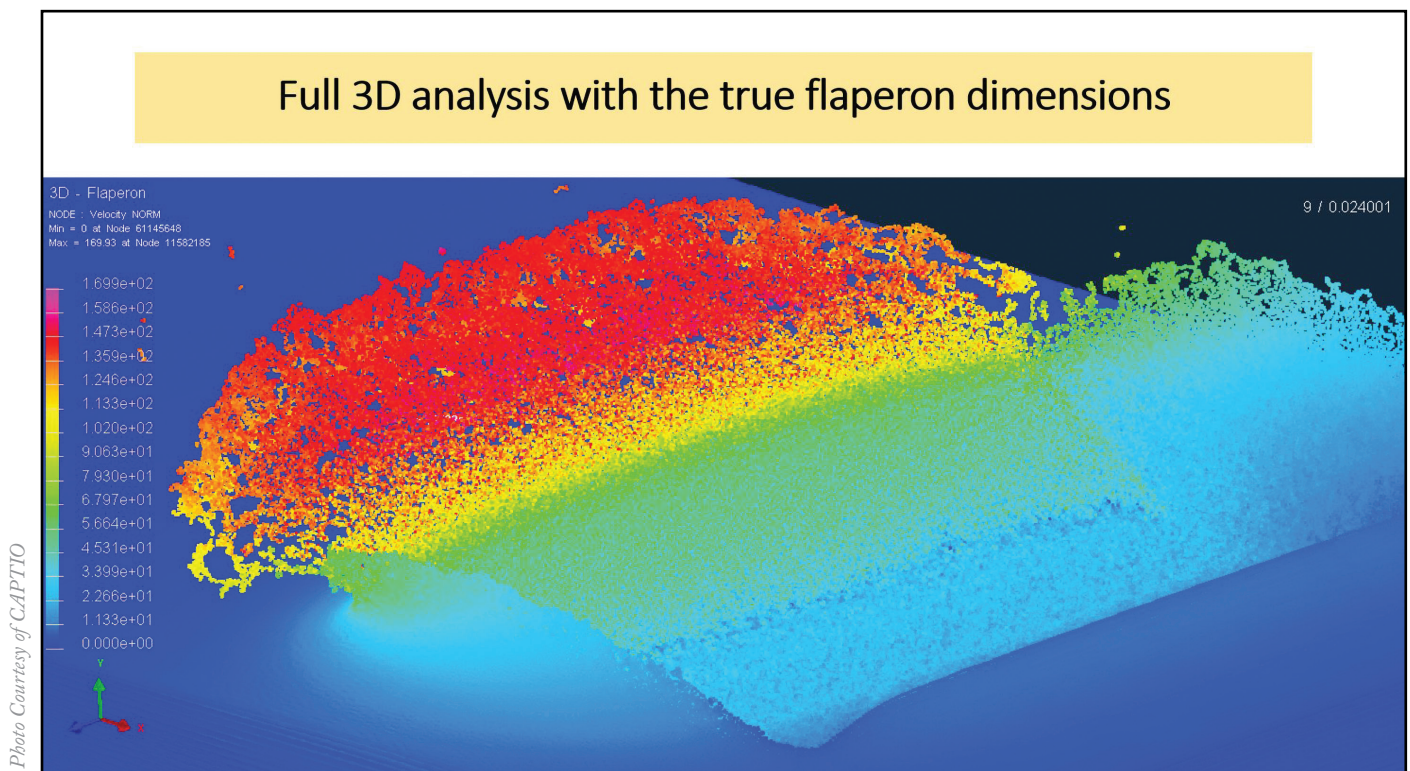
Figure 7. Details of the water velocity contours in the SPH ditching simulation.

In response, CAPTIO designed some basic structural models to examine the flaperon's response to ditching. A smoothed-particle hydrodynamics (SPH) method was used to model the flaperon's pressure-time evolution in the water.<sup>[10]</sup> When analyzed in a “rigid body” mode to obtain an upper bound of the water pressure loads plus using the Theory of Simple Bending and the Bredt-Batho Theory of shear stress, the corresponding internal stresses would be far too excessive for equilibrium, hence the need for a flexible flaperon model analysis.

and repeated the ditching simulations. In all cases, the trailing edge of the flaperon broke at the intersection with the associated spar, in agreement with the debris discovered. A typical simulation of the elastic flaperon in guided ditching is shown in Figure 7, CAPTIO full 3D analysis of the elastic flaperon in guided ditching.
