MH370 – What can be learnt from Kate Tee's sighting?

Jean-Luc Marchand CAPTION¹

Version 1.a - 10th Sept. 2021 (updated 7th Oct. 2021)

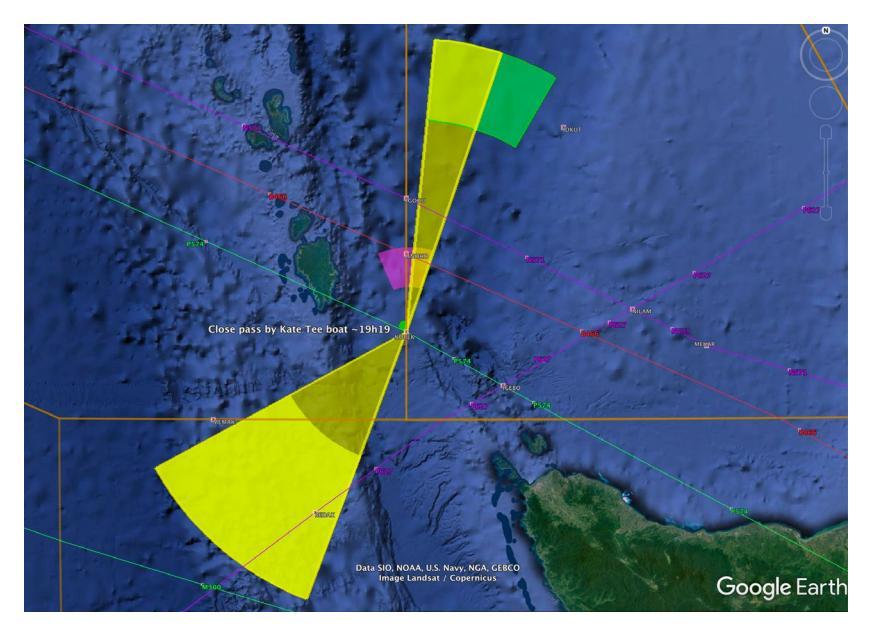
Figure 1: Possible 2-leg broken line paths with a turn at NOPEK

2- Two-segment trajectories with a slight turn nearby the boat have been identified and form a family of paths covering the full field of view sectors identified by the sailor as illustrated in Figure 1. Their corresponding ground speed is operationally acceptable.

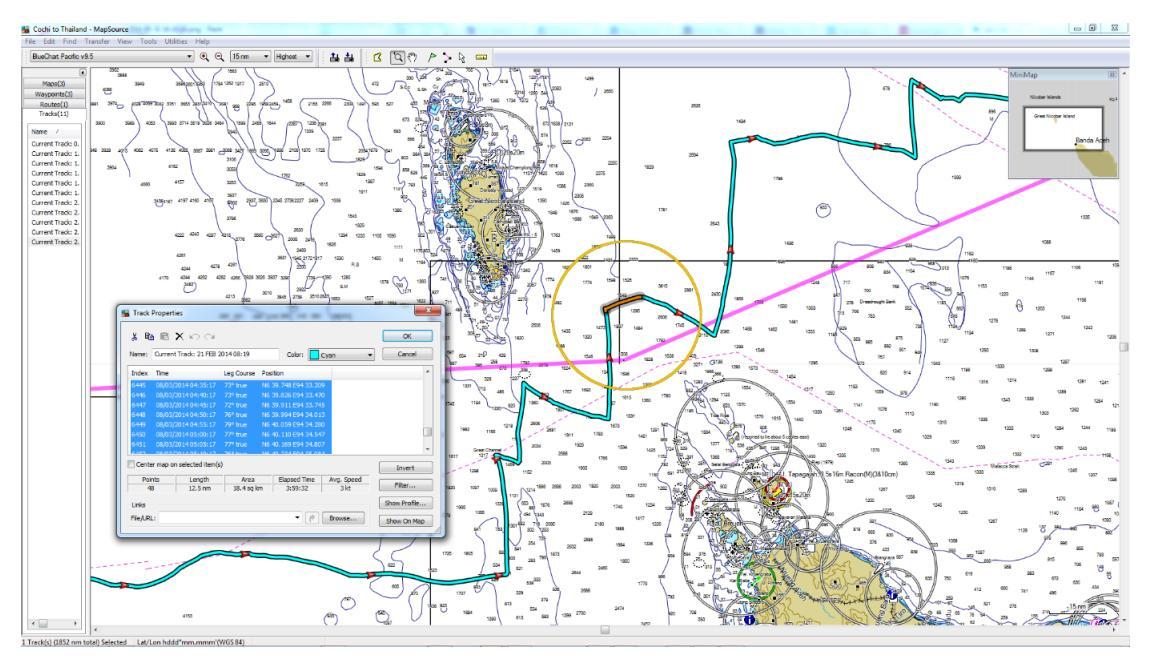
Figure 2: Extract of Aaza Dana's journey to Phuket. The orange leg inside the yellow circle is of interest (from K. Tee's web site)

In that night, somewhere from about 2:05 Indonesian time i.e. 19:05 UTC on March 7th, heading to Phuket (cf Figure 2) on board her 40foot Bermudan rigged sloop, she and one crew member witnessed the flyby of an aircraft very close to the sailing boat.

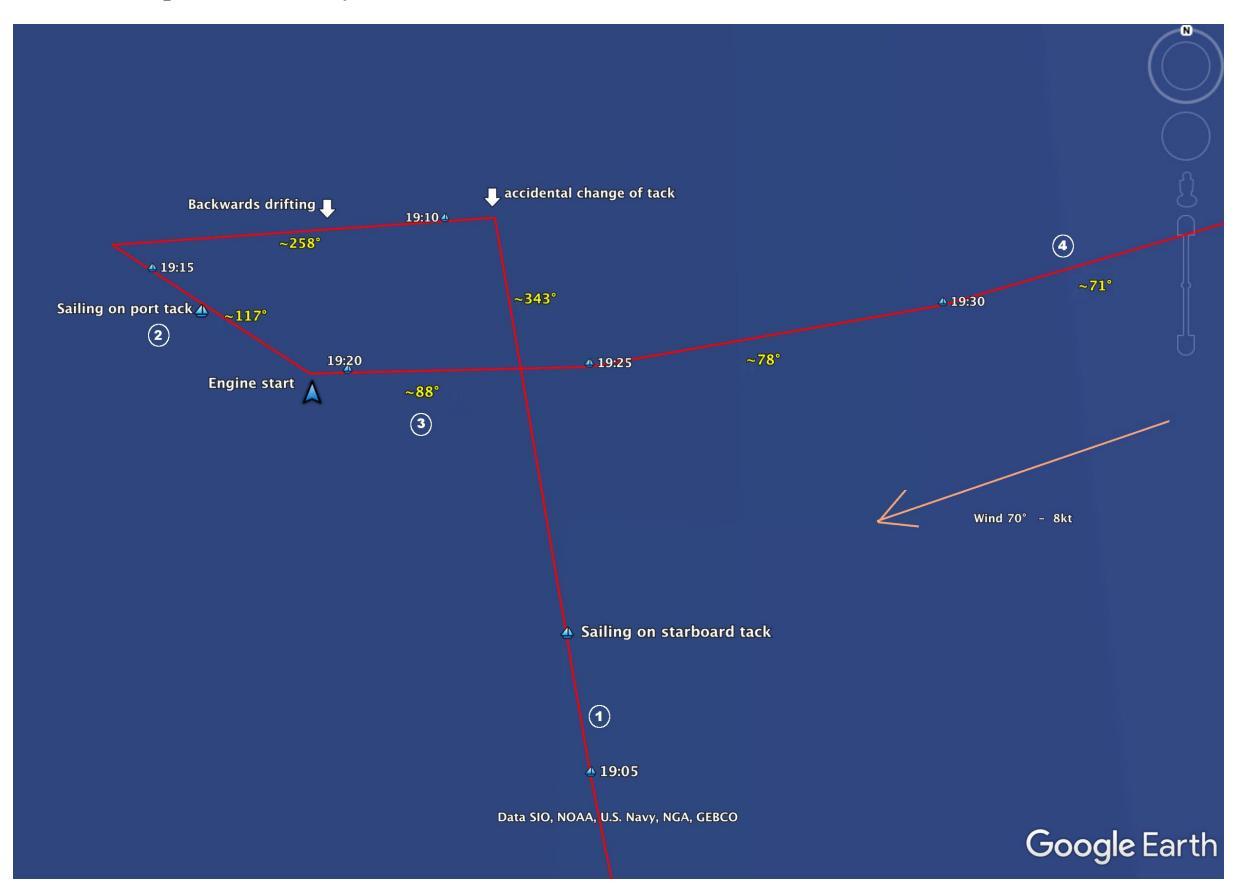
Figure 3: Kate Tee's sailing boat GPS recorded path with major events with the 4 sighting episodes

Aaza Dana's GPS data has been made available to the IG, which in turn nicely made it publicly available at [11] and partially reproduced in the table of Annex 2. Its analysis helped dating and geolocalising the facts and events in Table 1 and subsequently provided their relative geometry. Figure 3 sketches the path and the key events.

In this figure, let's firstly consider the red path reconstructed thanks to Annex 2 data.

From 19h00 UTC to a short time before 19:10 UTC the ship was sailing on starboard tack (wind coming from the right-hand side of the sails which were on the left side of the boat) along a quasinorthern track at ~343°. The 8kt wind (3Beaufort), coming from ~70°, initially stable decreased to almost lull. It is during this leg that Miss Tee saw the aircraft for the first time (Part 1 of the sighting). The difference between the wind direction and the ~343° GPS measured track (or ~ -17°) is equal to 70° - (-17°) = 87°. This fact is peculiar as usually the standard capability of a boat to progress upwind and close to the wind direction is of the order of ~40° to ~50° relative to the wind depending on the wind speed. At this geographical location, Phuket destination was basically in the upwind direction. Thus, the boat intentional route was aiming to navigate as close as possible upwind i.e. on a track direction between ~10° and ~30°. This means a 25° to 45° difference between the expected (or intentional) route and the actual route followed. This is probably the result of a low wind speed at this particular point in time (eventually becoming a lull as can be read in Annex 2) and a large contribution of the water current. Thus the "direction" of the boat actual speed relative to the water (along to its longitudinal axis) was somewhere between $\sim 10^{\circ}$ and $\sim 30^{\circ}$. Consequently, the boat was drifting away significantly in a westerly direction. A rough estimation of the boat true speed and the speed and direction of the current could be made as a function of the boat axis orientation. Typically, for a boat orientation at $\sim 15^{\circ}$ the boat speed is found at $\sim 2kt$ and the current speed is $\sim 1.8kt$ with a current coming from $\sim 120^{\circ}$. This hypothesis is supported by the analysis of the leg at $\sim 117^{\circ}$ (cf below).

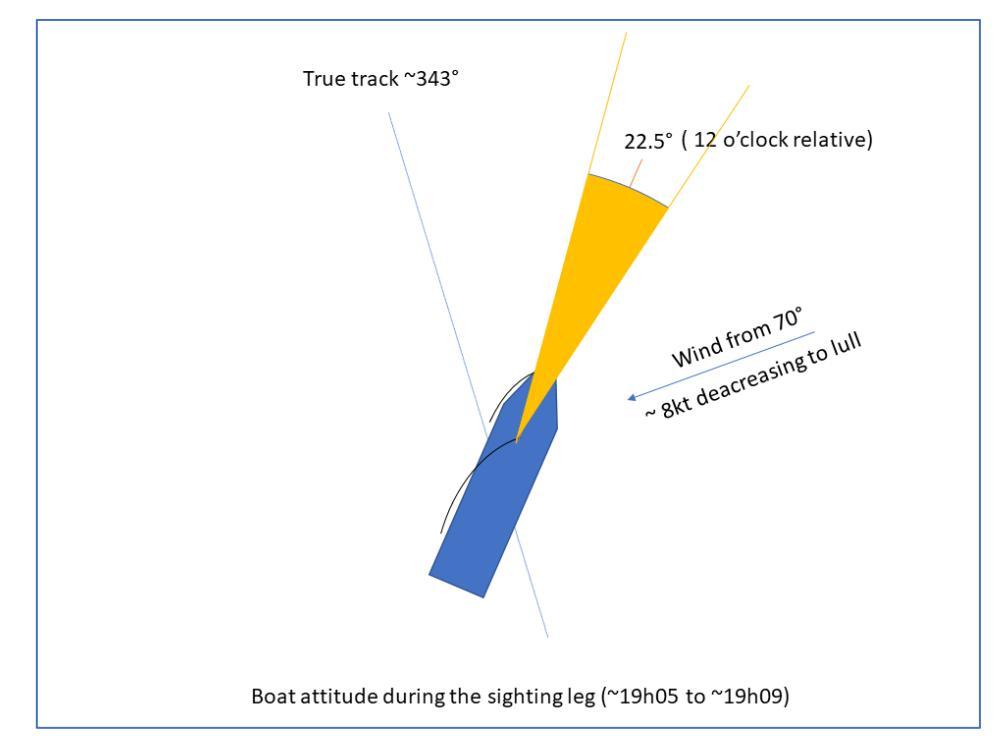
Figure 4: +/- 12.5° Angular sector around the 12 o'clock relative estimated direction of the sighting Part-1 from 19h05, the low wind speed and local drift component are the reason for the discrepancy between the boat attitude and the true track.

Sighting Part-1 is particular due to the low wind and relative high drift leading to a large divergence between the true track and the intentional direction thus with the instantaneous orientation of the boat. Furthermore, it is limited on the eastern side by the "unbreakable" minimum sailing angle of 40° from the wind direction (which could increase depending on the wind speed). The reading error margin was thus added to the left only leading to a reduced angular sector compared to the following sighting parts. In addition, the alignment of the sails, the mast and the skipper position make the relative reading more accurate. In Section 4, the instantaneous orientation of the boat was estimated between 10° and 30° .

Respective graphical illustrations of the four identified sectors based on Table 3 items are provided from Figure 4 to Figure 7.

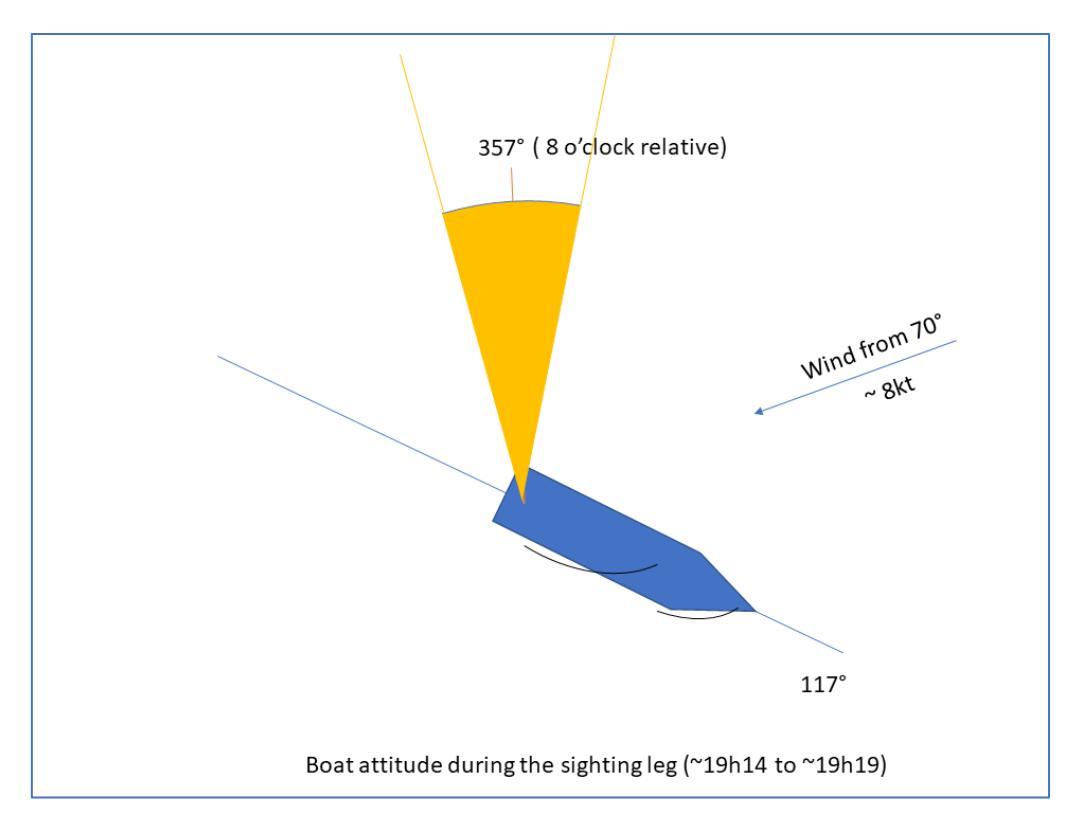
Figure 5: +/- 20° Angular sector ~ 8 o'clock relative estimated direction of the sighting Part-2 at 19h15

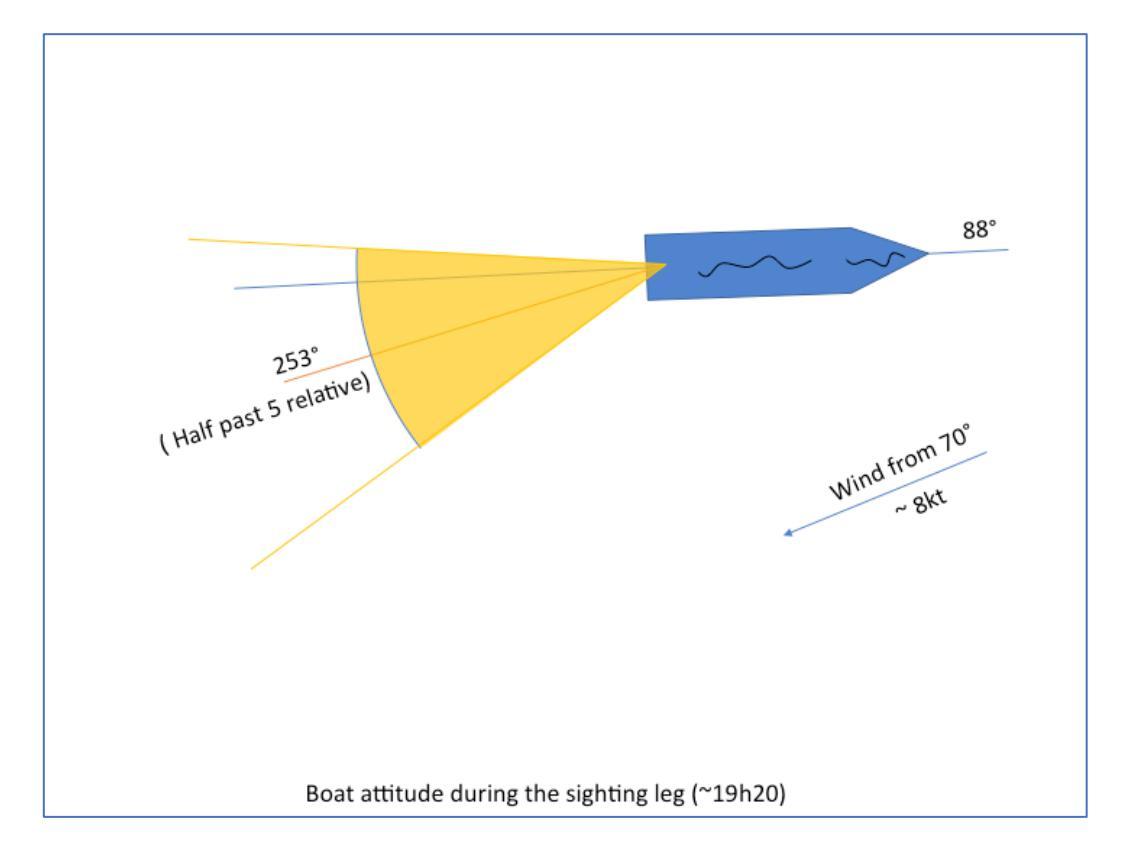
Figure 6: +/- 20° Angular sector ~ the half past 5 relative estimated direction of the sighting Part-3 at 19h20

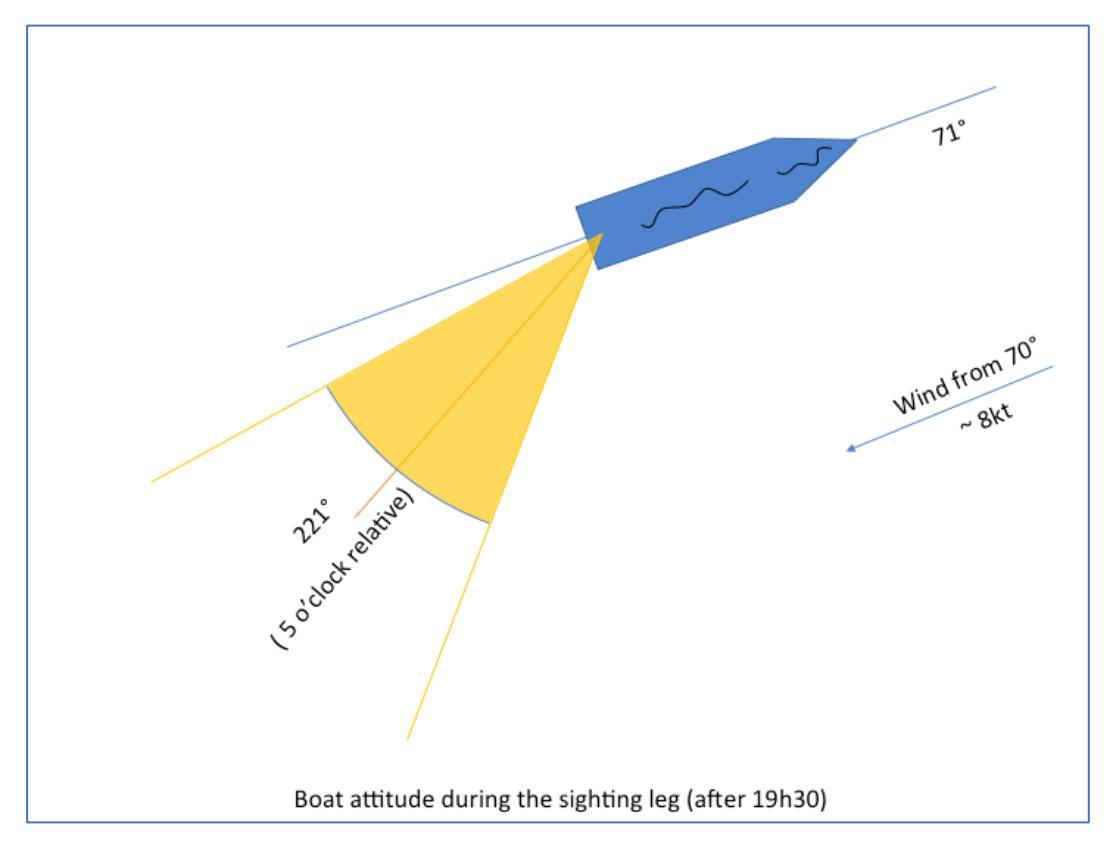
Figure 7: +/- 20° Angular sector ~ the 5 o'clock relative estimated direction of the sighting Part-4 after 19h30

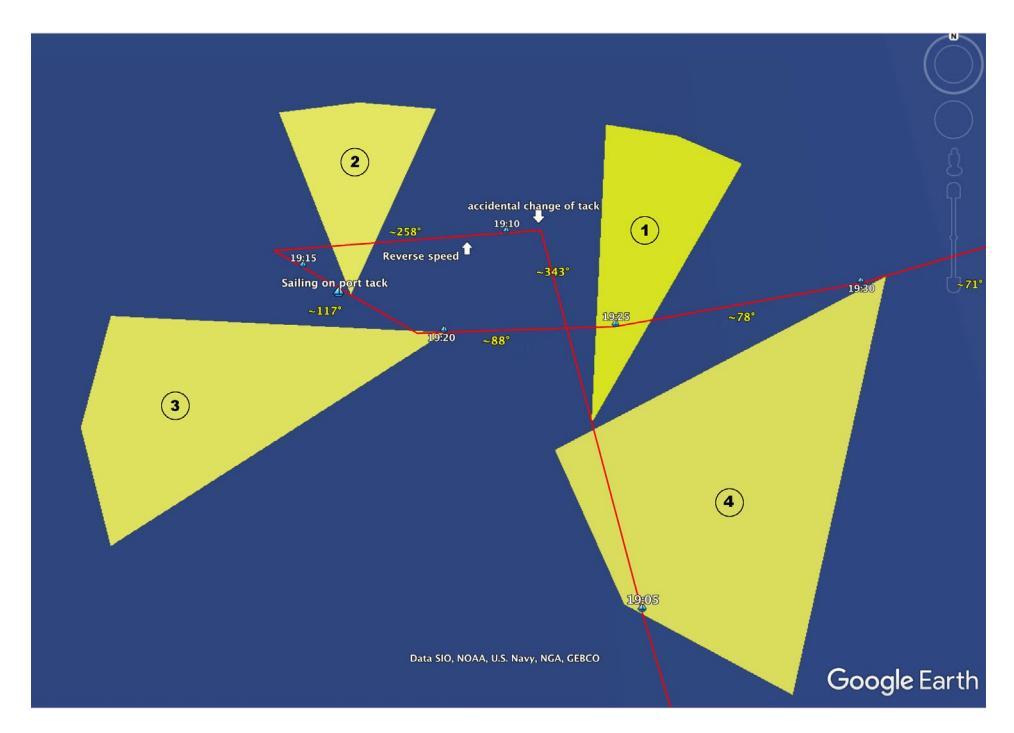
Figure 8: +/- 20° Angular sectors of Kate Tee's 4 sightings (1&2 alone and then with the crew) - Closeup

Figure 8 puts the four sighting sectors into the global context and allows visualising the situation of the sailor when she observed the plane at the different occasions.

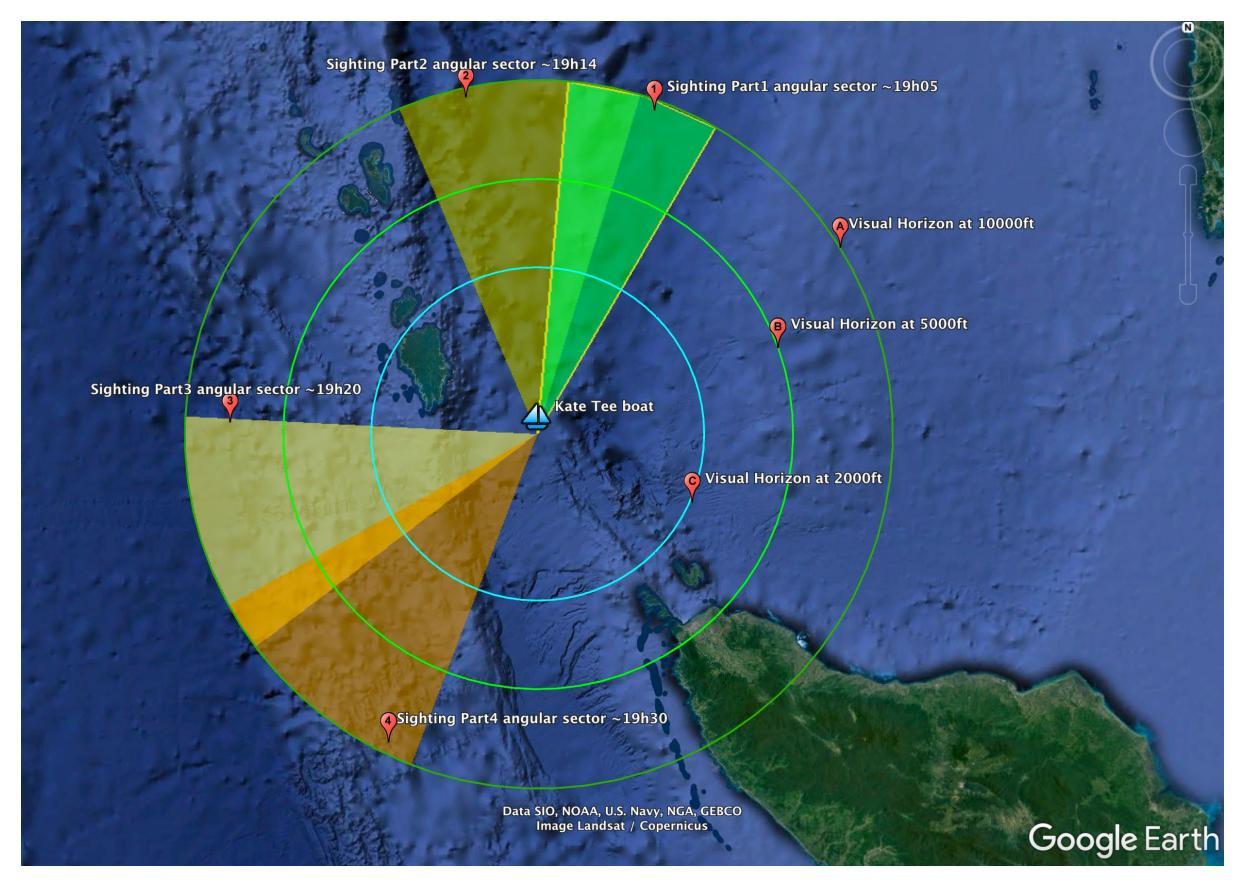
Figure 9: +/- 20° Angular sectors of Kate Tee's 3 sightings with visual horizons versus aircraft altitude

Thus, being conservative, we will consider that the aircraft could have flown up to 10000ft when overflying the boat. At 10000ft, the physical horizon the visual would be \sim 110Nm leading to a visual horizon at \sim 120Nm when corrected for the light atmospheric propagation. For an altitude of 5000ft, this visual horizon is \sim 86Nm and for 2000ft it is \sim 56Nm.

These horizons with the overall visual zone limits are illustrated in Figure 9.

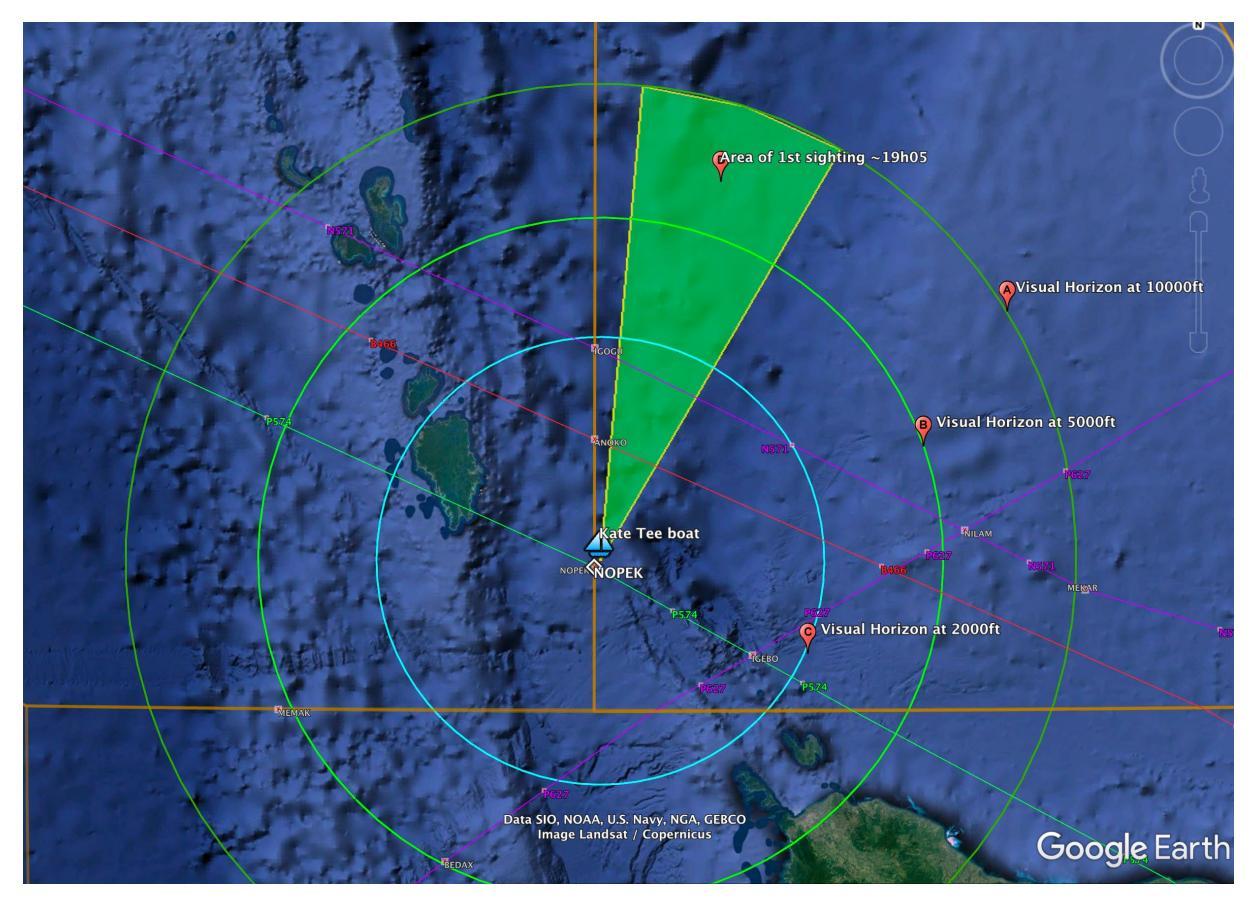
Figure 10: Area of the early start of the sighting Part1 at ~19h05 – the D pin indicates a rough estimation of the aircraft position at that time illustrated at an altitude of ~10000ft

Thus, using the boat attitude deduced above i.e. a mean direction of 22.5° and using a typical ground speed corresponding to a flight at an altitude of ~10000ft, one can roughly estimate the position of the aircraft at ~19h05. This is illustrated with the D pin inside the green sector in Figure 10.

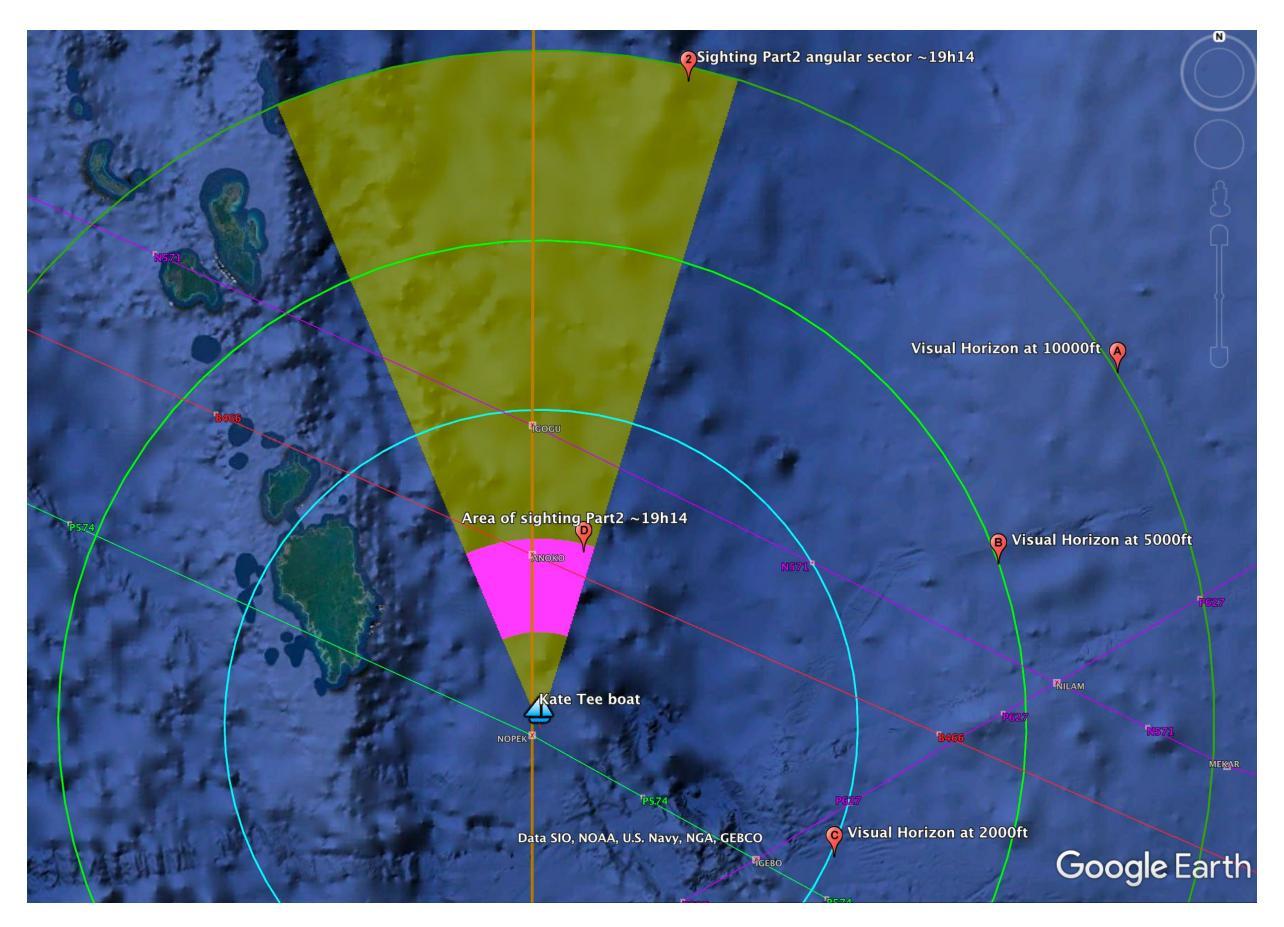
Figure 11: Area of the start of the sighting Part2 at ~19h14 after the accidental gybe

Later between ~19h14 and ~19h19, according to items E9, E19 and E21 of Table 2, the airplane was seen closer and moving past the ship. Thus, taking the boat location as an approximation of the plane location at 19h19 and going backwards one can estimate the gross area where probably the aircraft was seen for the second time. This is reported in Table 4. Thanks to items E17 and E18 describing an aircraft flying at slow speed, typical ground speeds are considered in their lower ranges for the considered altitudes. The justification for the estimation of the typical low speed is provided further below.

The subsequent area is illustrated as a purple sector in Figure 11.

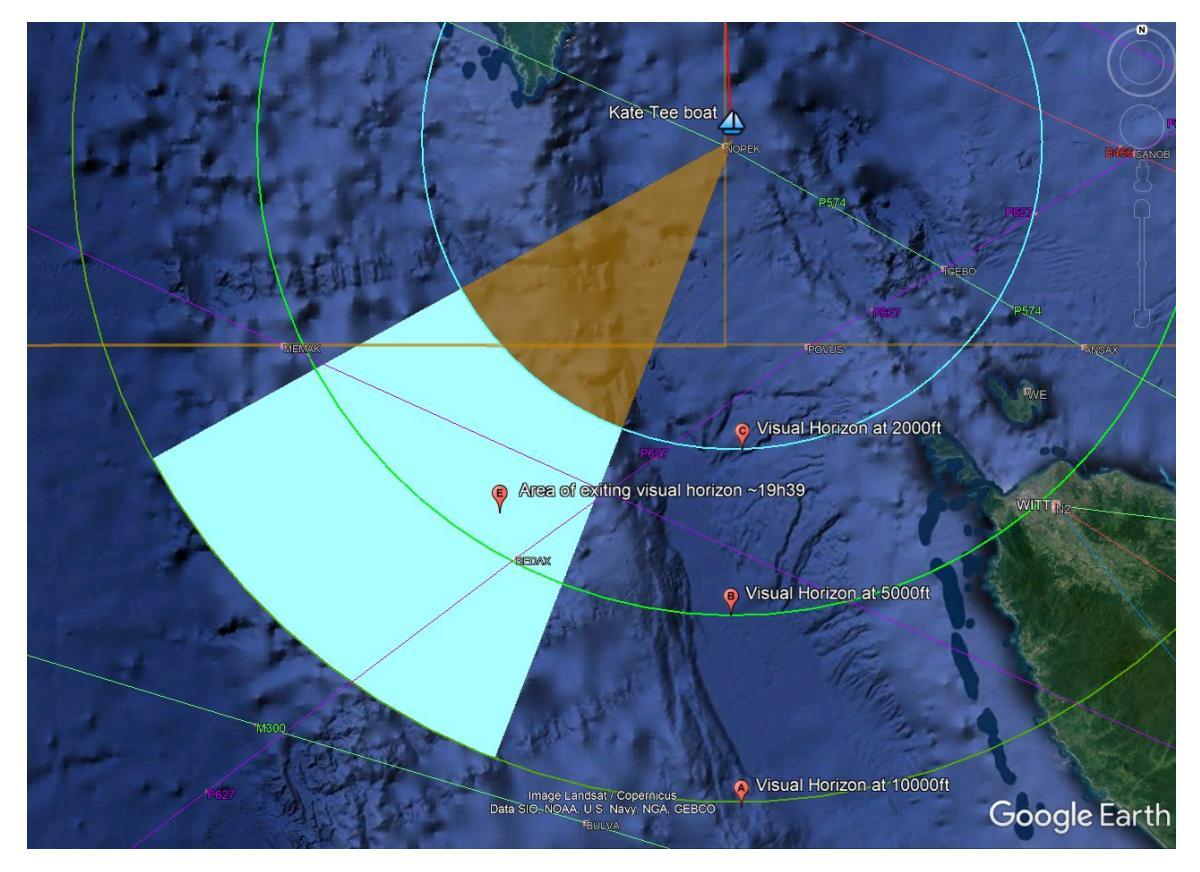
Figure 12: Area of the end of the last sighting at ~19h39 at the boundary of the visual horizon

At these various altitudes, a visual "exit area" can be grossly delimited as illustrated in Figure 12.

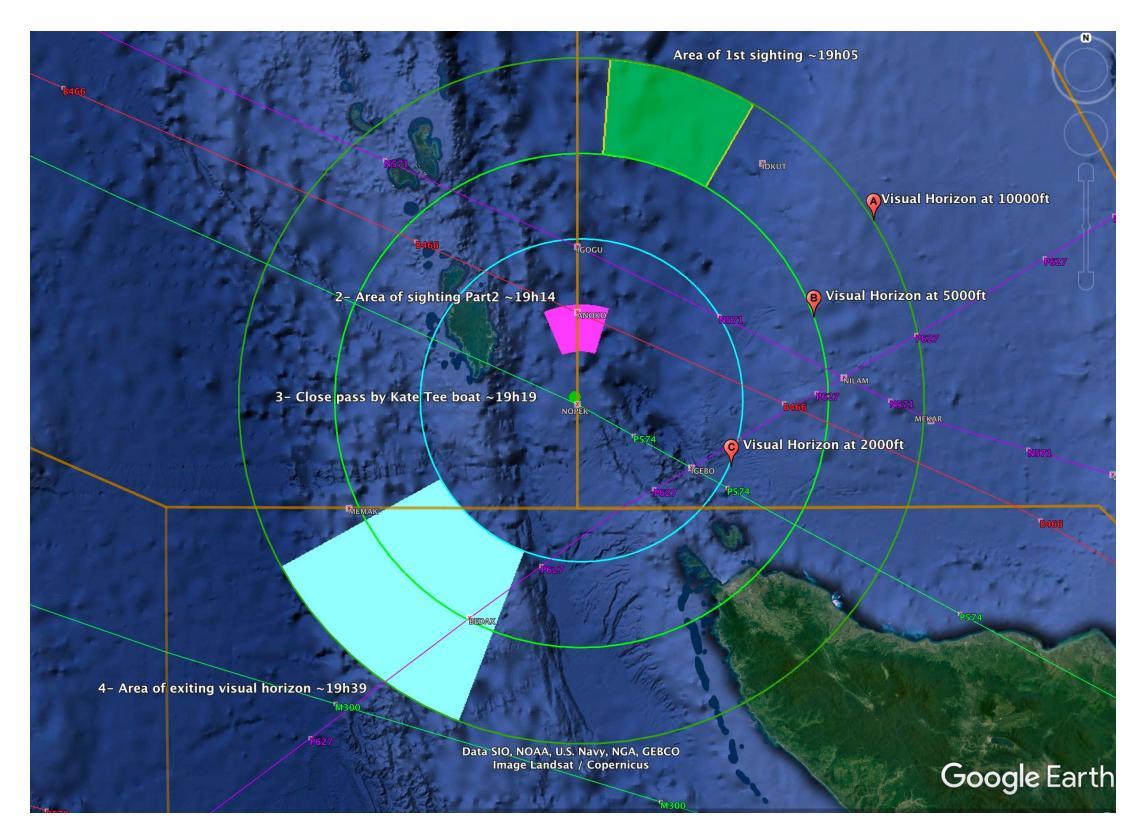
Figure 13: Overall view of Miss Tee's sighting 4 parts location and timing

Gathering the above elements, one can derive indications and characteristics useful for identifying a trajectory being "compliant" with Kate Tee's sighting, which are illustrated in Figure 13 and summarised in Table 5.

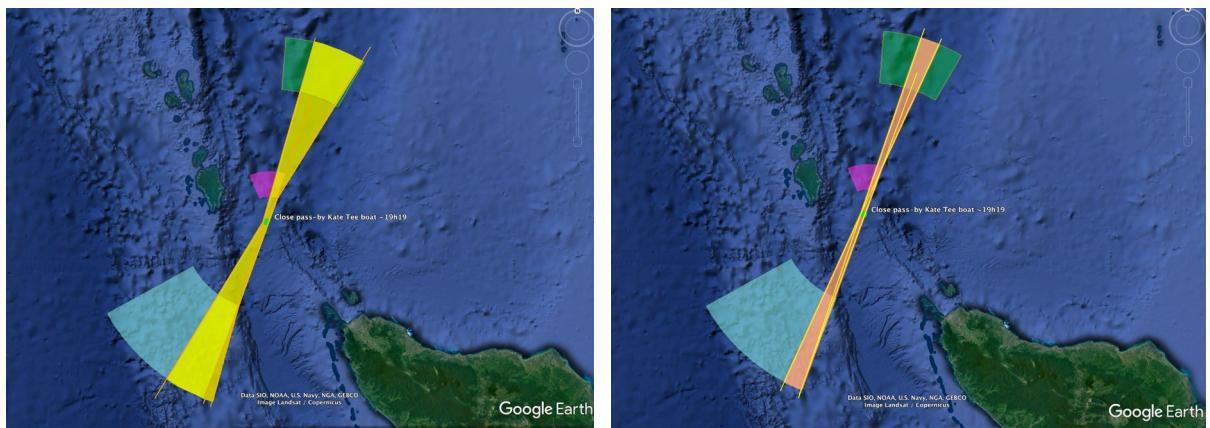
Figure 14: Families of possible straight-line trajectories passing through all sighting areas

Left yellow: at altitude 2000ft
 Right brown: at altitude 10000ft

Considering sighting part 3 area (Green spot in Figure 14) which is the most constraining area, one can draw the great circle lines at the edges limiting the angular sector containing the possible straight-line trajectories family as a function of altitude. Figure 14 illustrates the two extreme cases i.e. at altitude 2000ft and at altitude 10000ft.

One can conclude that for all altitude between 2000ft and 10000ft, there exists a family of great circle trajectories compliant with Miss Tee's sighting. The estimated minimum and maximum true track are presented in Table 6.

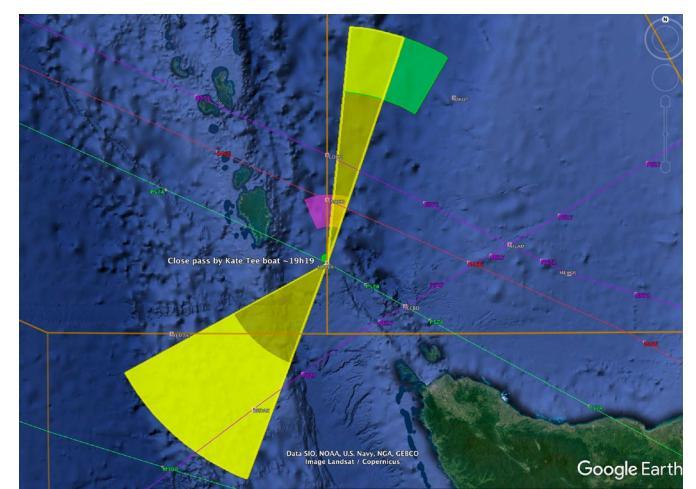
Figure 15: Families of possible broken line trajectories passing through NOPEK waypoint (altitude 2000 to 10000ft)

Starting from NOPEK, the limiting segments at the edges are first identified in each sector and then linked together to form the trajectories at the outer edges as a function of the altitude. Figure 14 illustrates the two extreme cases considered i.e. at altitude 2000ft and at altitude 10000ft.

One can conclude that for any altitude between 2000ft and 10000ft, there exists a family of broken line trajectories including a turn at NOPEK waypoint and compliant with Miss Tee's sighting. The estimated minimum and maximum true track per segment are presented in Table 7. These values are in fact independent of the altitude.
