Some scenarios for the last seconds of the MH370

Argiris Kamoulakos 5 March 2022

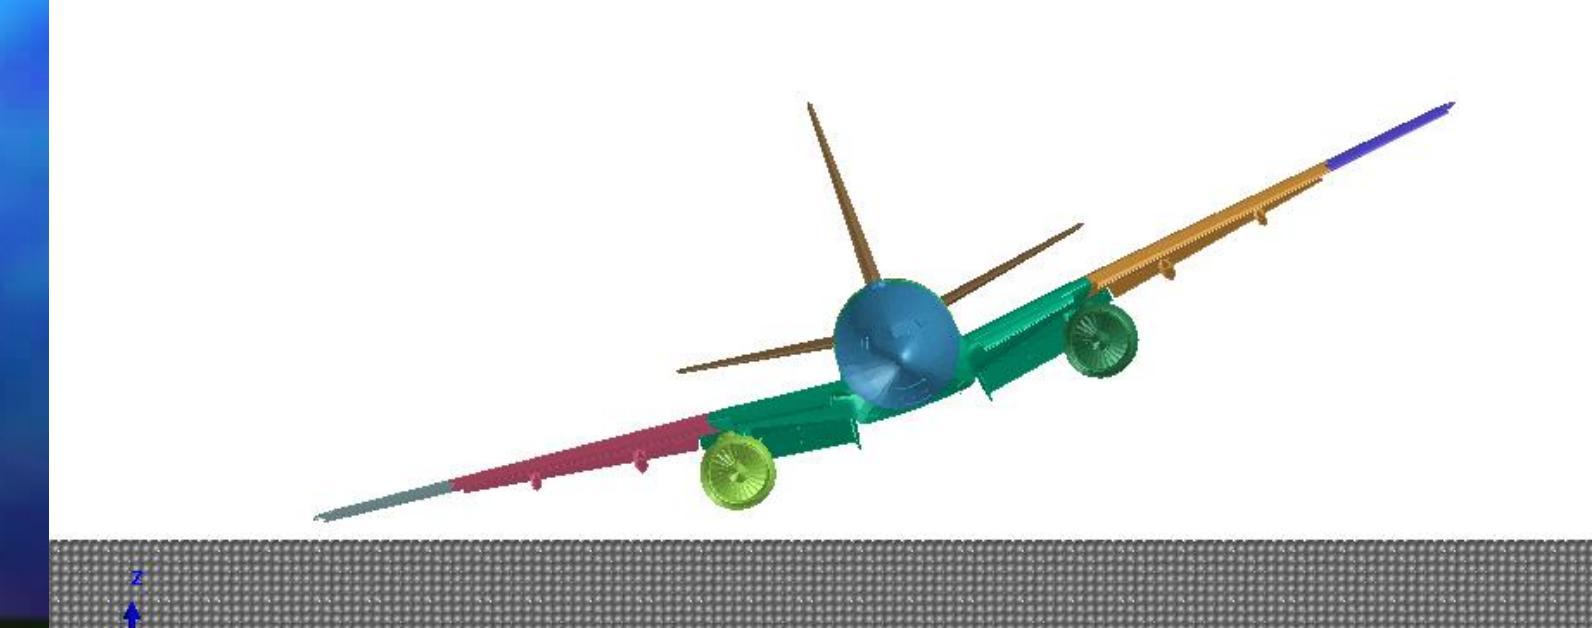
Ditching

- Right wing flaperon and inner flap attachments to fail in this catastrophic way can be due to combined loads resulting from large wing deformations and/or fracture of the wing.
- This can imply an impact of the aircraft with the sea at a large roll rotation and significant vertical speed, leading to:
 - impact of the right wing tip with the sea resulting in the ripping off of the right aileron,
 - then violent impact of the rest of the right wing suffering large deformations that break the flap attachments and lead to possible failure of the wing near the flaperon section, hence releasing flaperon and flap.

The case for a violent right wing first impact

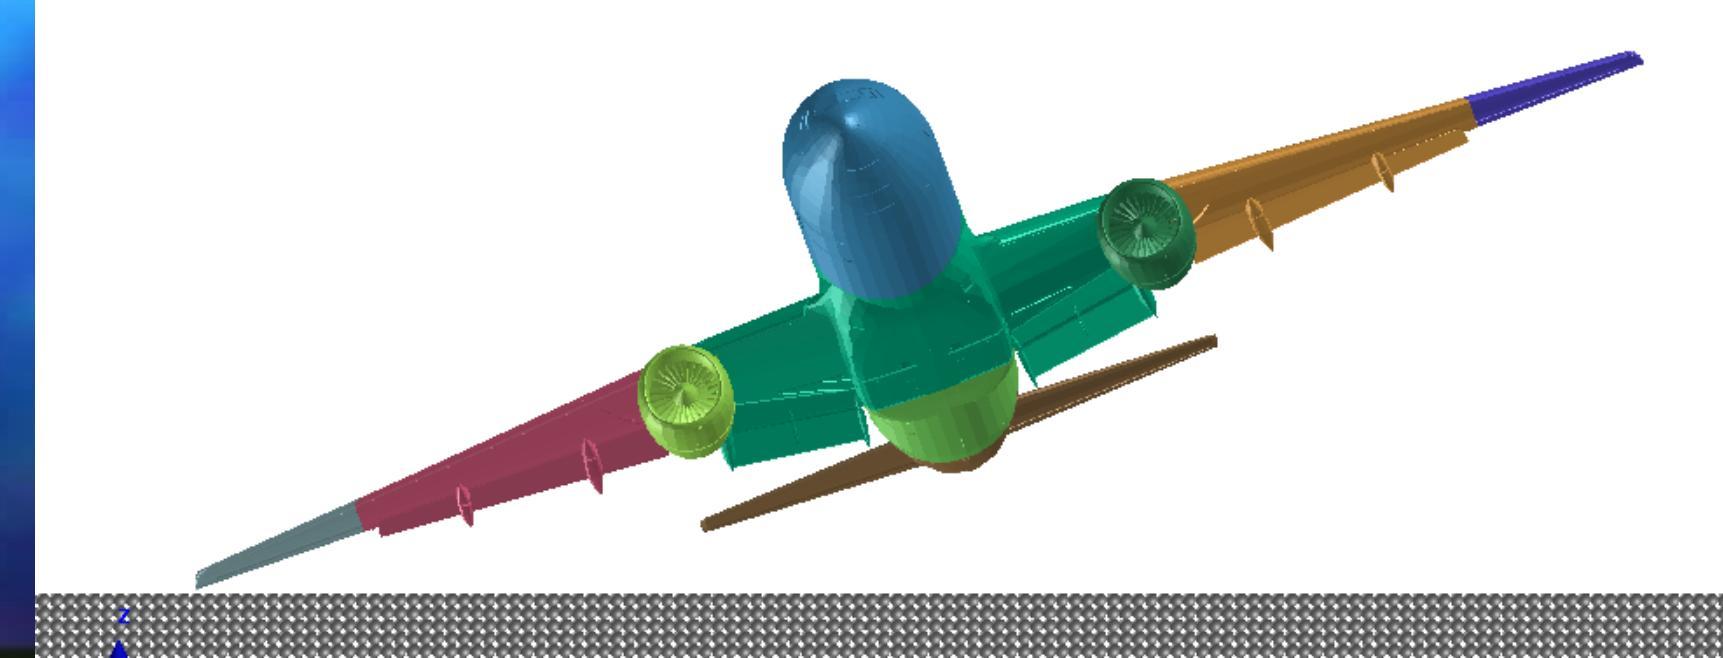
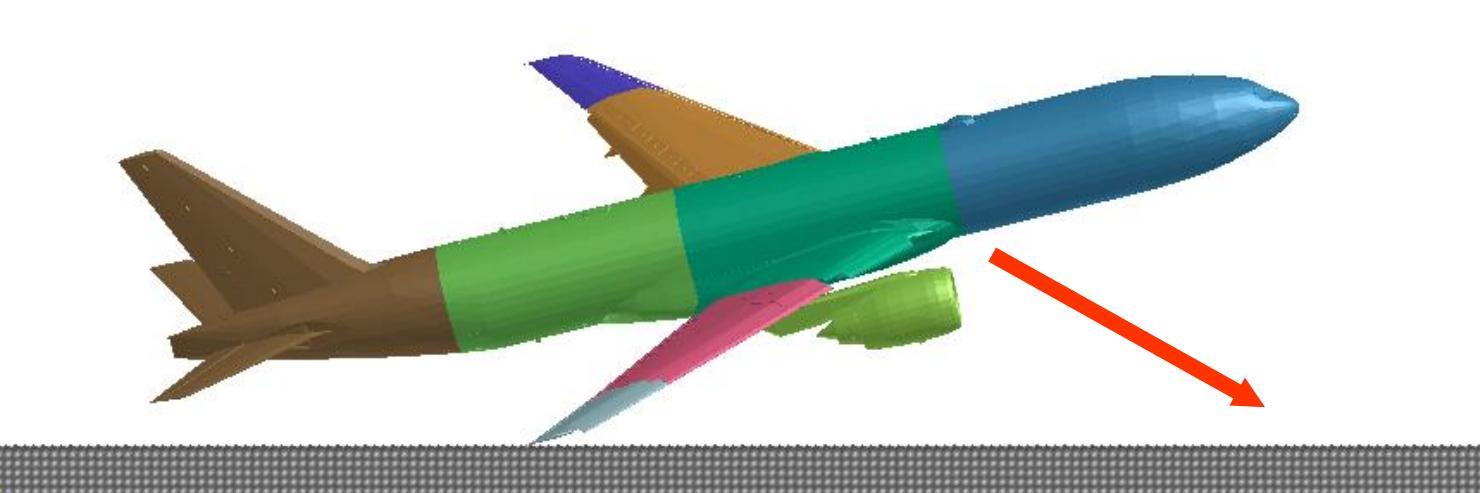
Uncontrolled ditching

The case for a violent right wing first impact

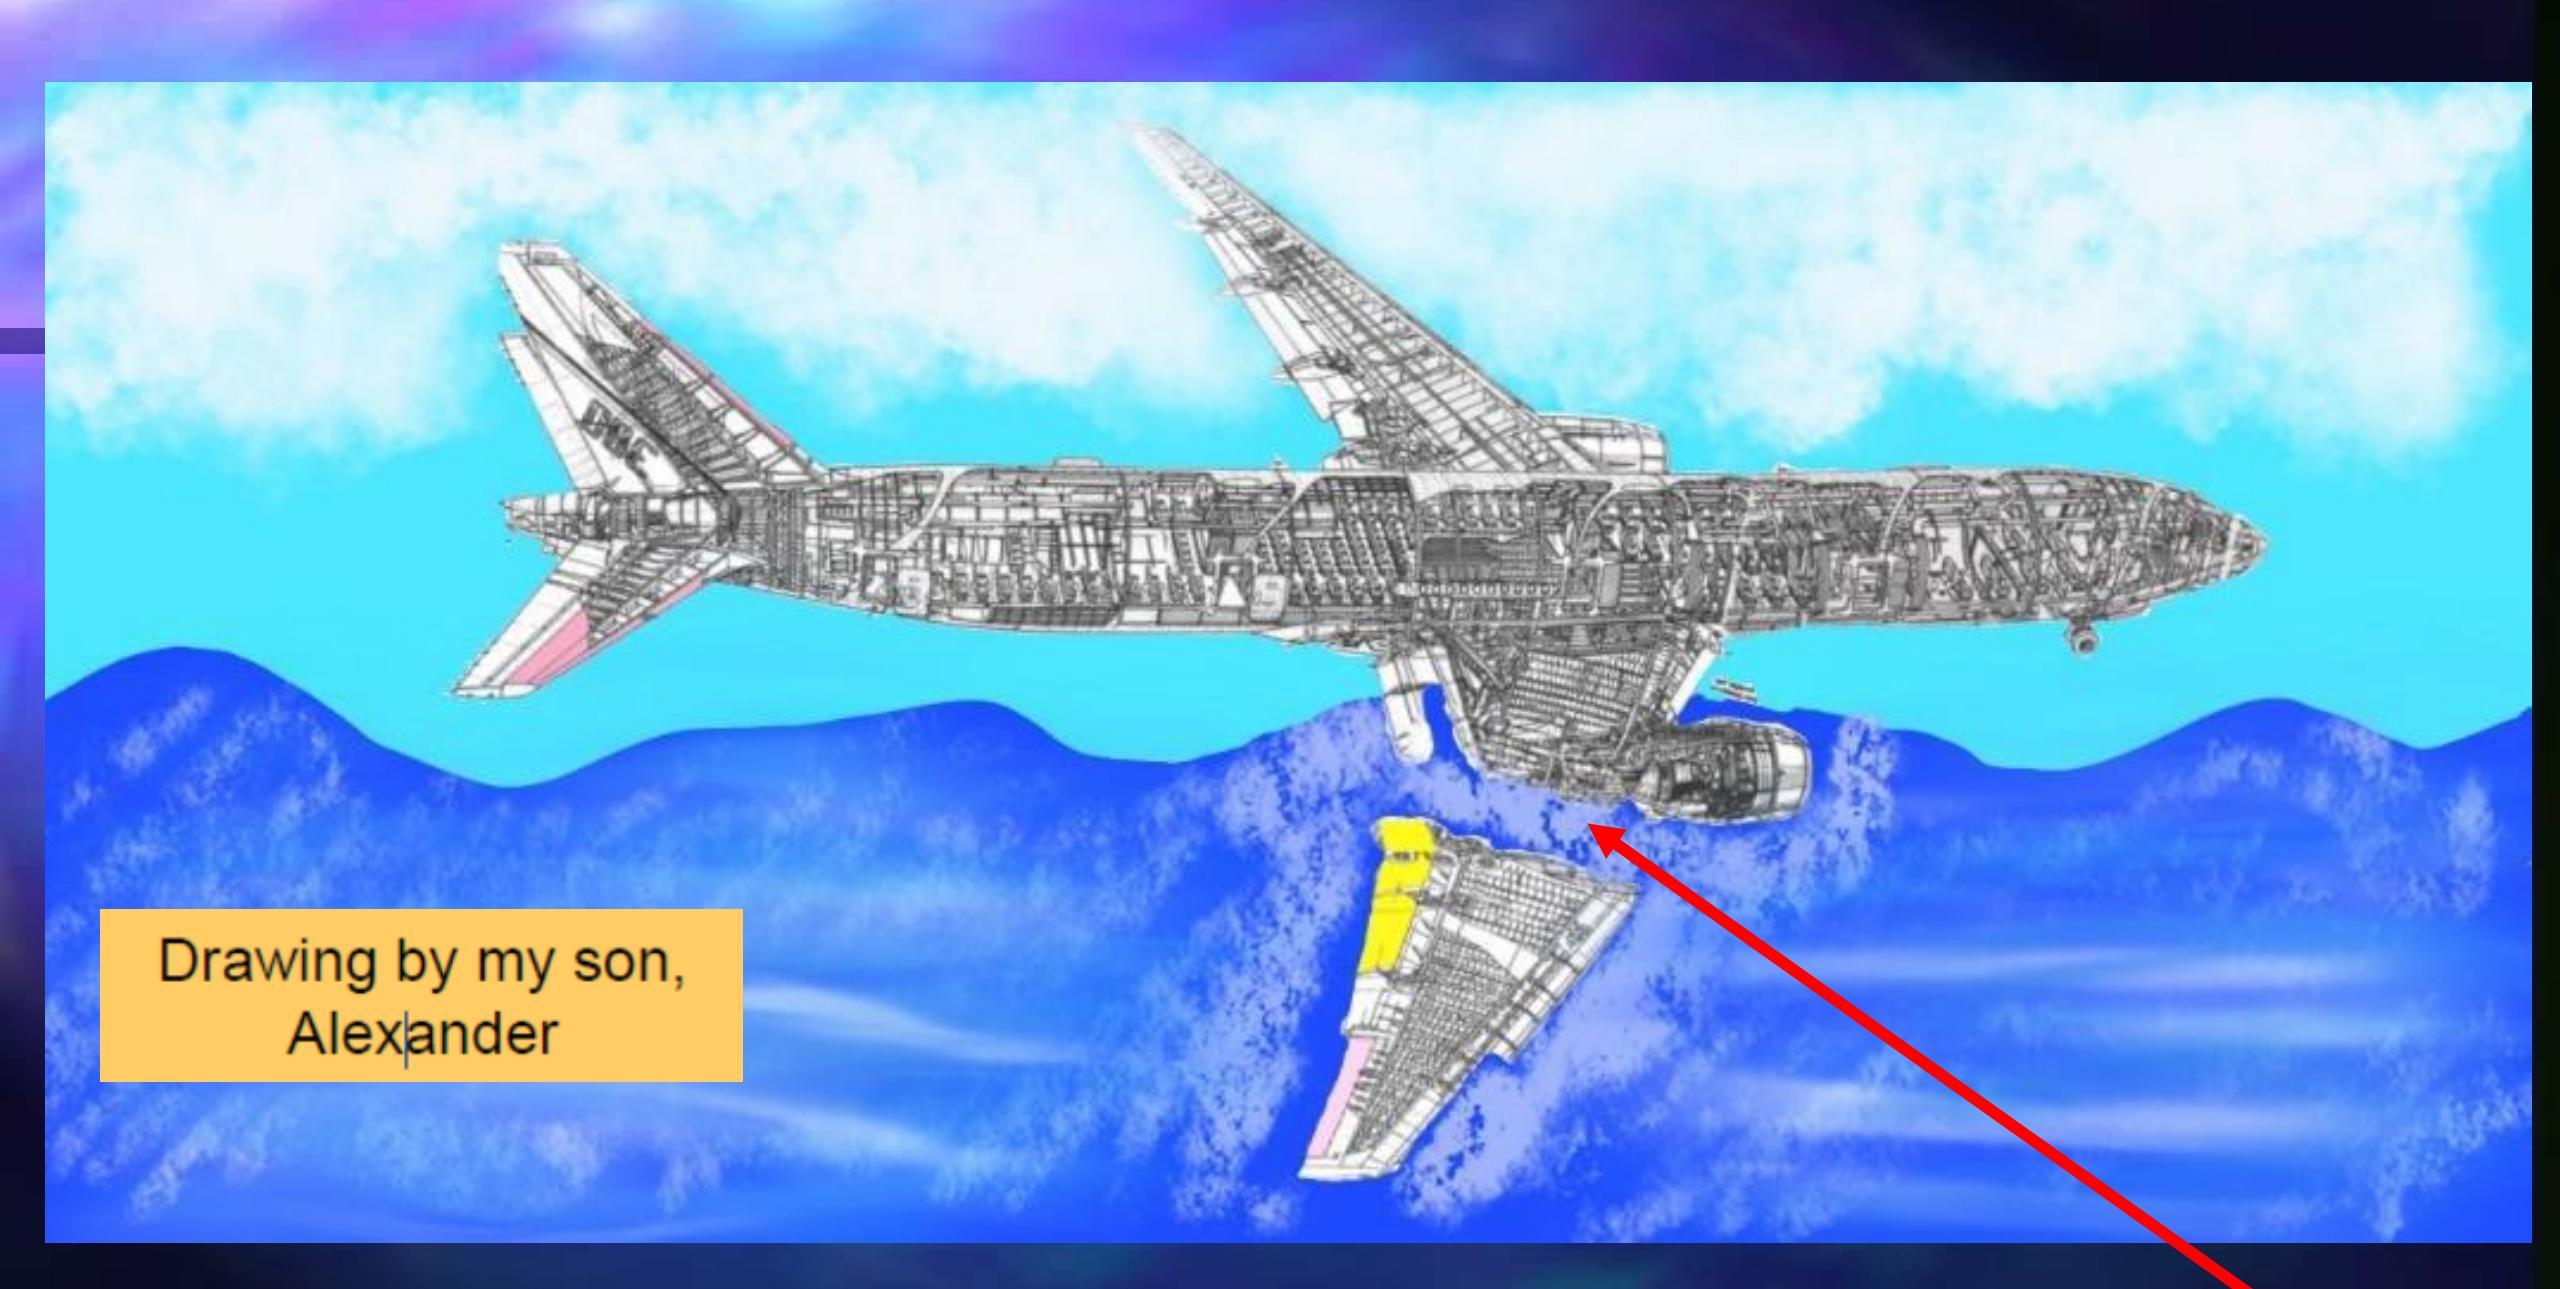
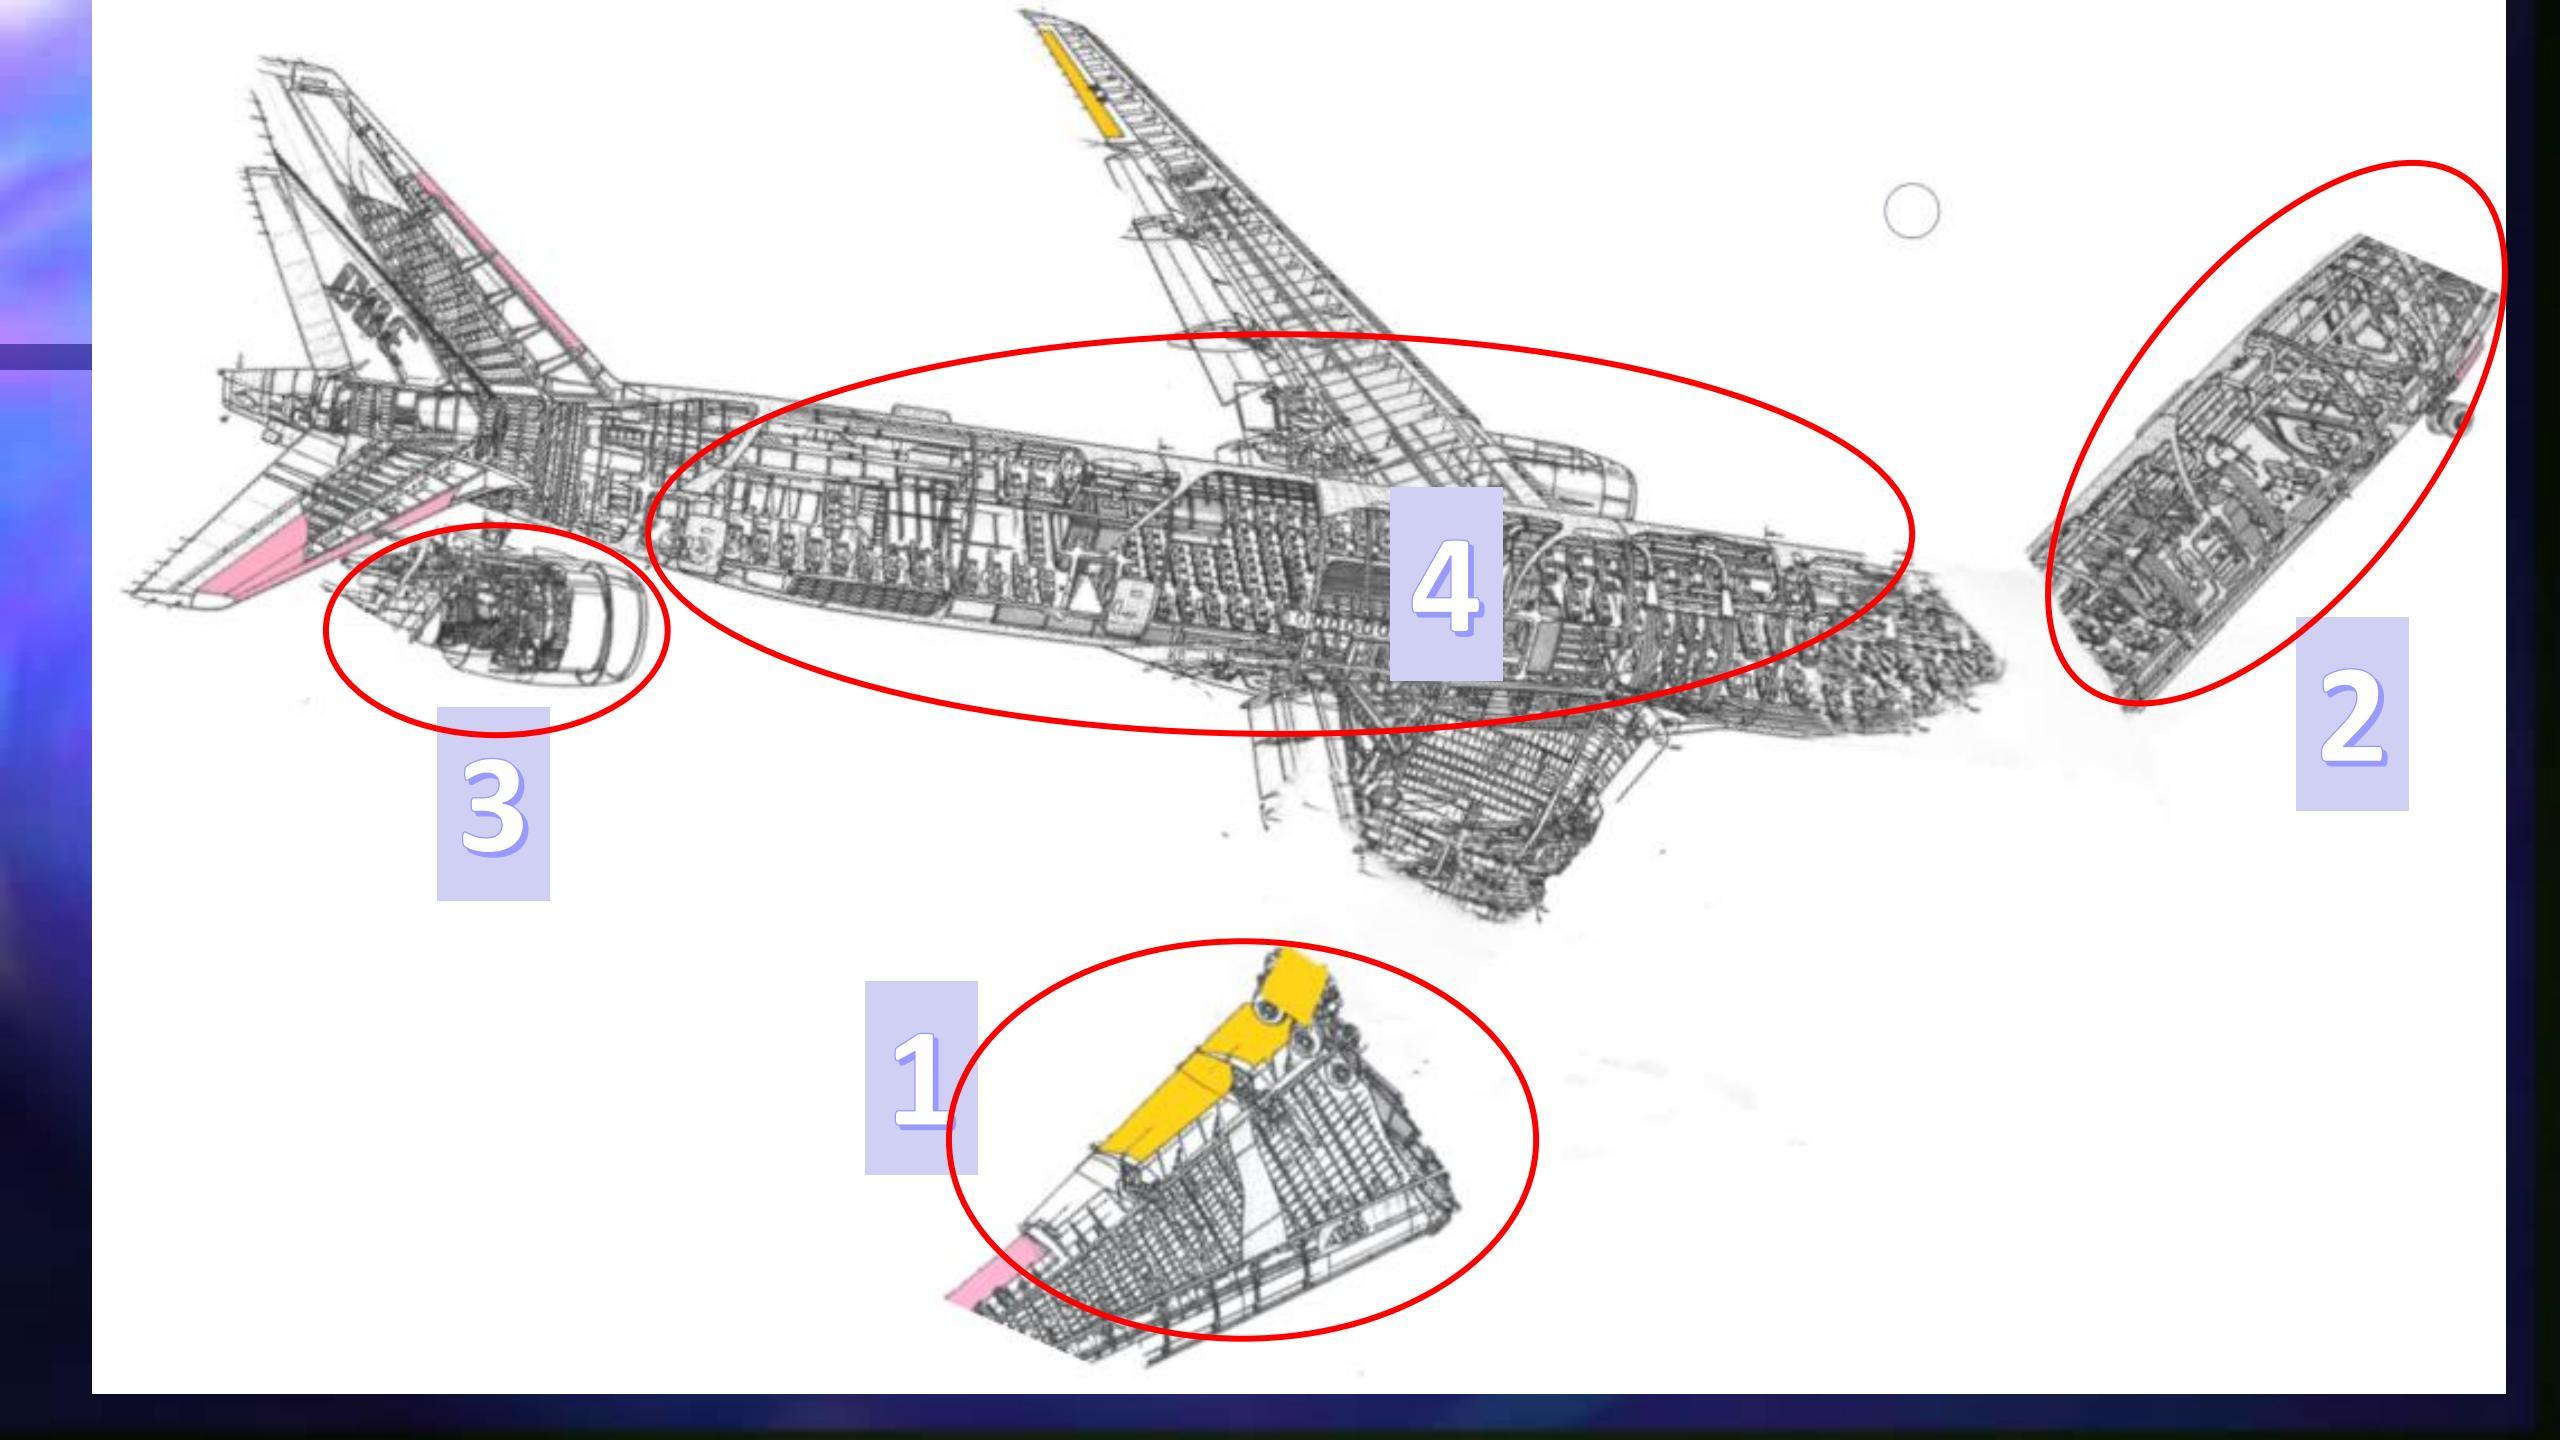
Violent wing first-impact with extreme upward bending leading to failure in Rib 25 area

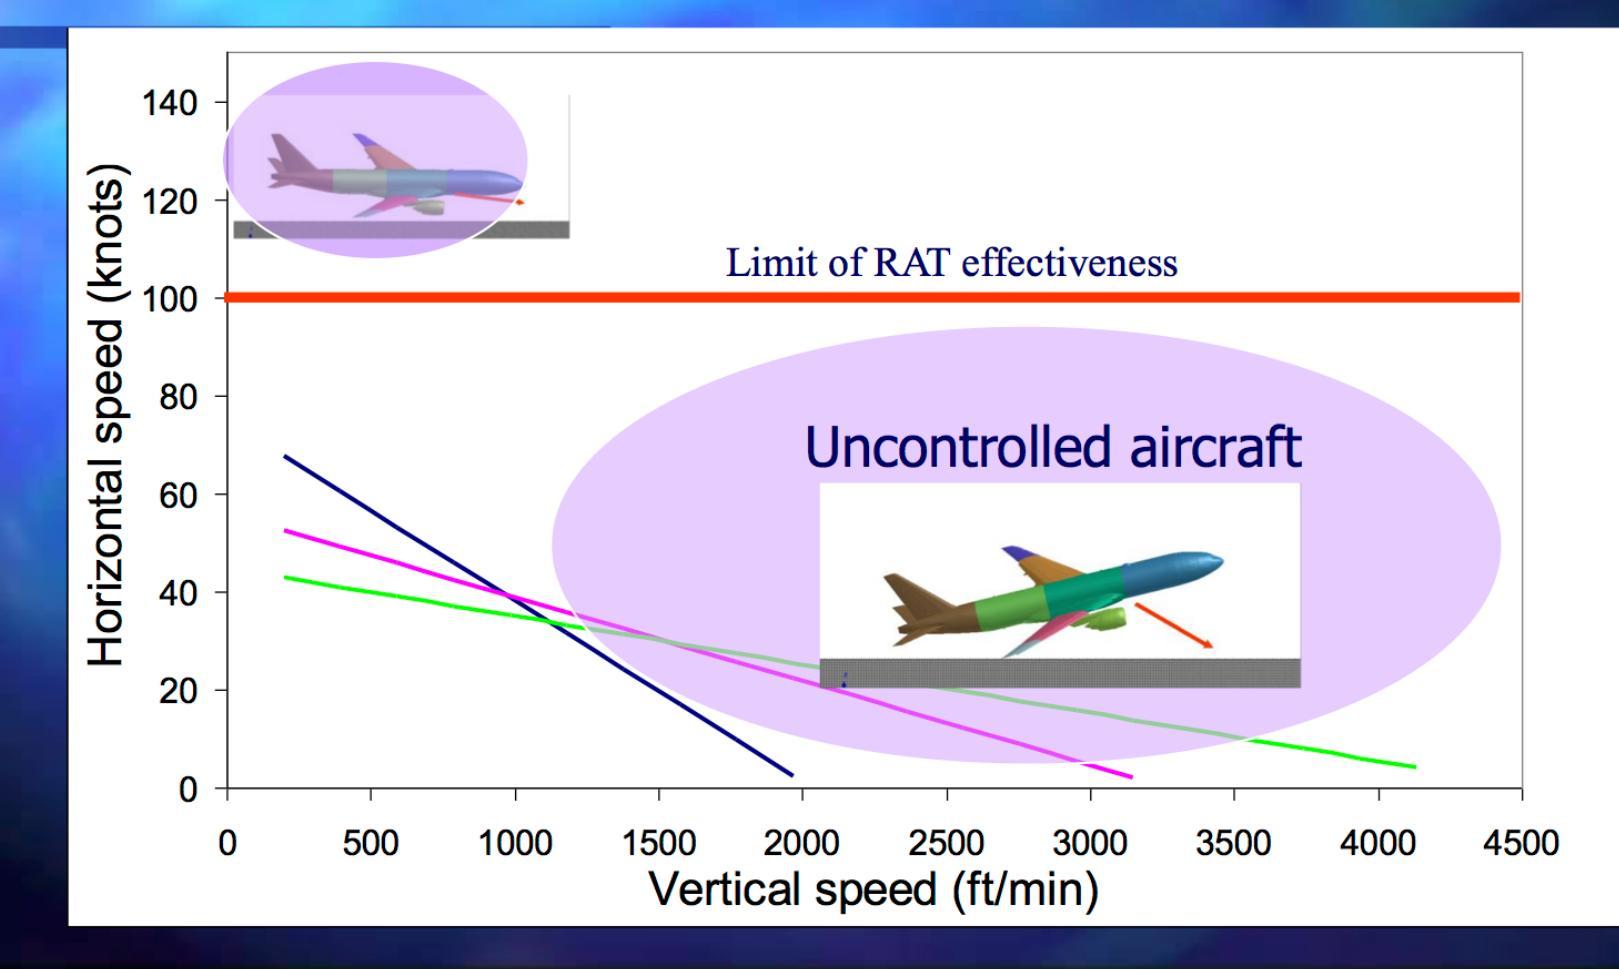
Privileging a " soft " ditching event (asymmetric first impact)

Satisfies the absence of debris floating mass in the ocean.
 Satisfies the recovery of limited debris parts, almost all originating from the right wing (including the right spoiler recently discovered).

Previledges hydrodynamic forces and satisfies the almost absence of fragment impacts upon the recovered debris.
 Assumes piloted aircraft to the end.

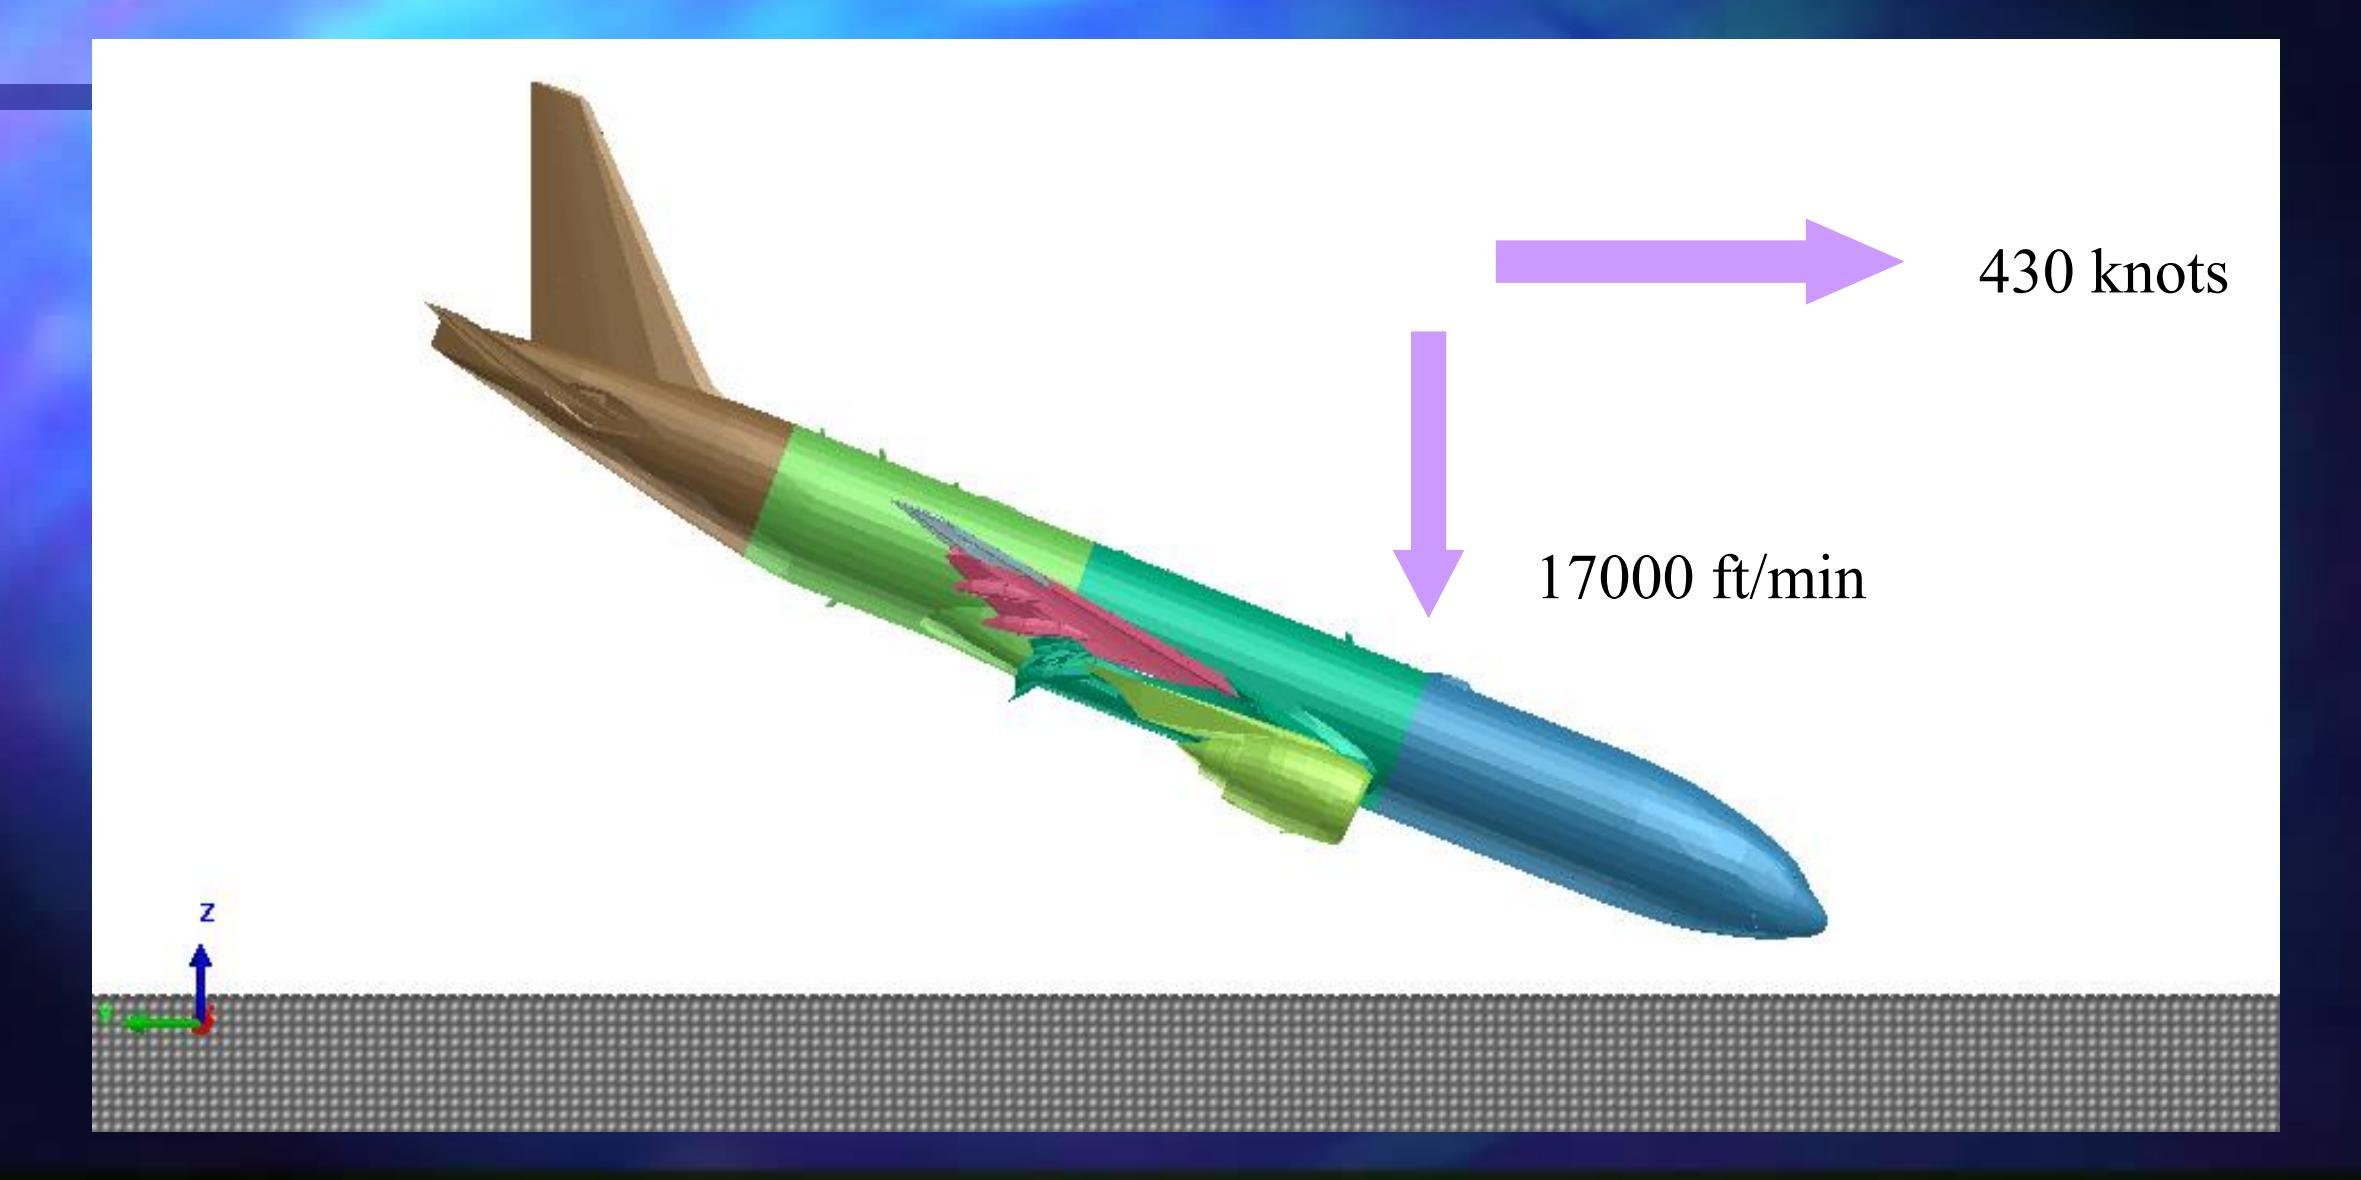
- Assumes the aircraft glided uncontrollably from cruise height.
 Assumes that it followed a complex phugoidal descent, in accordance to Boeing simulations.
- Some speculate that aeroelastic instabilities broke off the right wing.
- Some speculate that it hit the ocean with even supersonic speed.
 - Appears unlikely if the wing was broken due to asymmetry and increased drag coefficient.

Impact conditions with uncontrolled glide

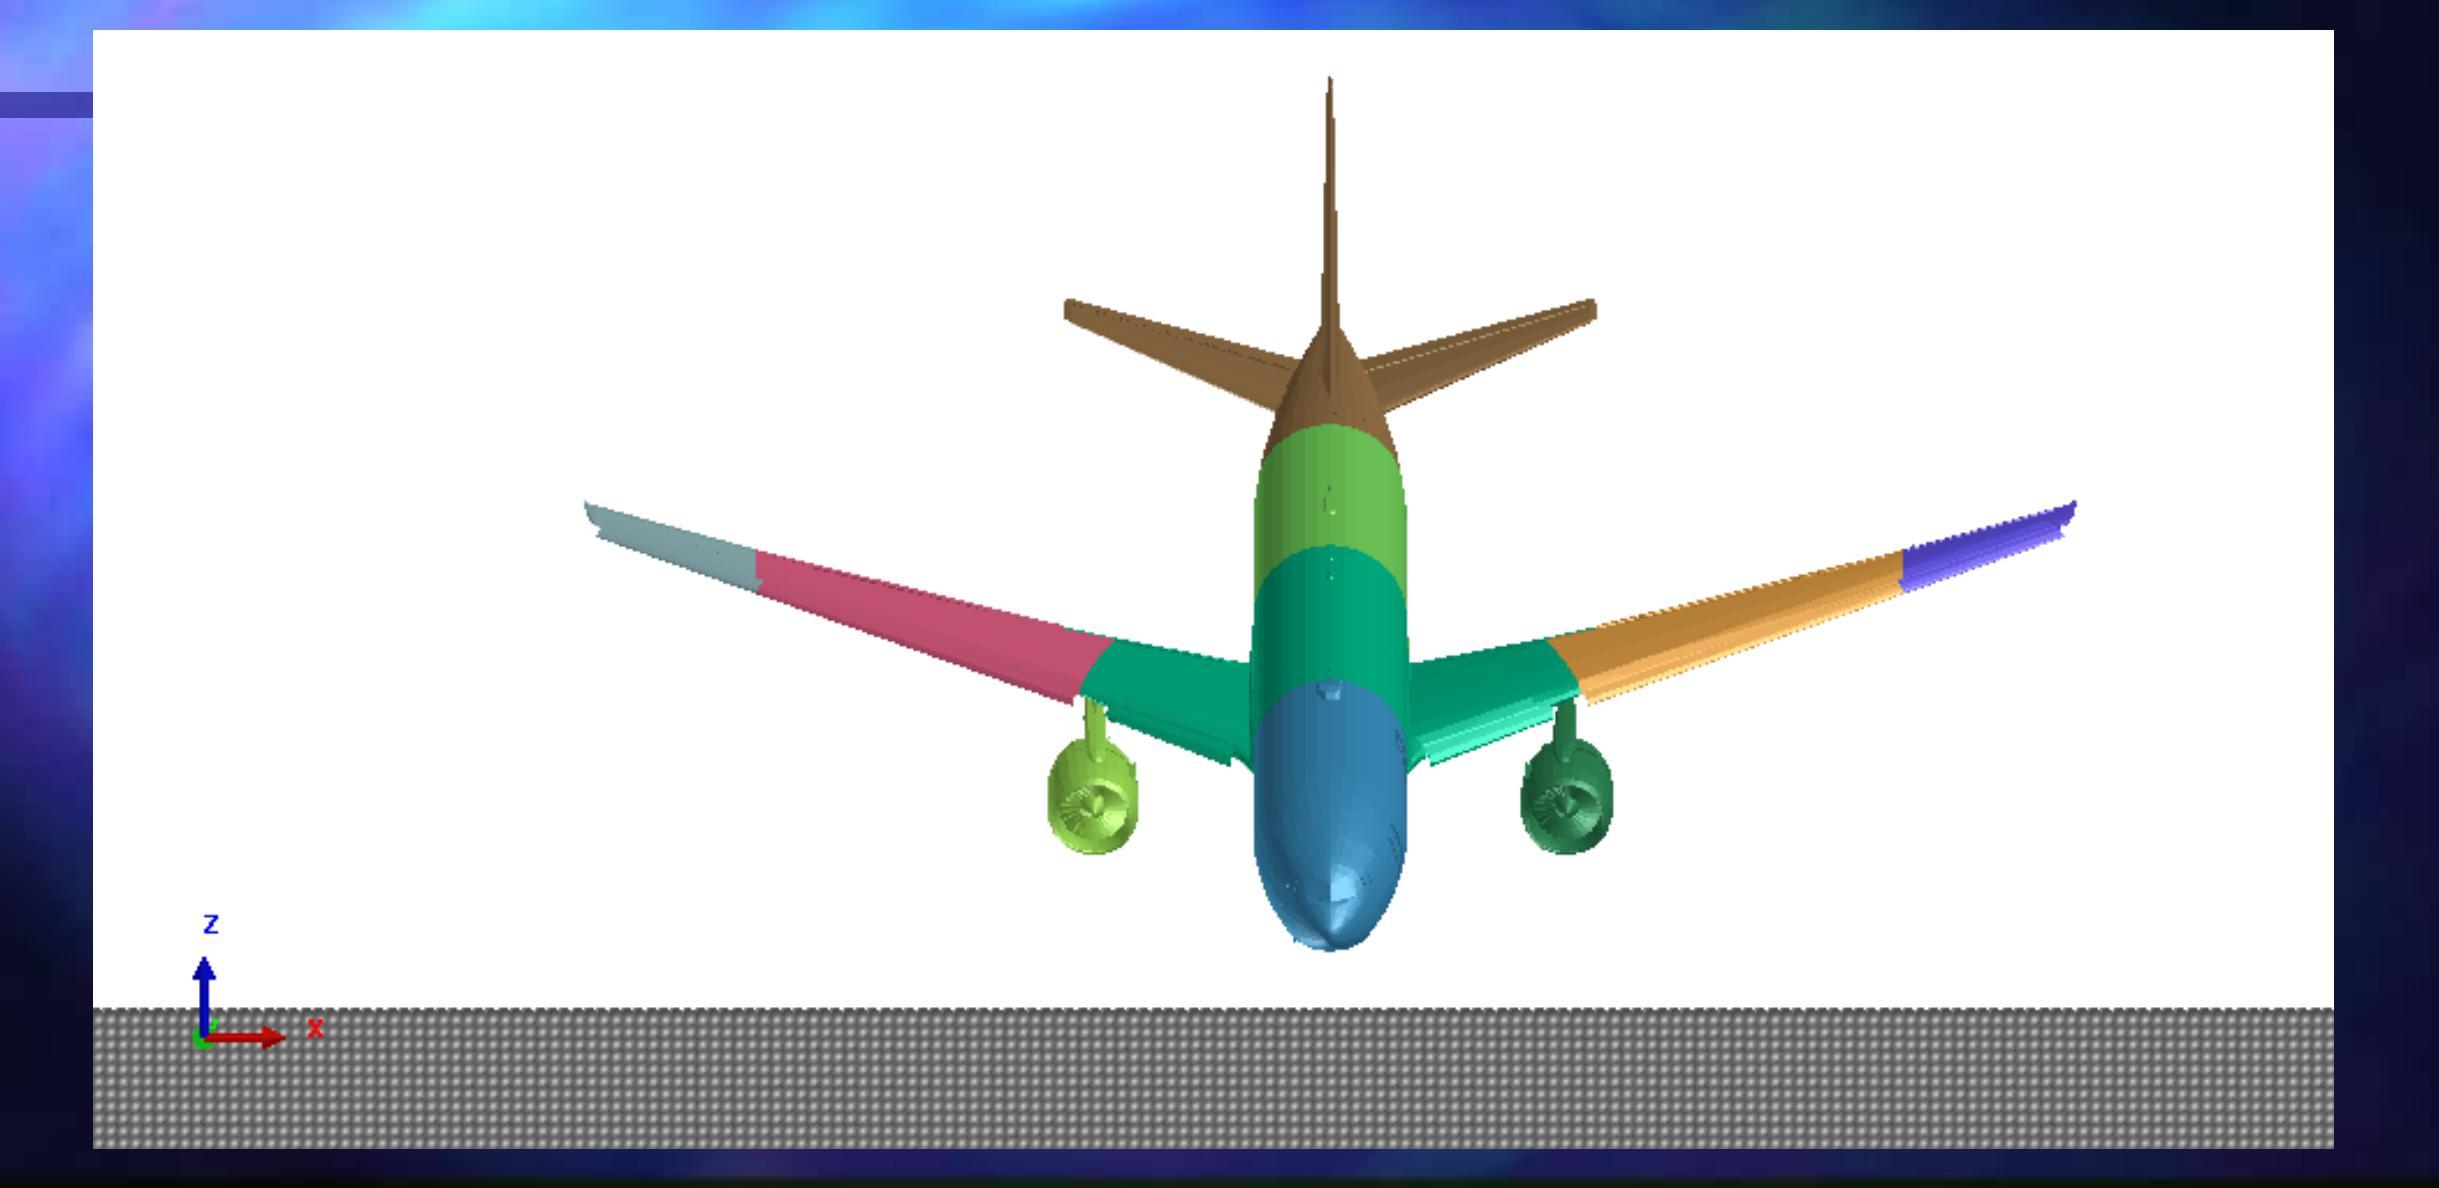
Impact conditions with uncontrolled glide

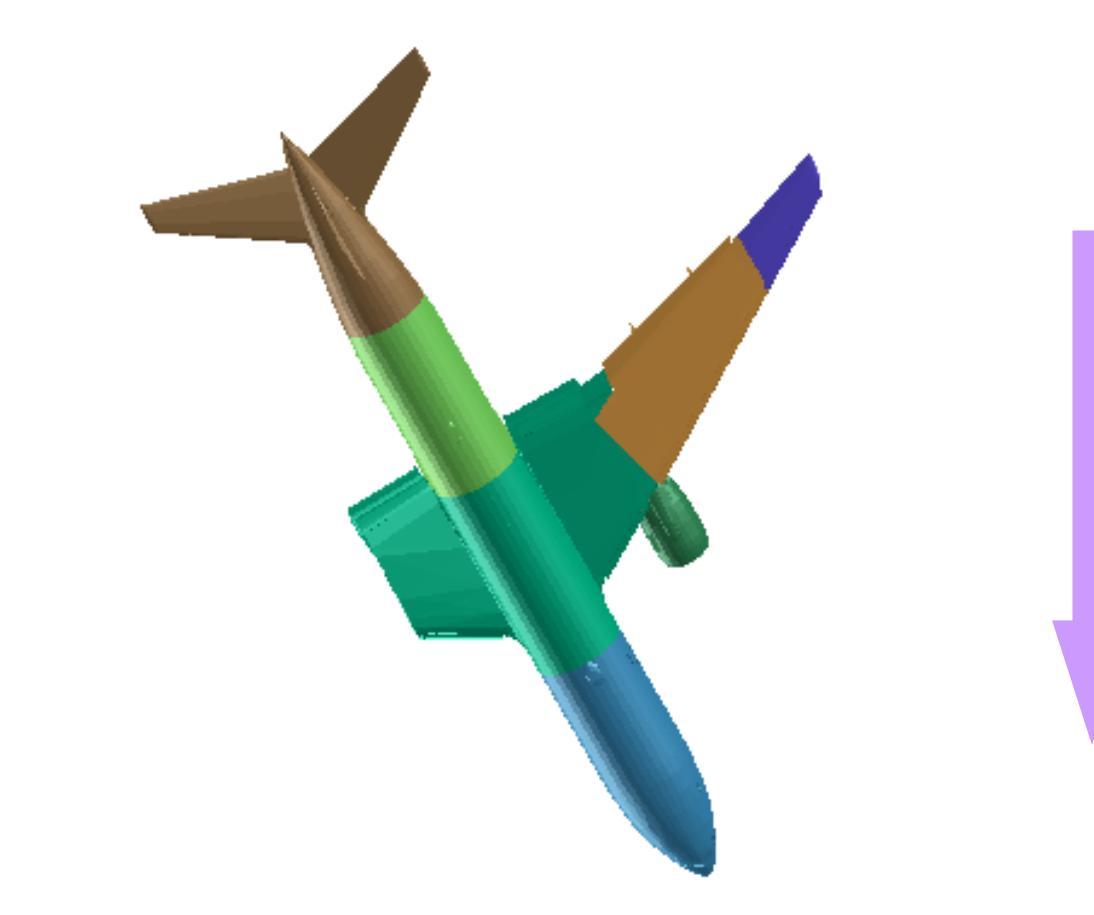
Uncontrolled glide – wing broken

Primarily very high vertical speed

- It leads to aircraft disintegration upon impact hence necessitates the creation of a significant debris floating mass over the ocean.
 In terms of vertical speed upon impact, similitude to the Rio-Paris accident or
 - the SwissAir mid-Atlantic accident.
- Does not satisfy the recovery of limited debris parts, almost all originating from the right wing.
- Privileges aerodynamic forces but does not necessarily agree with the state of overall damage of the discovered debris, if it had hit the ocean after a free fall from high altitude.
- Assumes unpiloted aircraft to the end.

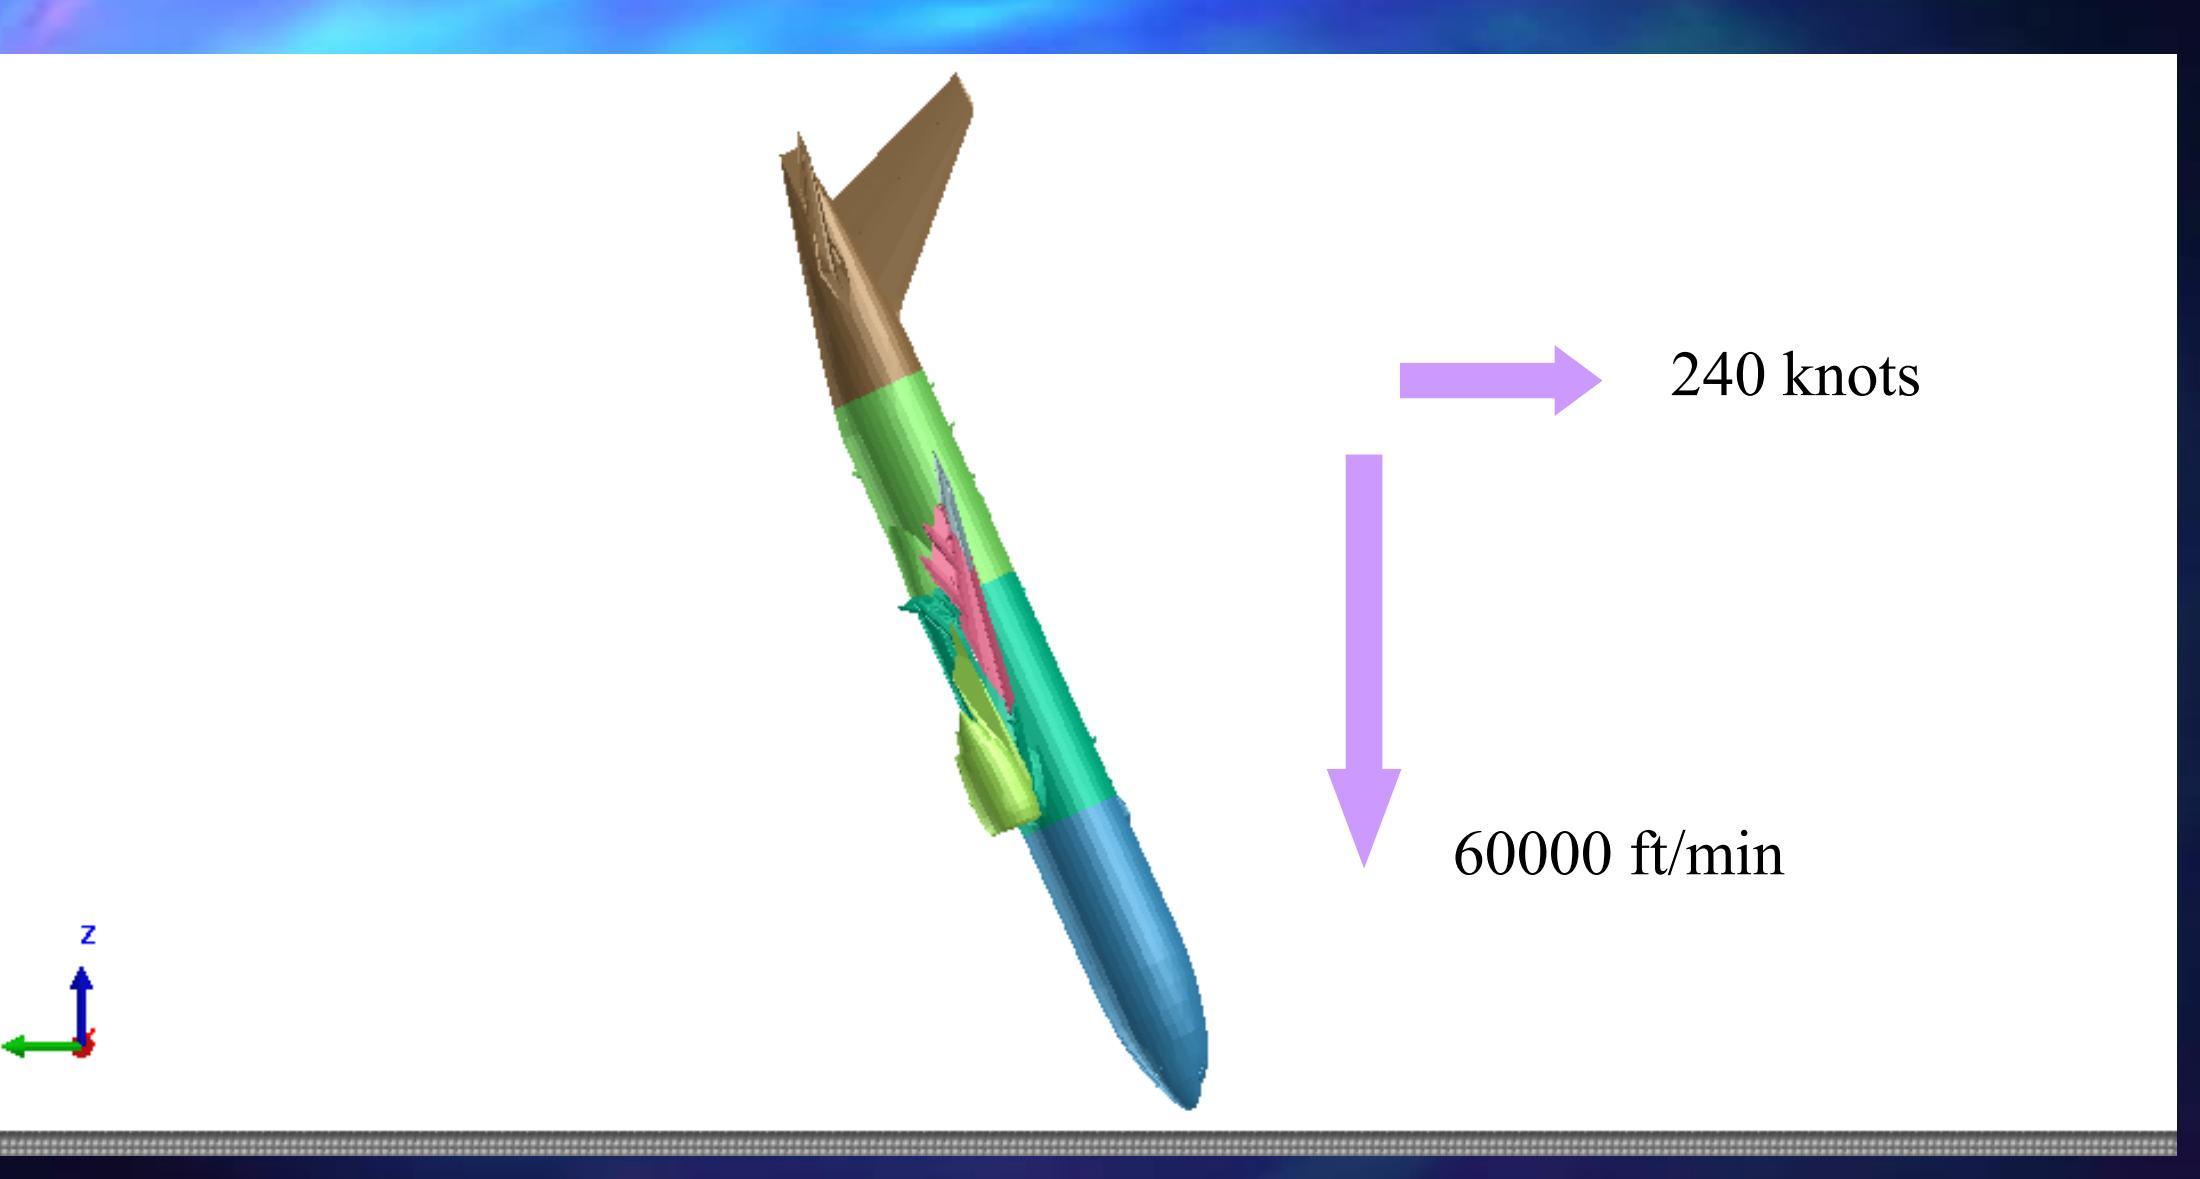
Piloted suicide

Assumes the aircraft glided ('dived") controllably from cruise height, along a glidepath of minimal lift.
 Assumes it hit the ocean in a streamlined path ('like a dart")
 Assumes that any aeroelastic instabilities were under control.
