Some scenarios for the last seconds of the MH370

Argiris Kamoulakos 5 March 2022

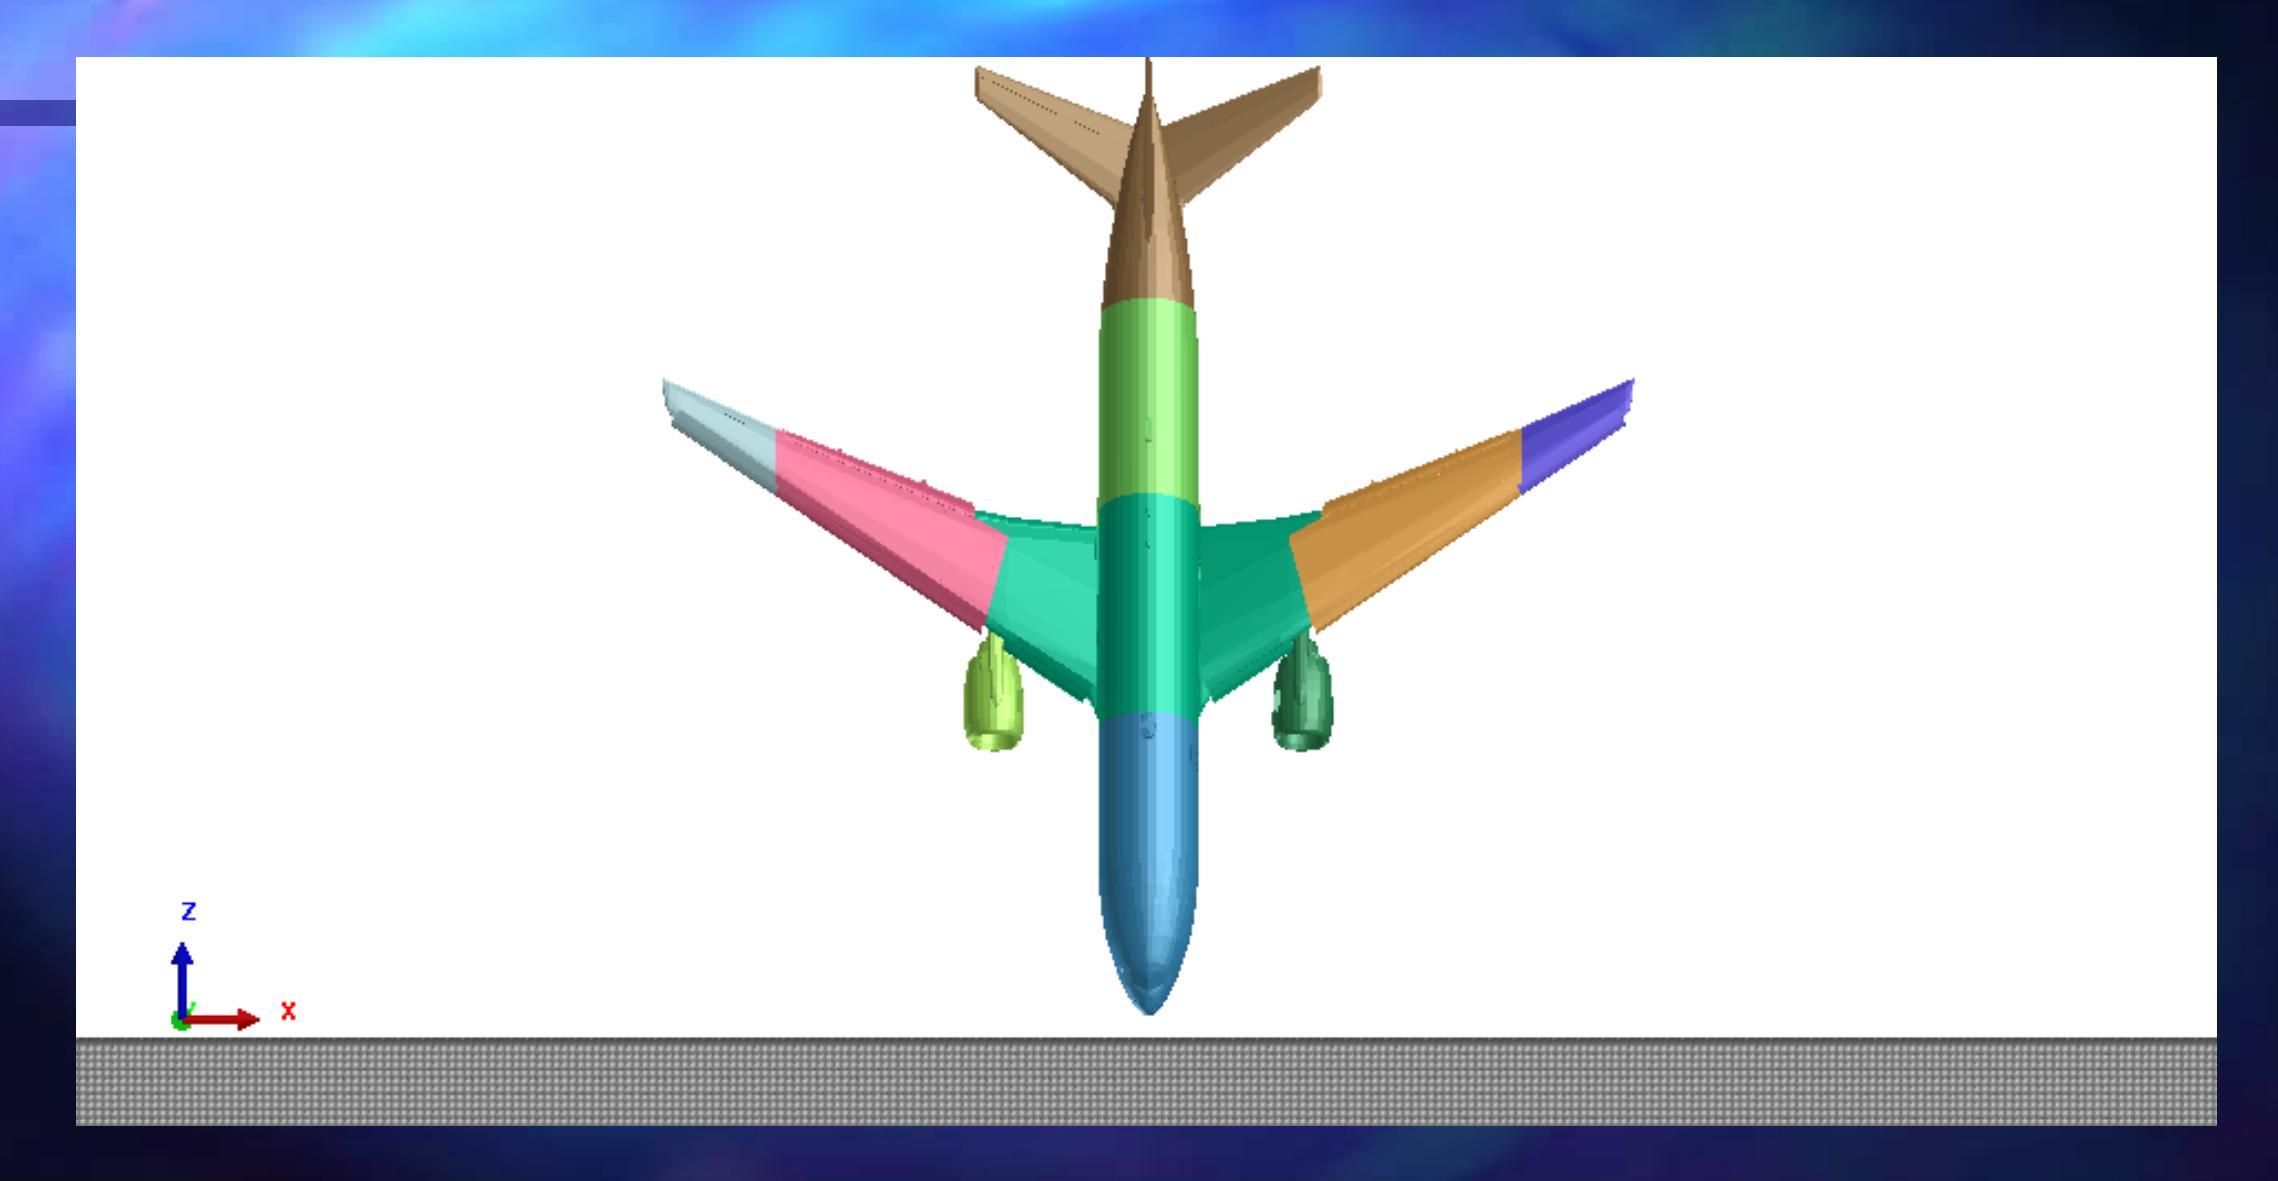
Piloted suicide

This is a ballistic type of event. It leads to aircraft destruction mostly after penetration into the ocean. The debris cloud might be inside the sea and probably sink fast. Might satisfy the recovery of limited debris parts, but not necessarily originating only from the right wing. Privileges hydrodynamic forces. Assumes piloted aircraft to the end.

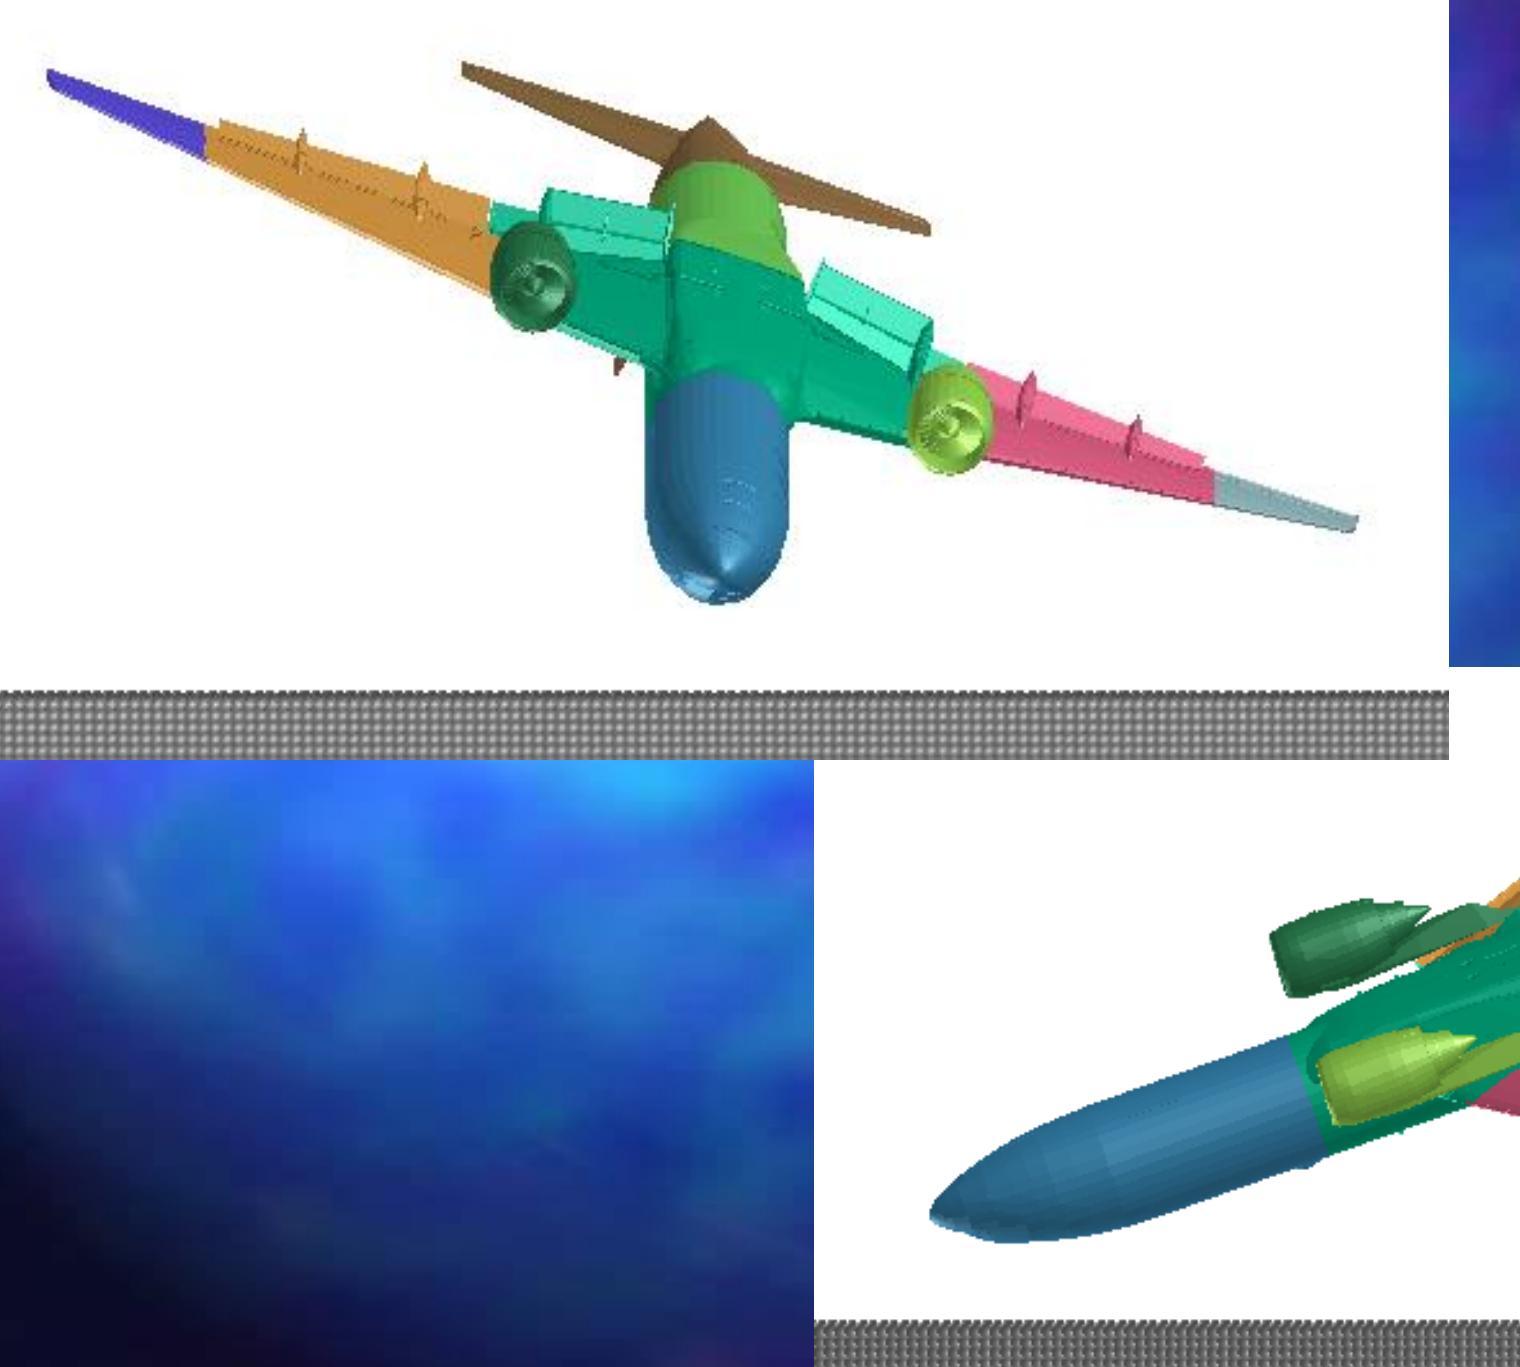
Inverted impact

It attempts to resolve the origin of damage to the flaperon by the water impact as the engine effect (which is normally in front of it) is now above it.

Hard to talk about debris in general but it will certainly include largely the tailplane, not only the wing.
